**Stephenson Street Flood Defence
Scheme, Newport, Wales**

**S38 and S278 Stage 1 Road Safety
Audit**

ARP-RP-RSA-01

Issue | 28 January 2021

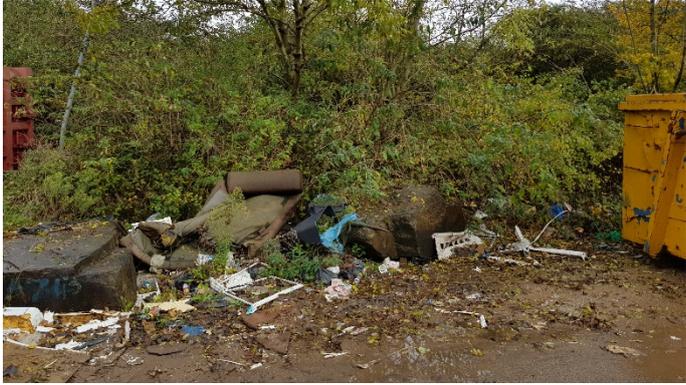
Location:	Existing East Bank Road
Drawing(s):	274580-ARP-XX-XX-DR-CX-1101
Summary:	Misuse of turning head leading to reversing collisions.
Problem:	<p>A turning head is proposed on the severed East Bank Road that could be used for parking and/or fly tipping, preventing a vehicle from using the turning head to turn around.</p> <p>Drivers unable to use the turning head may be forced to reverse for a significant distance and risk colliding with other road users whilst reversing.</p>
Photograph:

<p><i>Fly-tipping is already a problem in the industrial estate</i></p>
Recommendation:	Implement parking restrictions so that the turning head is not obstructed by vehicles and remove vegetation to discourage fly-tipping.
