# Kenson River Restoration

## Preliminary Roost Assessment

Prepared for  
Natural Resources Wales

Date  
16/04/2026

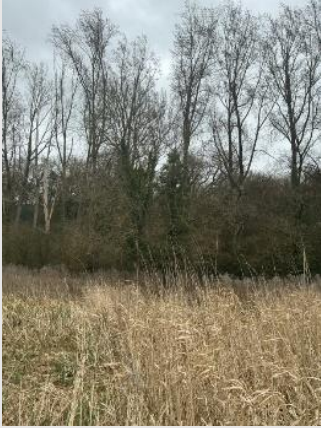
Tree/Group Number	Species	Notes	Photo	Bat Roost Suitability
Group 1	Hawthorn	Group of 10 small, scattered trees. No PRF noted and due to small size unsuitable to support roosting bats.

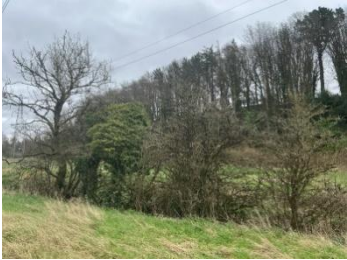
Tree/Group Number	Species	Notes	Photo	Bat Roost Suitability
Group 5	Willow, Hawthorn, Ash	Group of 11 scattered trees and bank side scrub. No PRF noted.

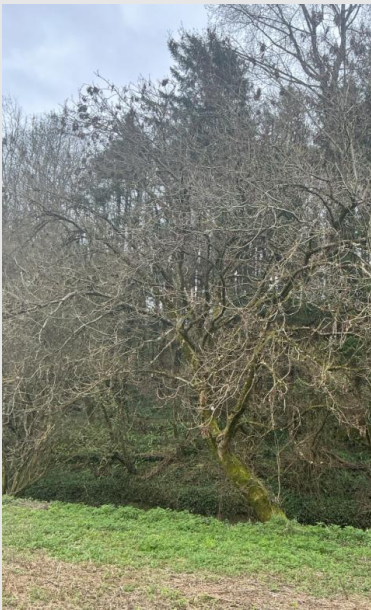
Negligible
Tree 25	Ash	Ash dieback disease (stage 4).  One PRF noted in form of small hole on upper tunk.

Low

For the three trees that have been assessed as having Low suitability for bat roost potential soft felling methods should be used during tree removal. Parts of the tree where low potential roost features have been identified should be removed by making cuts away from the feature, with this section then lowered gently to the ground. This trees section should then be leant against a standing tree for 24 hours with the roost feature facing outwards to allow any bat present to fly out overnight. Removal should ideally be carried out in autumn or spring, a time period less sensitive to bats.

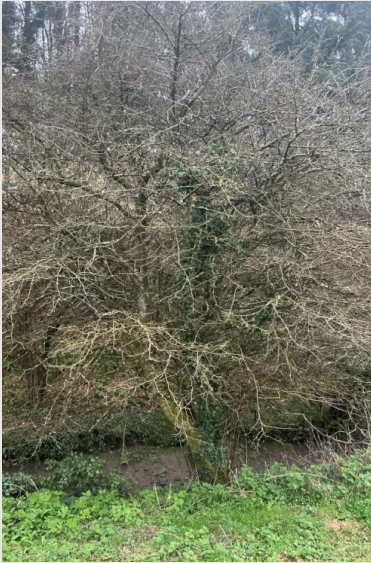
Tree/Group Number	Species	Notes	Photo	Bat Roost Suitability
Tree 25a	Ash	Ash dieback disease (stage 4). PRF in form of extensive ivy on right stem.

Low
Tree 26	Hawthorn	No PRF noted and due to small size unsuitable to support roosting bats.

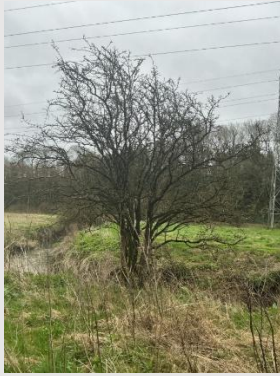
Tree/Group Number	Species	Notes	Photo	Bat Roost Suitability
Tree 30	Hawthorn	No PRF noted and due to small size unsuitable to support roosting bats.

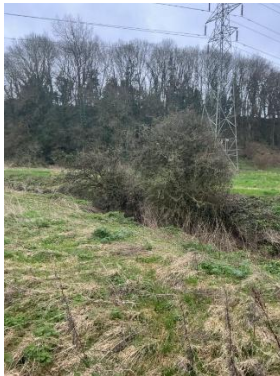
None
Tree 31	Hawthorn	No PRF noted and due to small size unsuitable to support roosting bats.

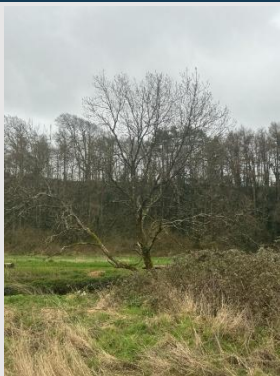
None
Tree 32	Ash	One PRF noted in form of small crack on upper trunk.

Low
Tree 33	Oak	Trees have been felled since arboricultural impact assessment was completed.		
Tree 34	Field Maple			
Tree 35	Field Maple			
Tree 36	Sycamore			
Tree 37	Field Maple			
Tree 38	Field Maple			
Tree 39	Goat Willow			
Tree 40	Ash
