# **PEN-YR-ENGLYN**

## Geotechnical Desk Study

**Project no. 4021526**

Natural Resources Wales

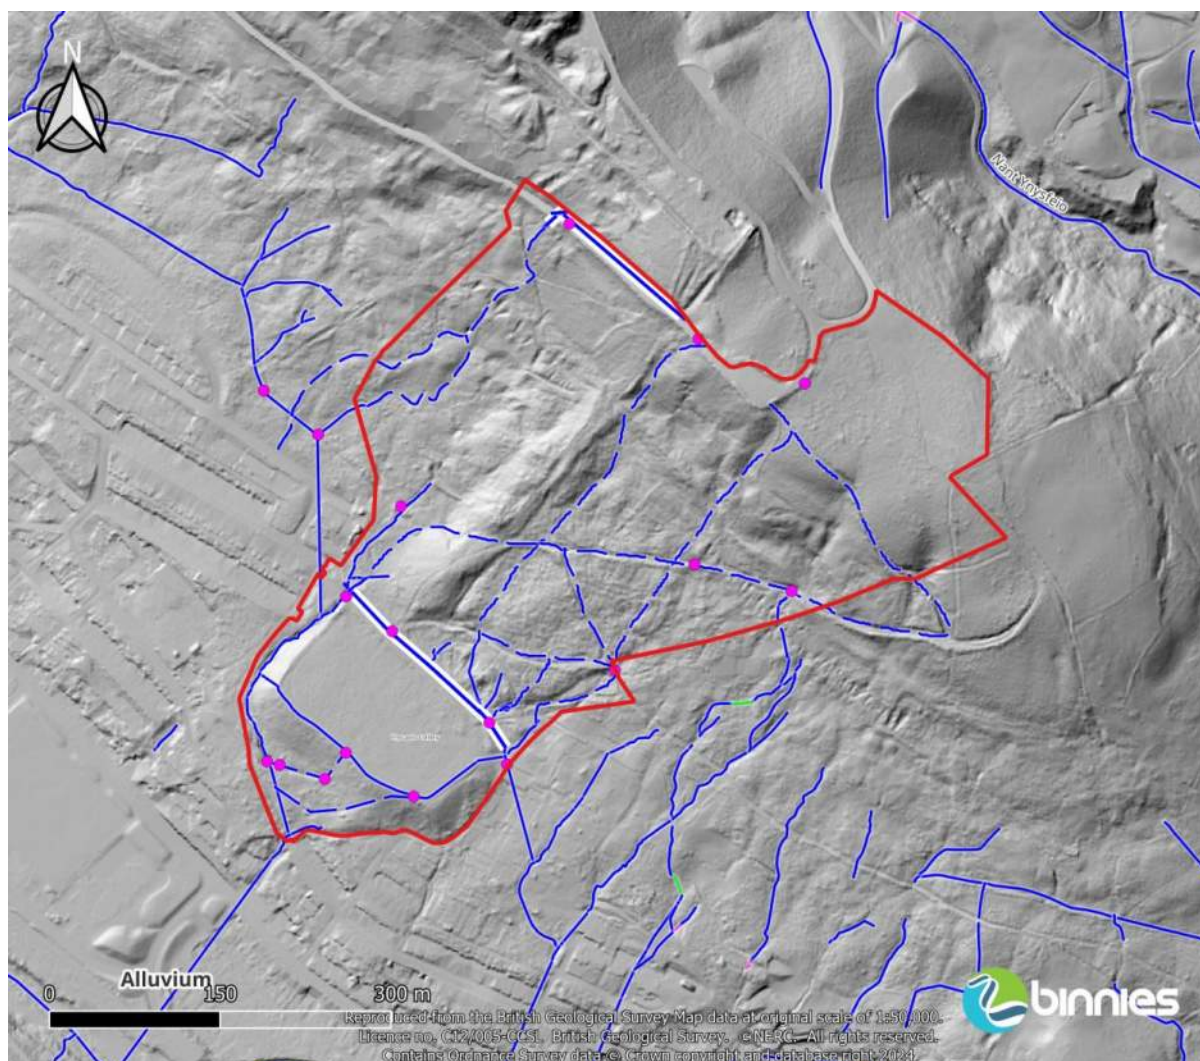
**Figure 7: Hydrology mapping including Binnies observed surface water flow pathways (blue-dashed) and culvert locations (pink)**

Based on historical mapping several issues (springs) were present prior to the tipping of any spoil which indicates that there may be a naturally occurring spring line beneath the spoil. The spring line is presumed to be associated with the upper extent of the glacial till which has a low permeability reducing the ability for groundwater to flow vertically into the more permeable middle coal measures.

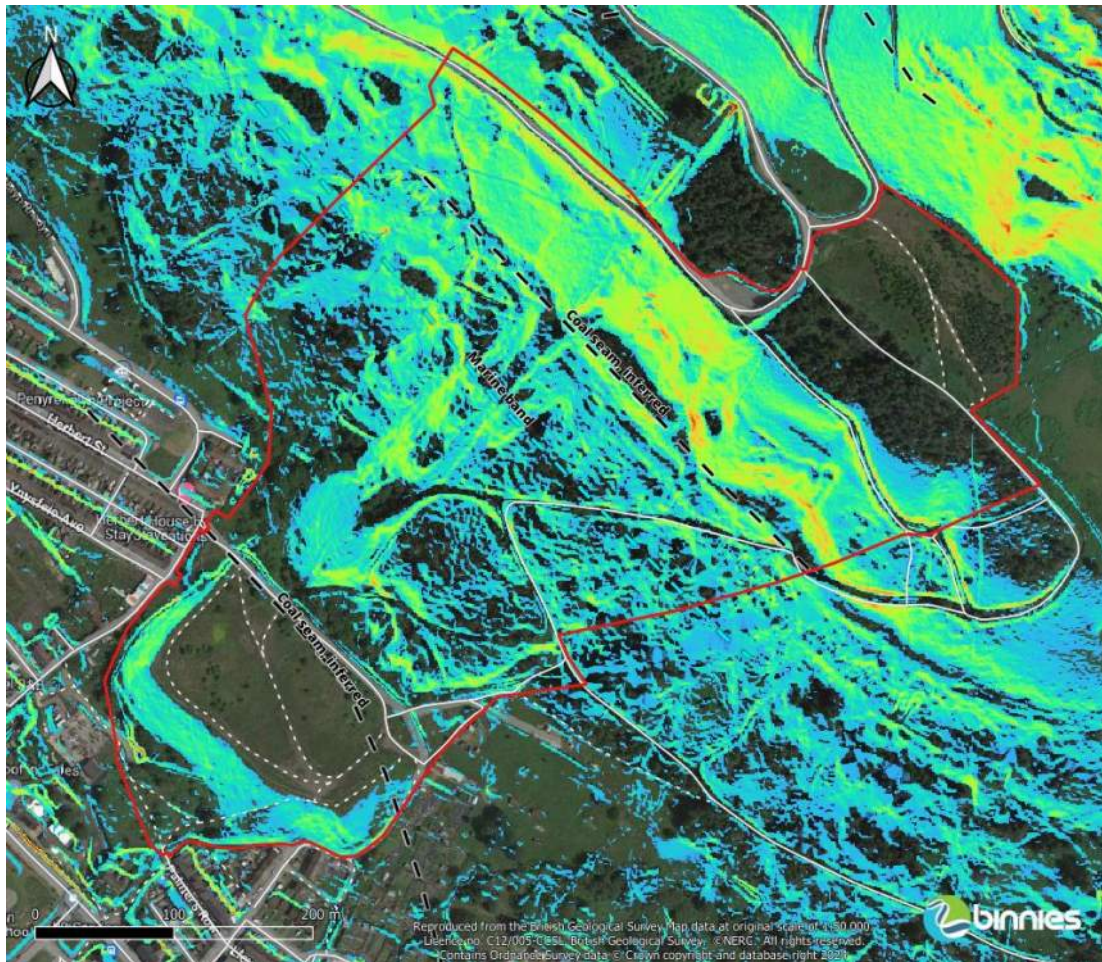
**Figure 11: Map of topographic slope angle analysis that highlights slope angles between 16 (blue) to a maximum of 72° (red) at a resolution of 1m.**

The South East tips on Pen Yr Englyn have historically shown signs of potential instability. The ground model developed from recent topographic measurements and historic ground investigation data shows that the upper part of this area would fail over a depth not exceeding 15m, which would result in a failure length of between 58 and 160m (average 100m, in accordance with the findings of Jennings & Siddle, (1998). The distance from this

failure location to the lower site boundary is around 250m (ie approximately 90m further than the longest potential failure length) so it is most likely that any failure will be contained within the site.

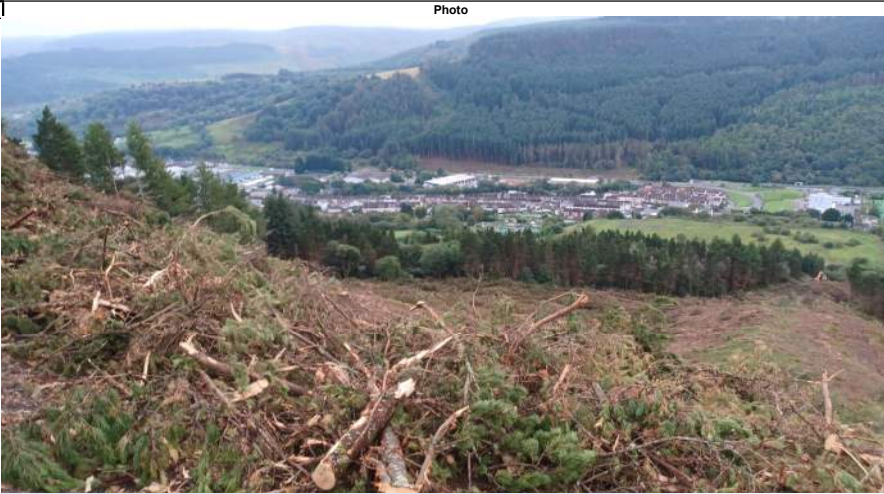
| Photo ID | Easting | Northing | Notes | Photo |
|---|---|---|--|--|
| 5 | -391840.4888 | 6741218.42 | Logs and brash making up down slope side of forestry track | |

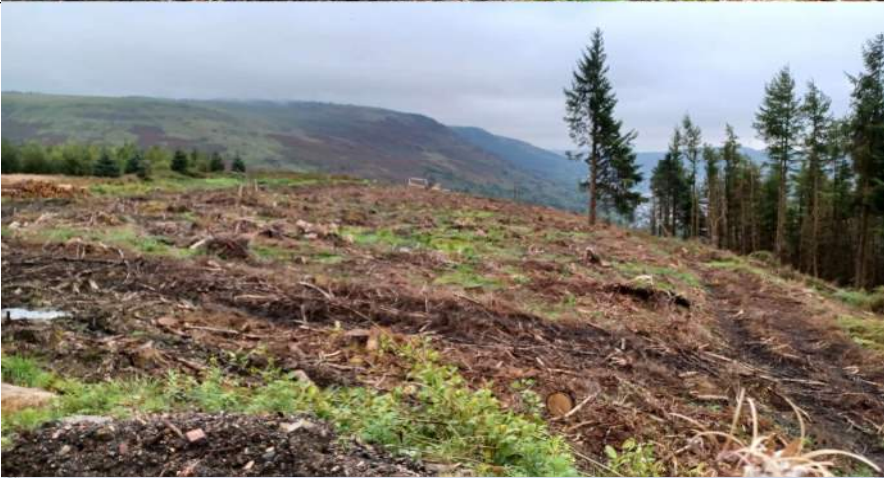
| Photo ID | Easting | Northing | Notes | Photo |
|---|---|---|--|--|
| 10 | -391687.6471 | 6741128.377 | Gentle slope dipping east. | |

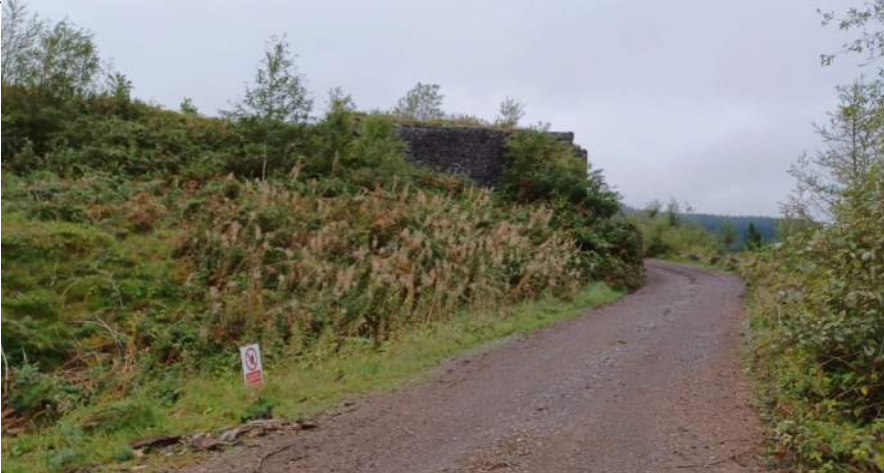
| Photo ID | Easting | Northing | Notes | Photo |
|---|---|---|--|--|
| 15 | -391721.5872 | 6741336.195 | Stoned track | |

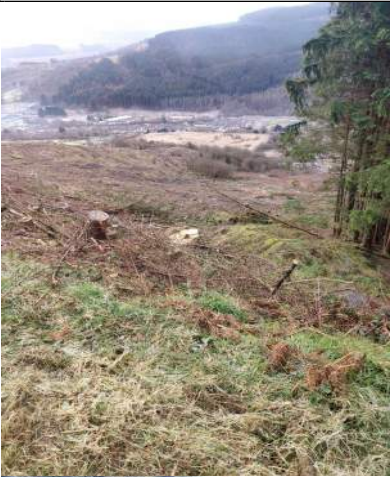
| Photo ID | Easting | Northing | Notes | Photo |
|---|---|---|--|--|
| 76 | -392056.5354 | 6741401.618 | Natural drainage channel forming around tree stumps. | |

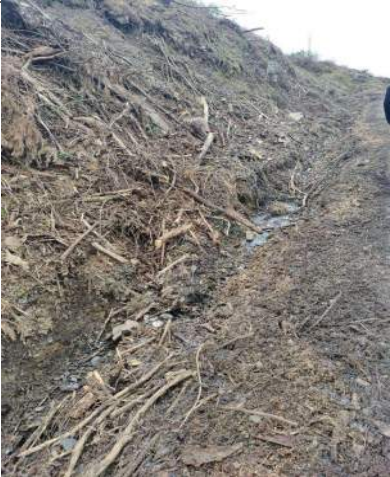
| Photo ID | Easting | Northing | Notes | Photo |
|---|---|---|--|--|
| 77 | -391891.118 | 6741283.264 | Blocked concrete lined channel from brash | |

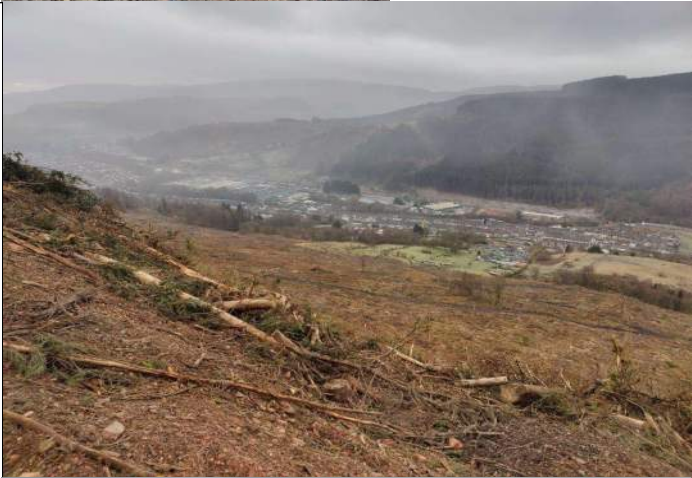
| Photo ID | Easting | Northing | Notes | Photo |
|---|---|---|--|--|
| 80 | -391781.9792 | 6741151.588 | Steep slope below forestry track. Limited tip material identified. | |

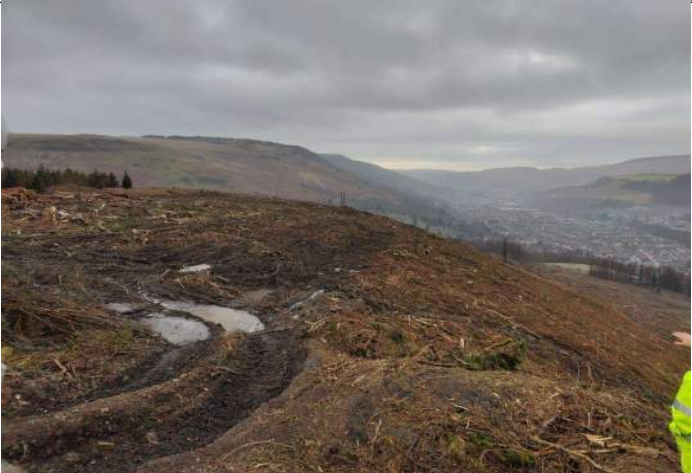
| Photo ID | Easting | Northing | Notes | Photo |
|---|---|---|--|--|
| 83 | -391722.1773 | 6741112.124 | Soft, waterlogged forestry track. | |

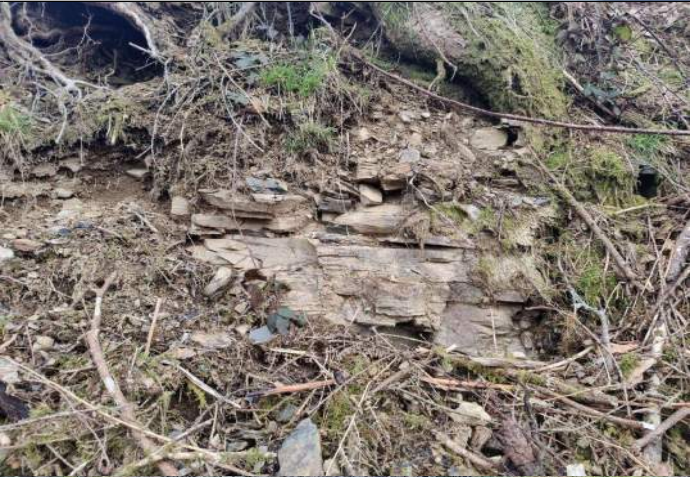
| Photo ID | Easting | Northing | Notes | Photo |
|---|---|---|---|--|
| 102 | -391580.8483 | 6740807.262 | Exposed weathered mudstone | |

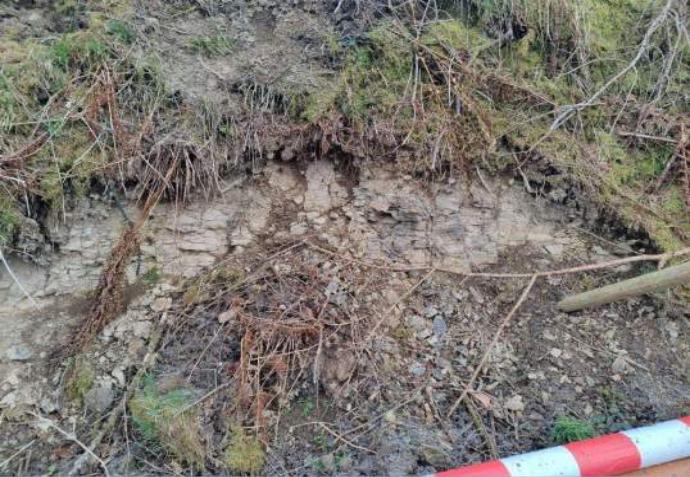
| Photo ID | Easting | Northing | Notes | Photo |
|---|---|---|---|--|
| 103 | -391598.6839 | 6740817.707 | Exposed weathered bedrock indicating no tip material. | |

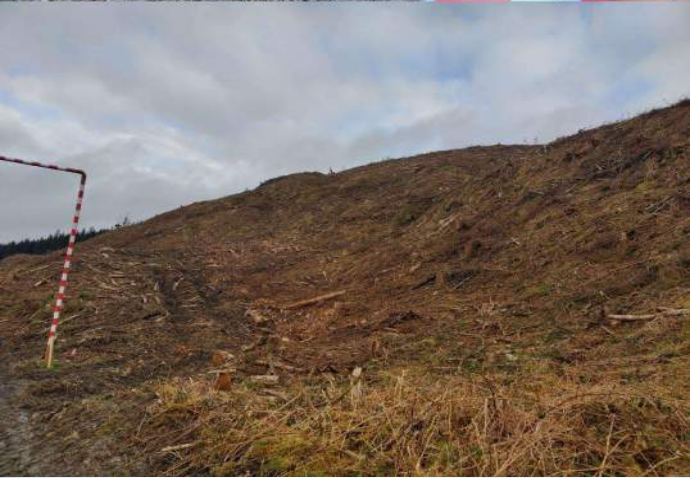
| Photo ID | Easting | Northing | Notes | Photo |
|---|---|---|---|--|
| 105 | -391634.4909 | 6740832.124 | Eastern extent of tip material | |

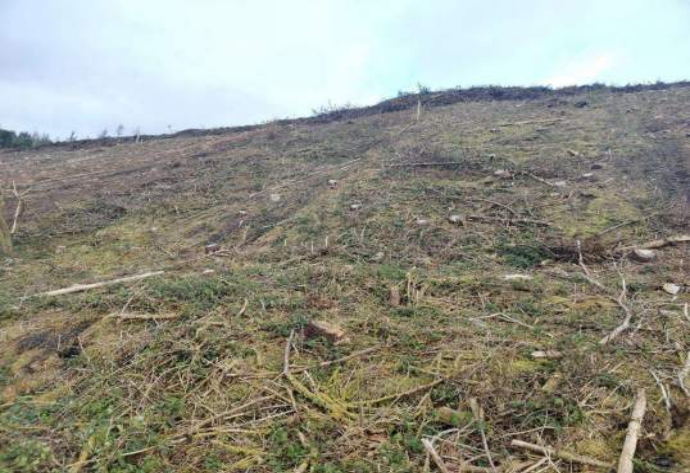
| Photo ID | Easting | Northing | Notes | Photo |
|---|---|---|---|--|
| 112 | -391961.6968 | 6741146.996 | Overgrown tip covering evidence of historic failure. No evidence on tension cracks or recent movement observed. | |

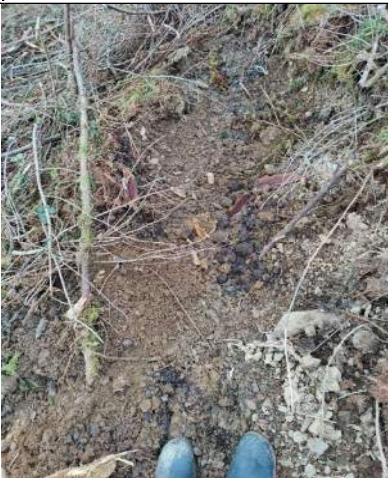
| Photo ID | Easting | Northing | Notes | Photo |
|---|---|---|--|--|
| 117 | -391930.5496 | 6741256.034 | Weathered bedrock exposed at the edge of historic tramway | |

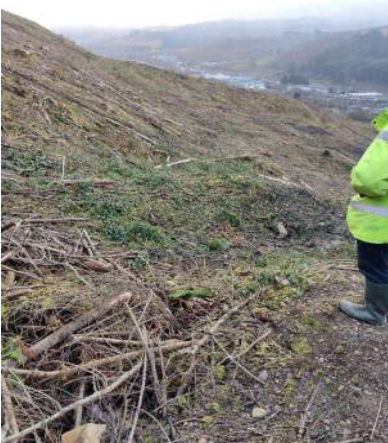
| Photo ID | Easting | Northing | Notes | Photo |
|---|---|---|--|--|
| 120 | -392053.5164 | 6741297.631 | Small gully developing along pathway of a small stream flowing through it. Steam not visible but audibly flowing under brash. Thought to be linked with culvert on forestry track. | |

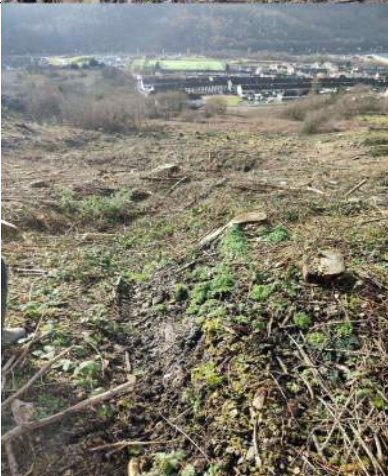
| Photo ID | Easting | Northing | Notes | Photo |
|---|---|---|--|--|
| 122 | -392048.32 | 6741211.636 | Water present in natural gully | |

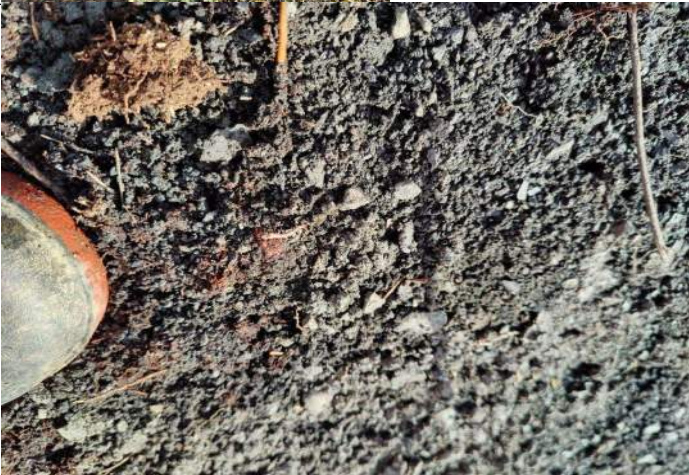
| Photo ID | Easting | Northing | Notes | Photo |
|---|---|---|--|--|
| 123 | -392058.4234 | 6741114.422 | Fine clayey material at base of the historic tip. Evident on weathered bedrock rather than tip material. | |

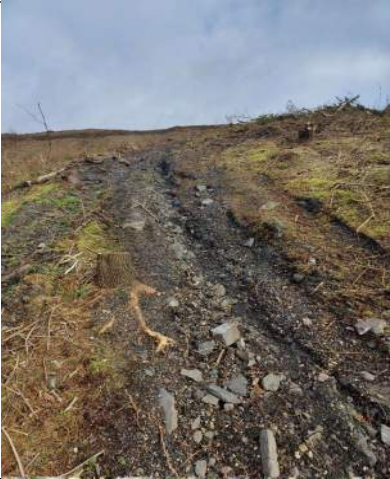
| Photo ID | Easting | Northing | Notes | Photo |
|---|---|---|---|--|
| 126 | -392204.5825 | 6740848.316 | Spoil visible on track | |

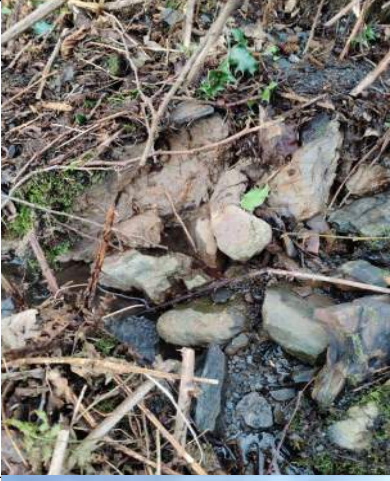
| Photo ID | Easting | Northing | Notes | Photo |
|---|---|---|---|--|
| 129 | -392060.4739 | 6740676.716 | Till lining spring | |

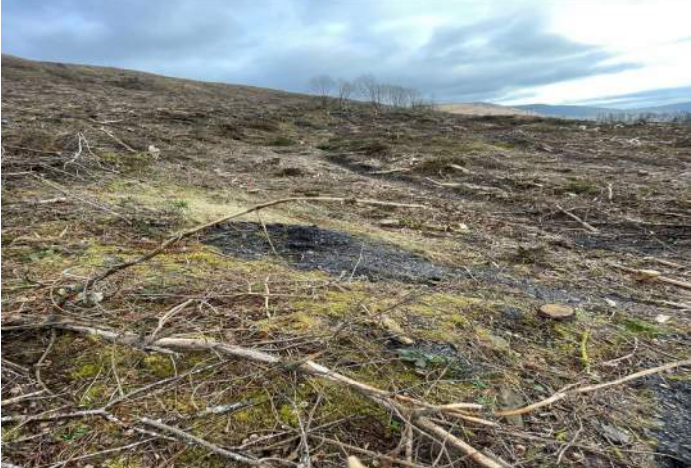
| Photo ID | Easting | Northing | Notes | Photo |
|---|---|---|---|--|
| 133 | -392097.9124 | 6740907.399 | Minor spring | |

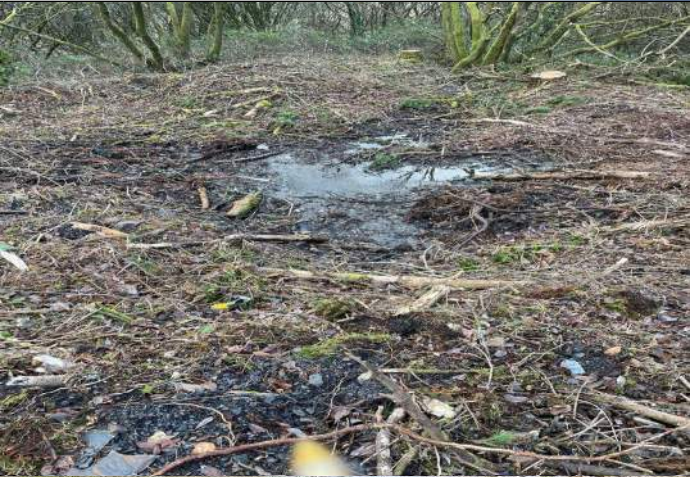
| Photo ID | Easting | Northing | Notes | Photo |
|---|---|---|---|--|
| 134 | -392094.5095 | 6740751.057 | Collection of springs indicating groundwater seeping below forestry track | |

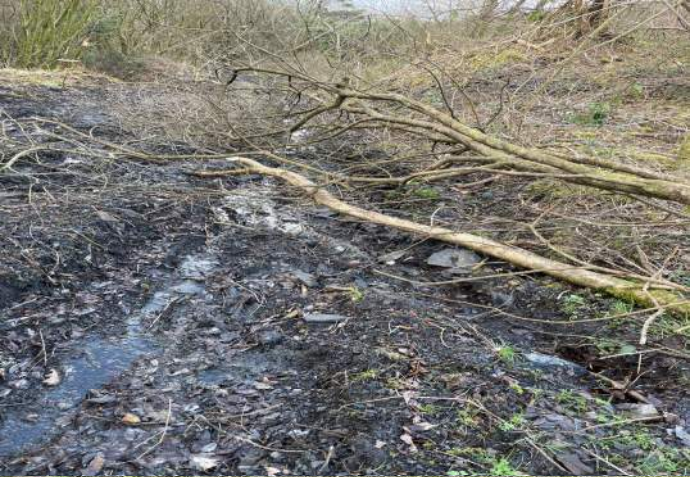
| Photo ID | Easting | Northing | Notes | Photo |
|---|---|---|---|--|
| 135 | -392114.8406 | 6740792.599 | Spring with stream tributating to forestry track stream | |

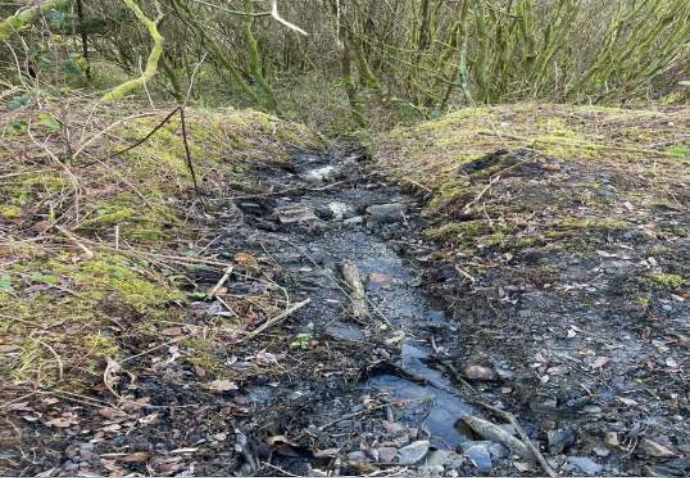
| Photo ID | Easting | Northing | Notes | Photo |
|---|---|---|---|--|
| 136 | -392126.4552 | 6740801.745 | Spring | |

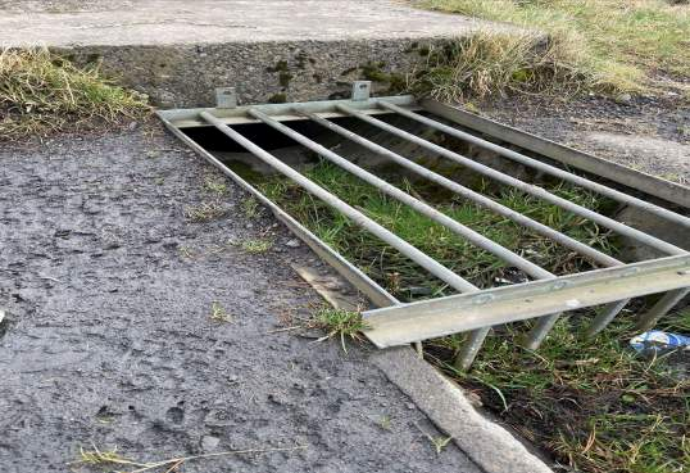
| Photo ID | Easting | Northing | Notes | Photo |
|---|---|---|---|--|
| 145 | -392204.8799 | 6740554.888 | Drain | |

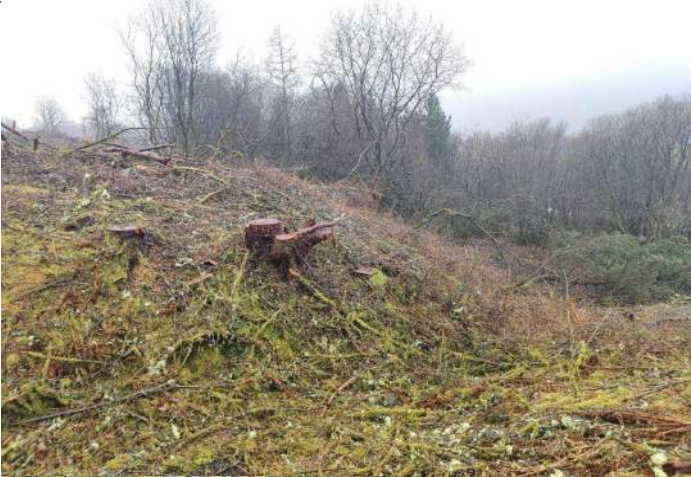
| Photo ID | Easting | Northing | Notes | Photo |
|---|---|---|--|--|
| 151 | -392148.1068 | 6740841.838 | Steep face at the toe of the slope. Roots are likely improving stability but will decrease over time due to deforestation. | |

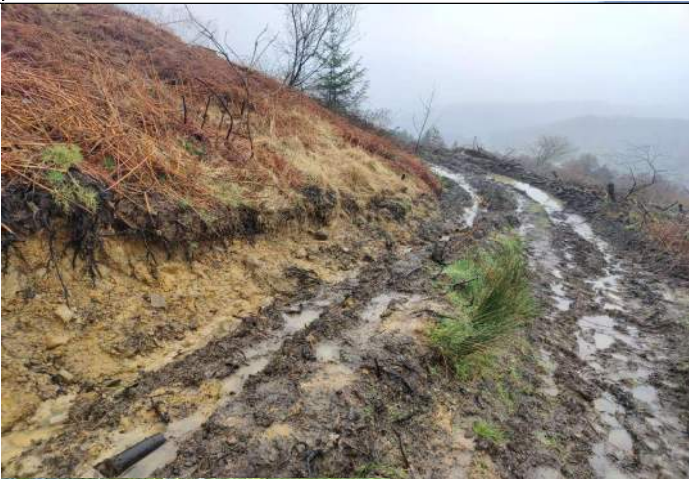
| Photo ID | Easting | Northing | Notes | Photo |
|---|---|---|---|---|
| 161 | -391920.5119 | 6740732.581 | Exposed<br>Glacial Till | |

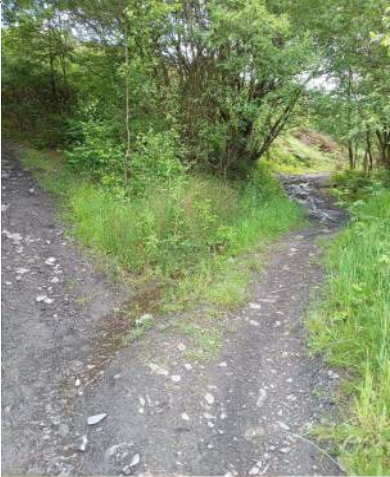
| Photo ID | Easting | Northing | Notes | Photo |
|---|---|---|---|---|
| 171 | -392227.5466 | 6740796.315 | Seepage<br>from tip<br>flowing after<br>a dry spell of | |

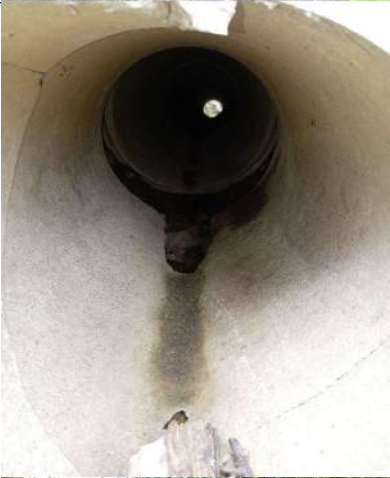
| Photo ID | Easting | Northing | Notes | Photo |
|---|---|---|---|---|
| 173 | -392027.1716 | 6741375.807 | Culvert pipe | |

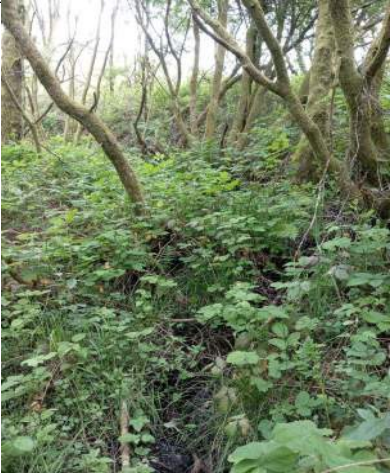
| Photo ID | Easting | Northing | Notes | Photo |
|---|---|---|---|---|
| 174 | -392140.7174 | 6740710.457 | Stream at<br>foot of slope<br>in wooded<br>area. Flowing<br>after dry | |
