Arboricultural Impact Assessment

NRW Stephenson Street Flood Defences

Report Title: 274580-ARP-XX-XX-RP-EN-0005 Arboricultural Impact Assessment

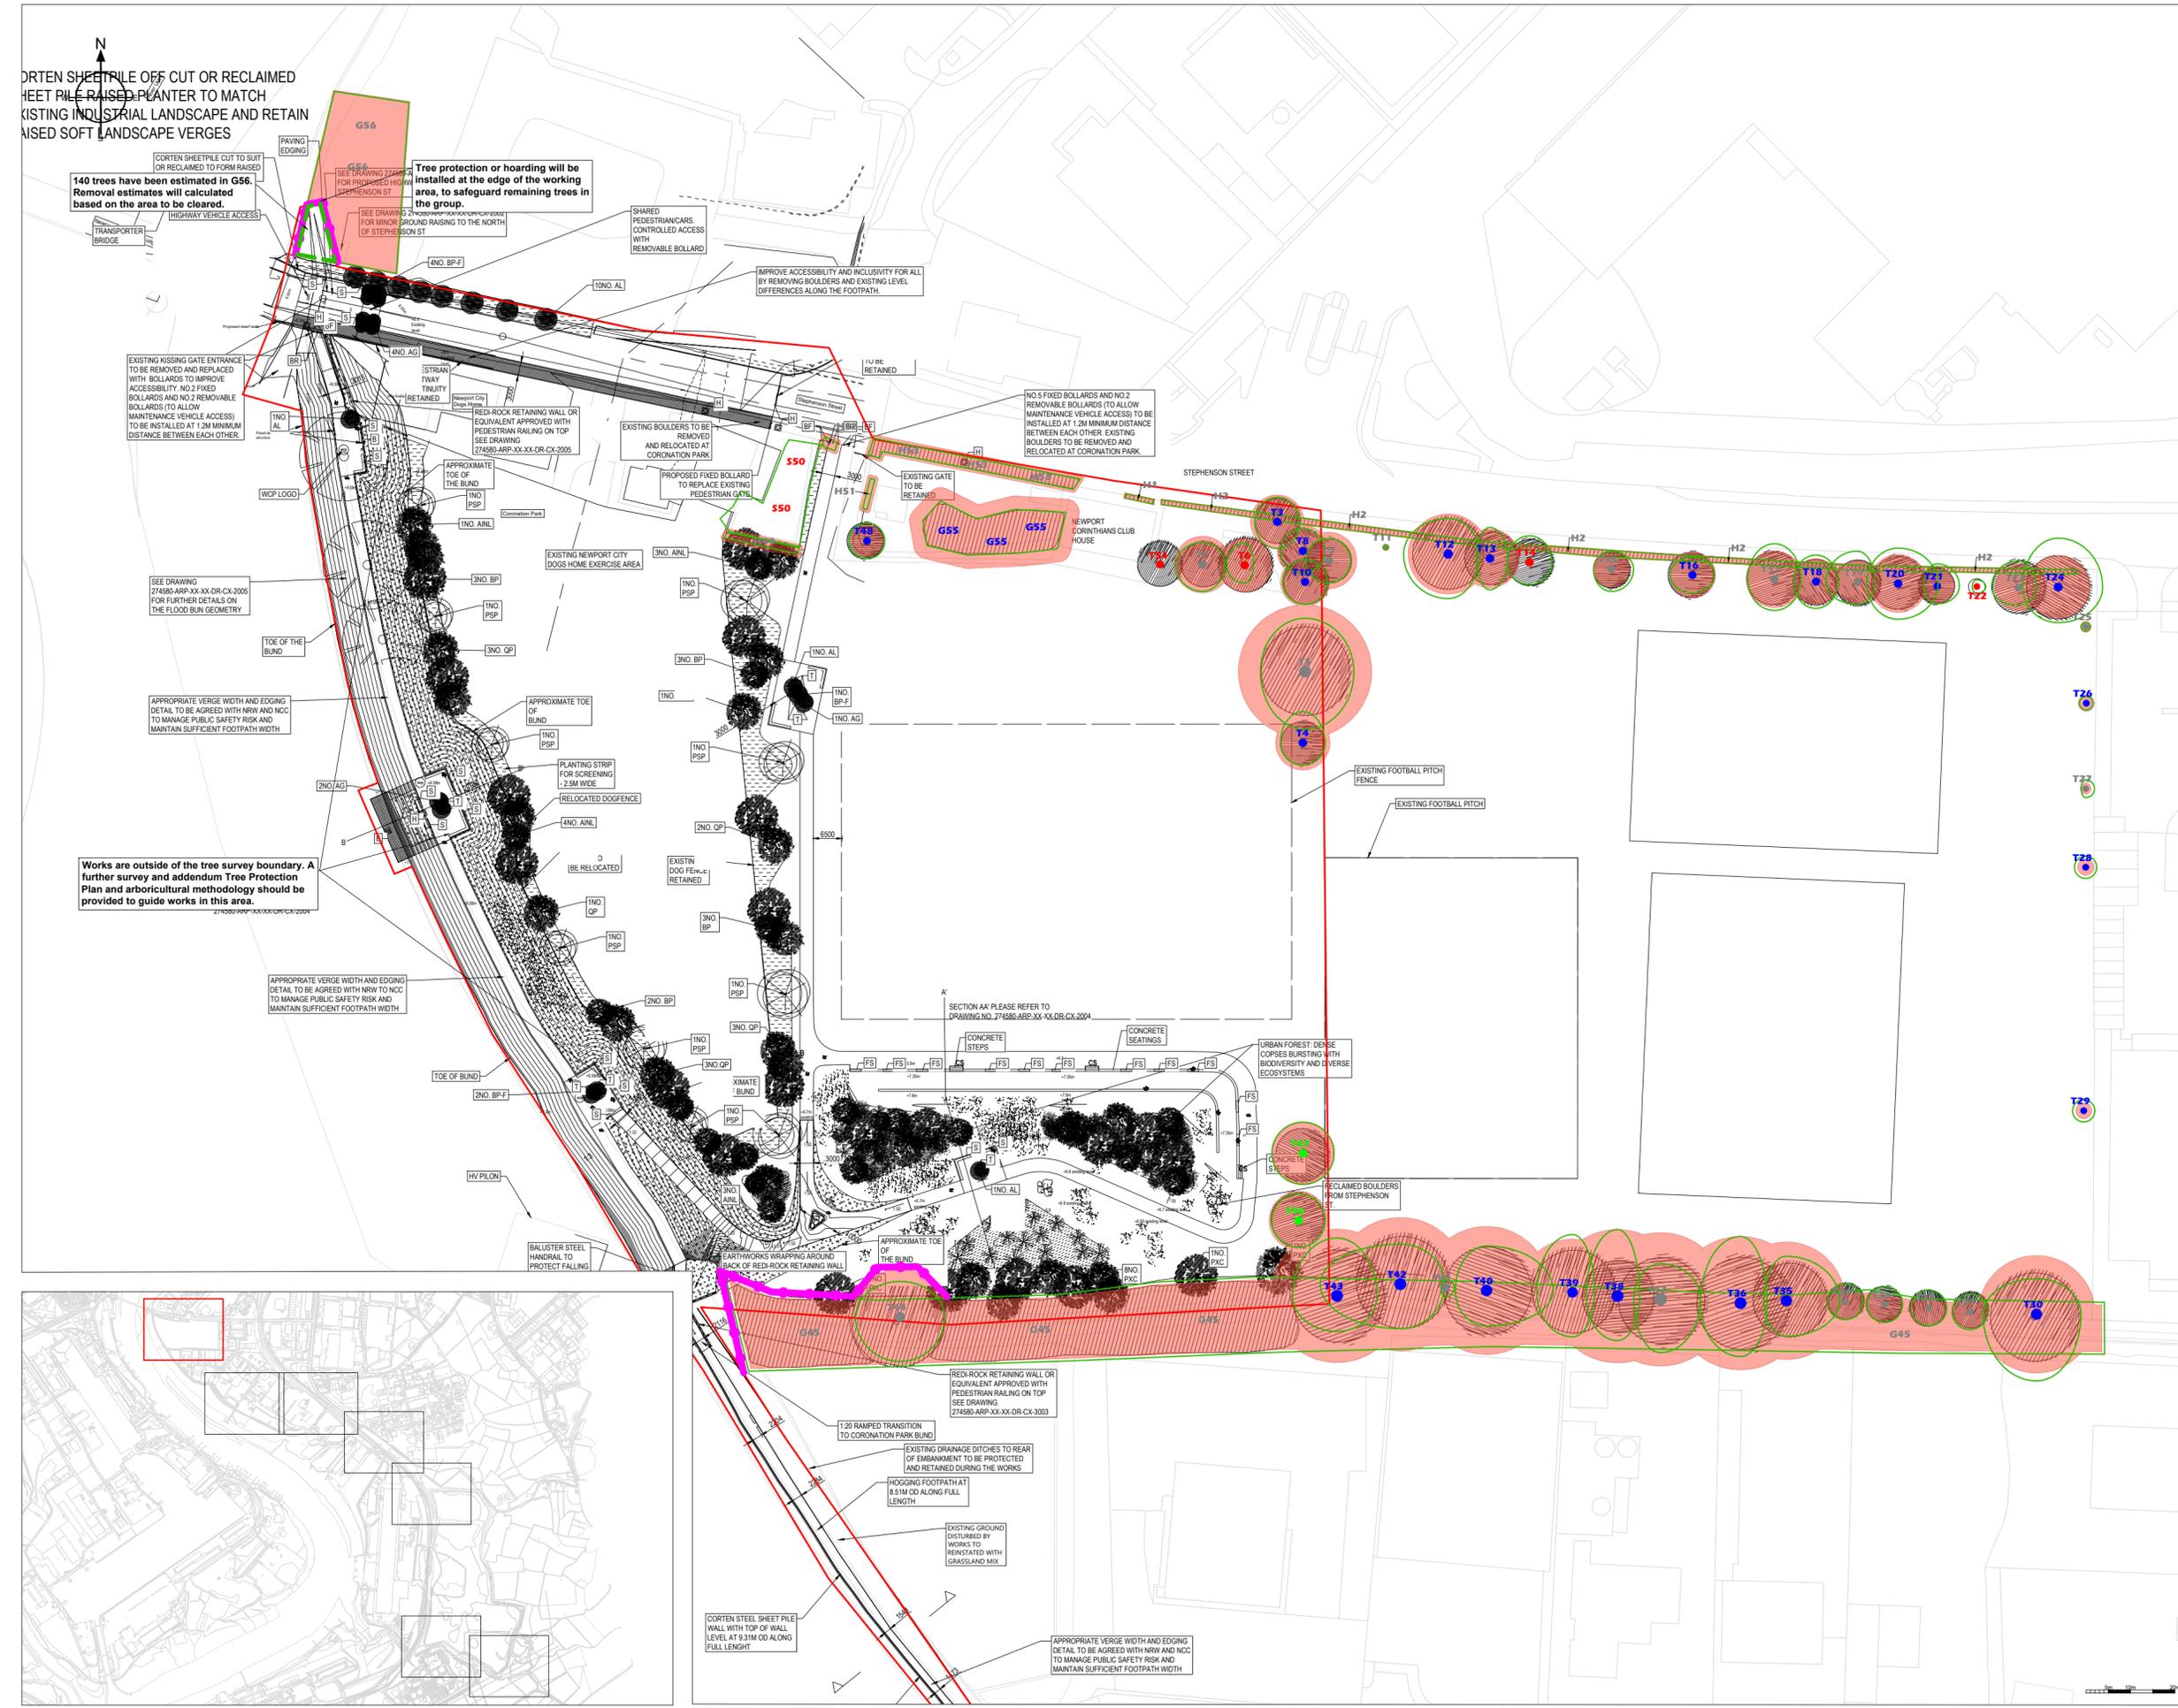
- The remaining trees within all groups and woodlands, in addition to the individual trees will be retained and protected where necessary throughout the project construction period. Retained tree protection measures are discussed throughout this report and illustrated on the Tree Protection Plan at Appendix B.

Retained trees will be protected during development by establishing a Construction Exclusion Zone (CEZ) around their Root Protection Areas (RPAs). RPAs are a layout design tool, indicating the minimum area around a tree deemed to contain sufficient roots and soil to maintain the tree's viability. RPAs should be treated as a precautionary area within which activities such as ground compaction, excavation, the storing of materials, ground level changes and other construction activity are likely to cause damage to trees and should therefore be excluded. This CEZ can be achieved by the erection of barriers at the locations shown on the Tree Protection Plan at Appendix B. Tree protection barriers must be installed before any demolition or construction works start, and, unless approved by the Local Planning Authority or by an arboriculturist approved by them, should remain in place until all construction activity has been completed.

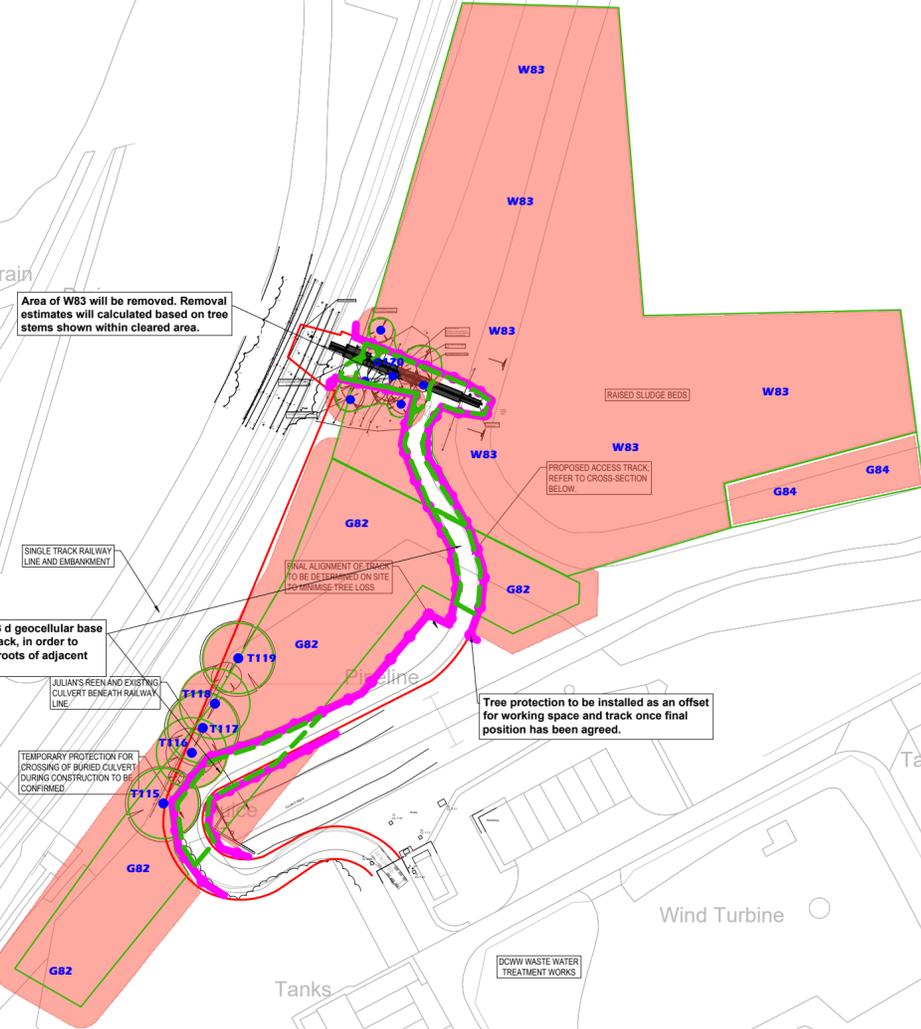
Area of W83 will be removed. Removal estimates will be calculated based on tree stems shown within cleared area.

A no-dig approach and 3 d geocellular base is recommended for this track, in order to minimise impact on the roots of adjacent retained trees.

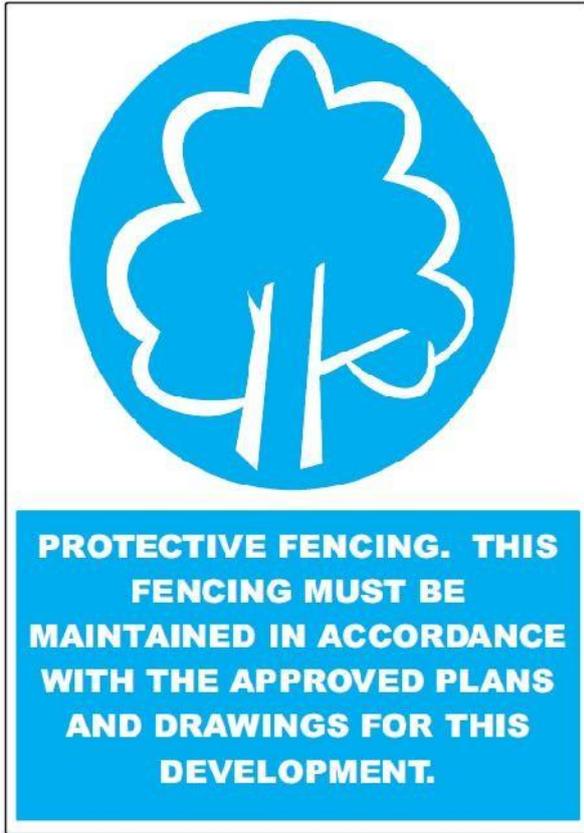
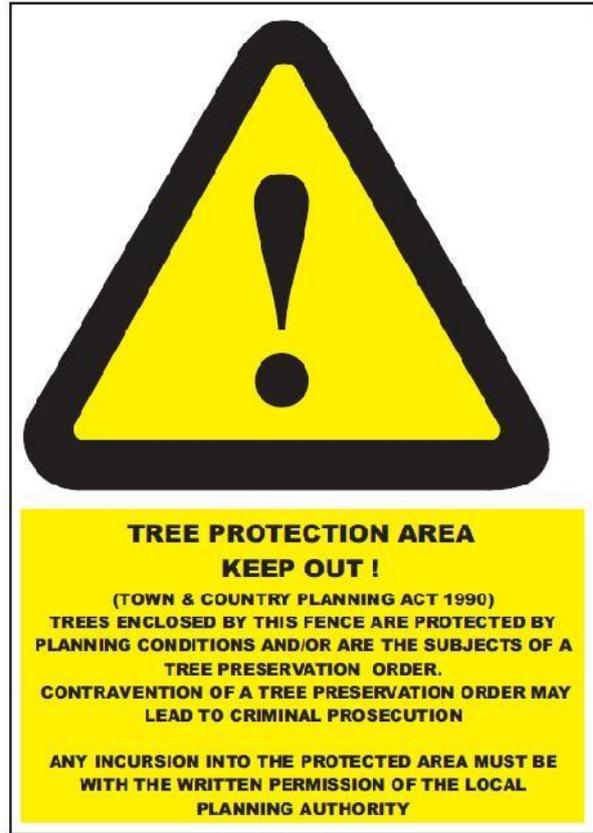
Example Tree Protection Fencing Sign

- The CEZ will be clearly identified (see Construction Exclusion Zone sign example below)

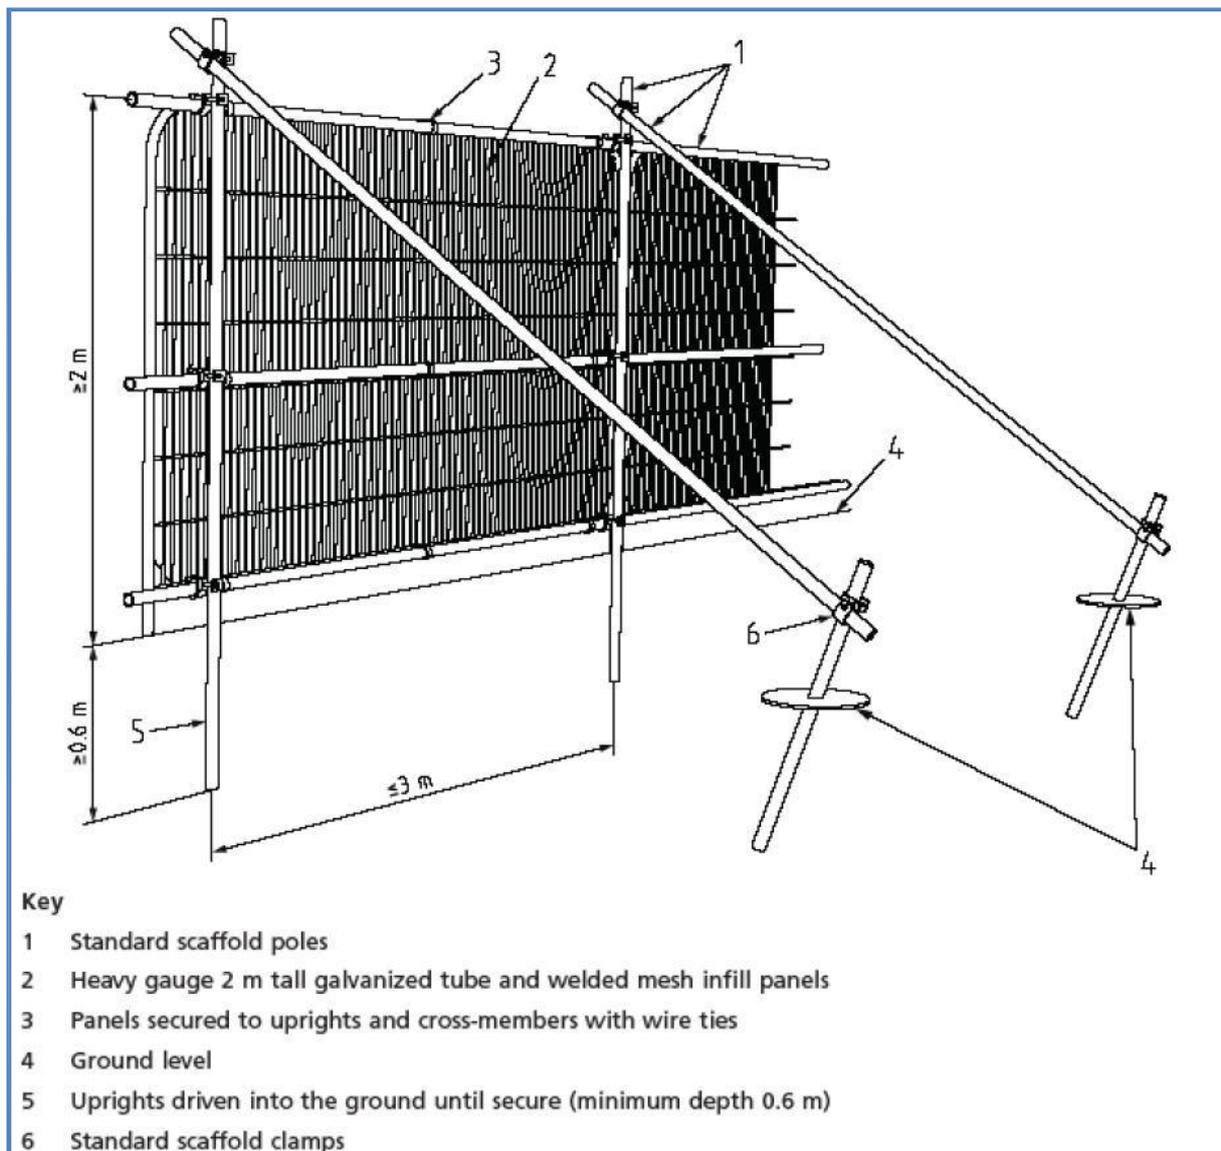
BS5837: 2012 - Figure 2 – Tree Protective Barrier

- Fence panels will be made of mesh (e.g.: Heras fencing) or, if solid, will have 30cm windows cut into enough panels to enable conditions within the CEZ to be viewed.

- The Tree Protection Fencing will be installed and removed without causing damage to retained trees.
- Installation, removal and, where required, replacement of Tree Protection Fencing will be supervised and signed off by the Arboricultural Consultant.
