# *Archaeology Wales*

## **Stephenson Street, Newport**

Desk Based Assessment and Site Visit

Report No. 1788

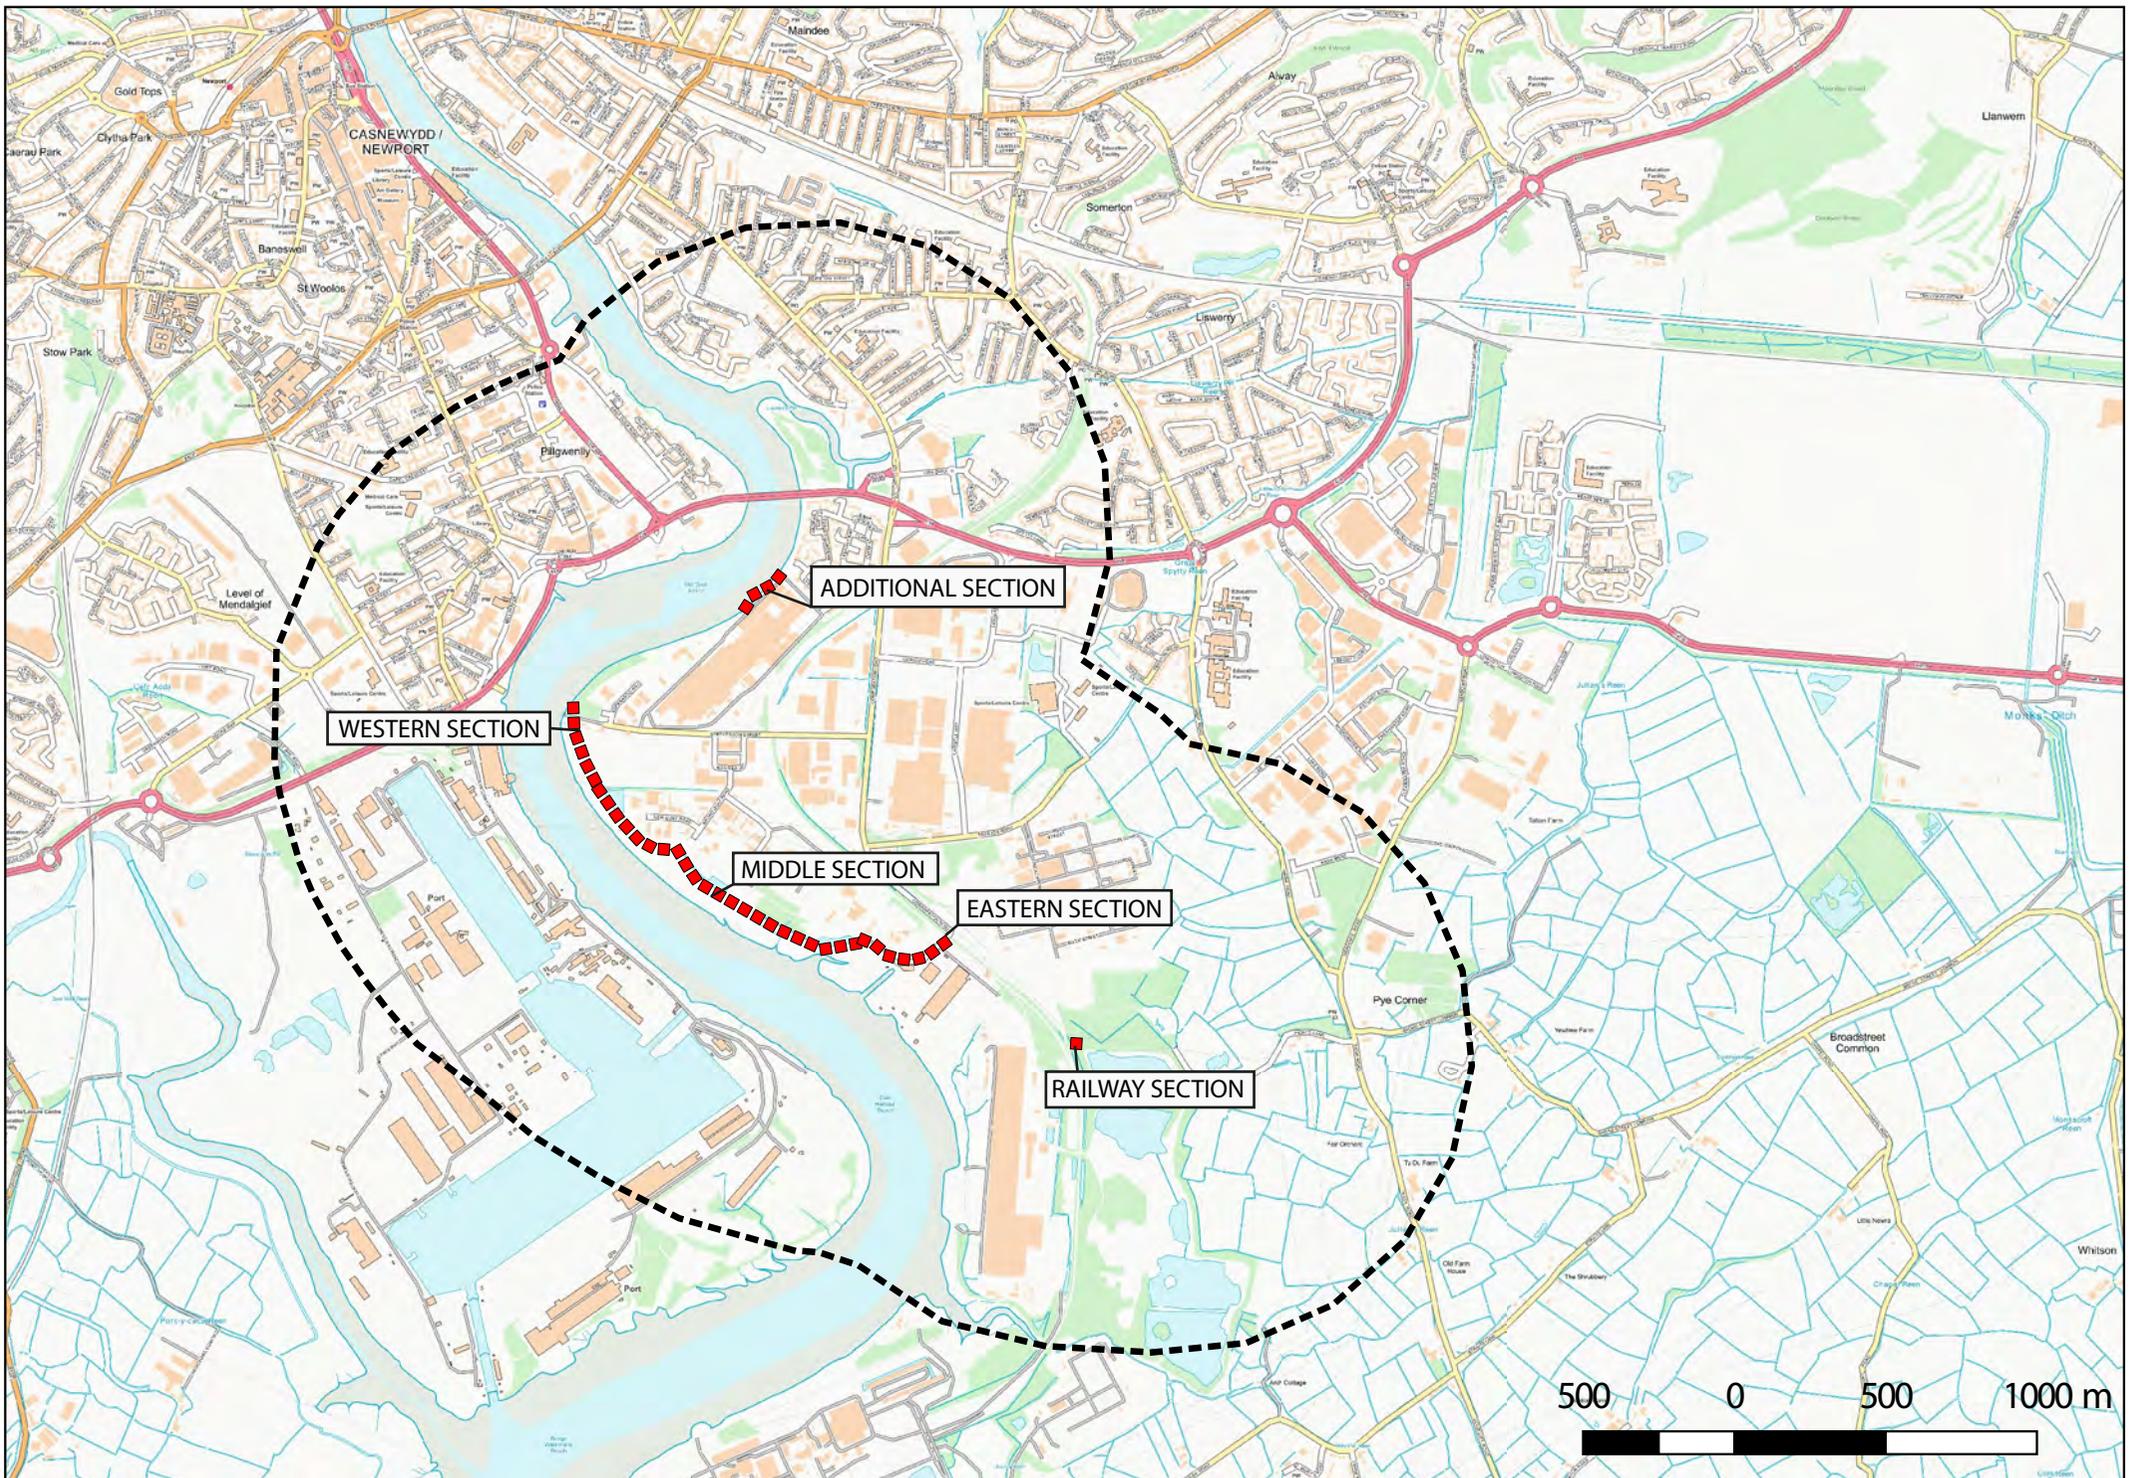
Figure 1. Proposed development area within 1km applied search area.

11.2.1 The existing embankment covers the full extent of the area outlined in Figure 1. Modification to this and associated groundworks such as topsoil stripping, foundation excavation have the potential to expose, damage or destroy potential archaeological remains.

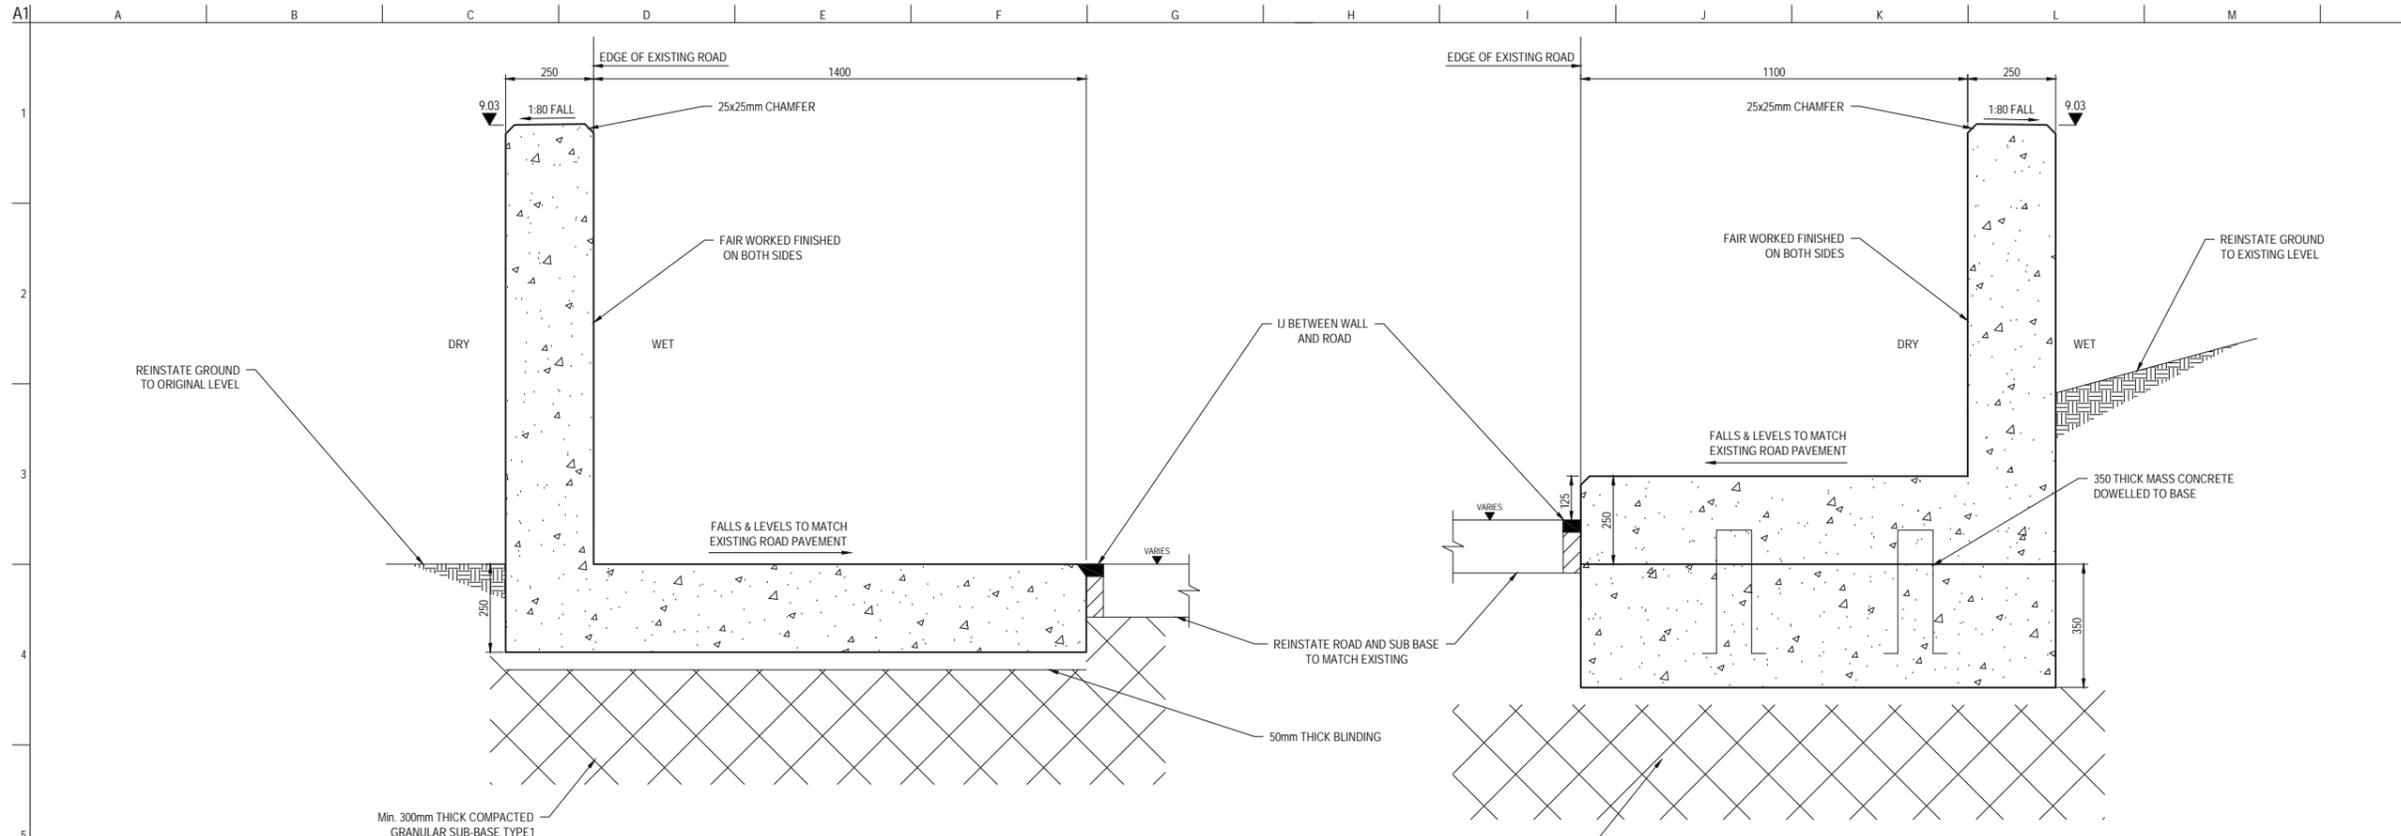
TYPICAL SECTION THROUGH WALL A

THIS DETAIL IS TO BE USED WHERE THE ROAD IS ON THE DRY SIDE

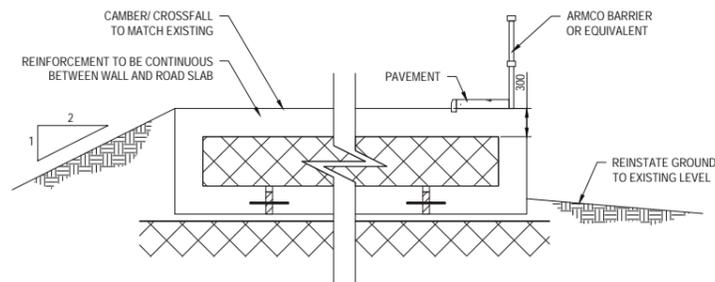
SECTION X-X

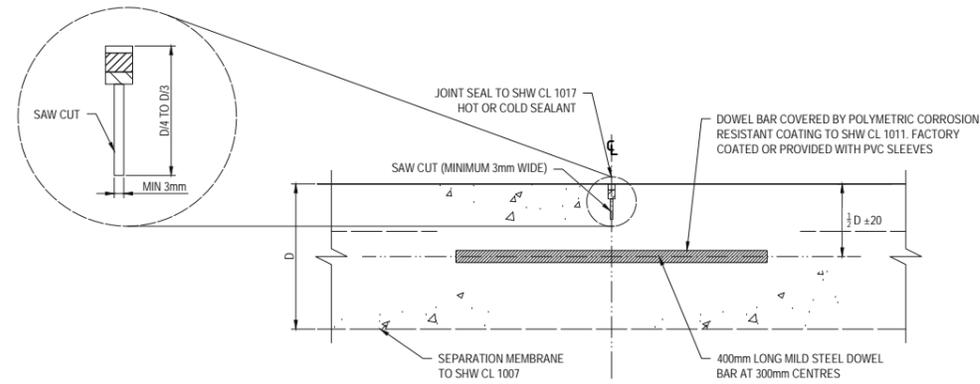
TYPICAL TRANSVERSE (CONTRACTION) JOINT

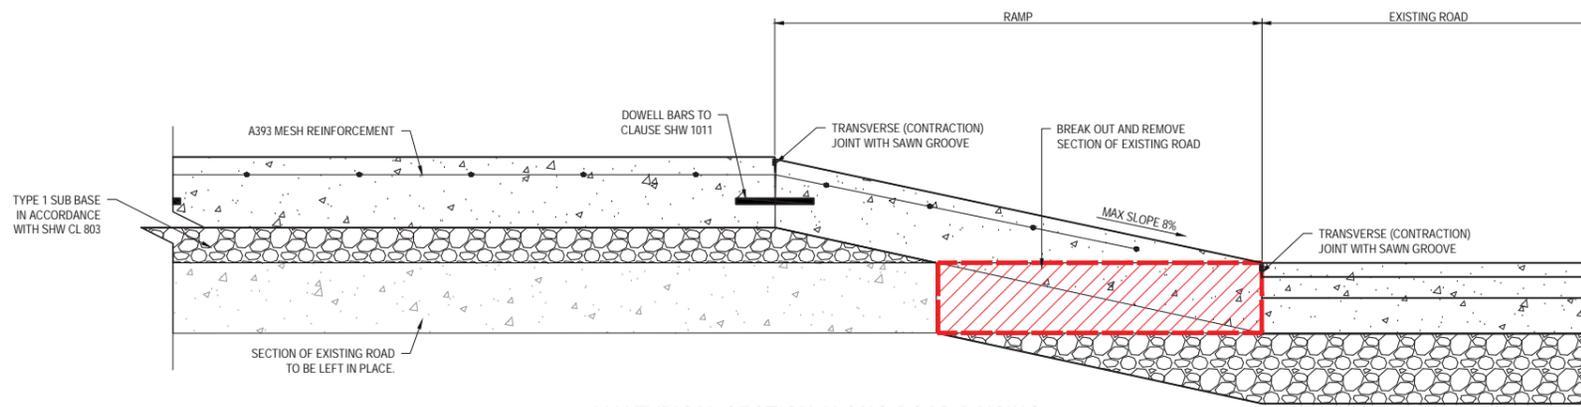
Y-Y TYPICAL SECTION ALONG ROAD RAISING

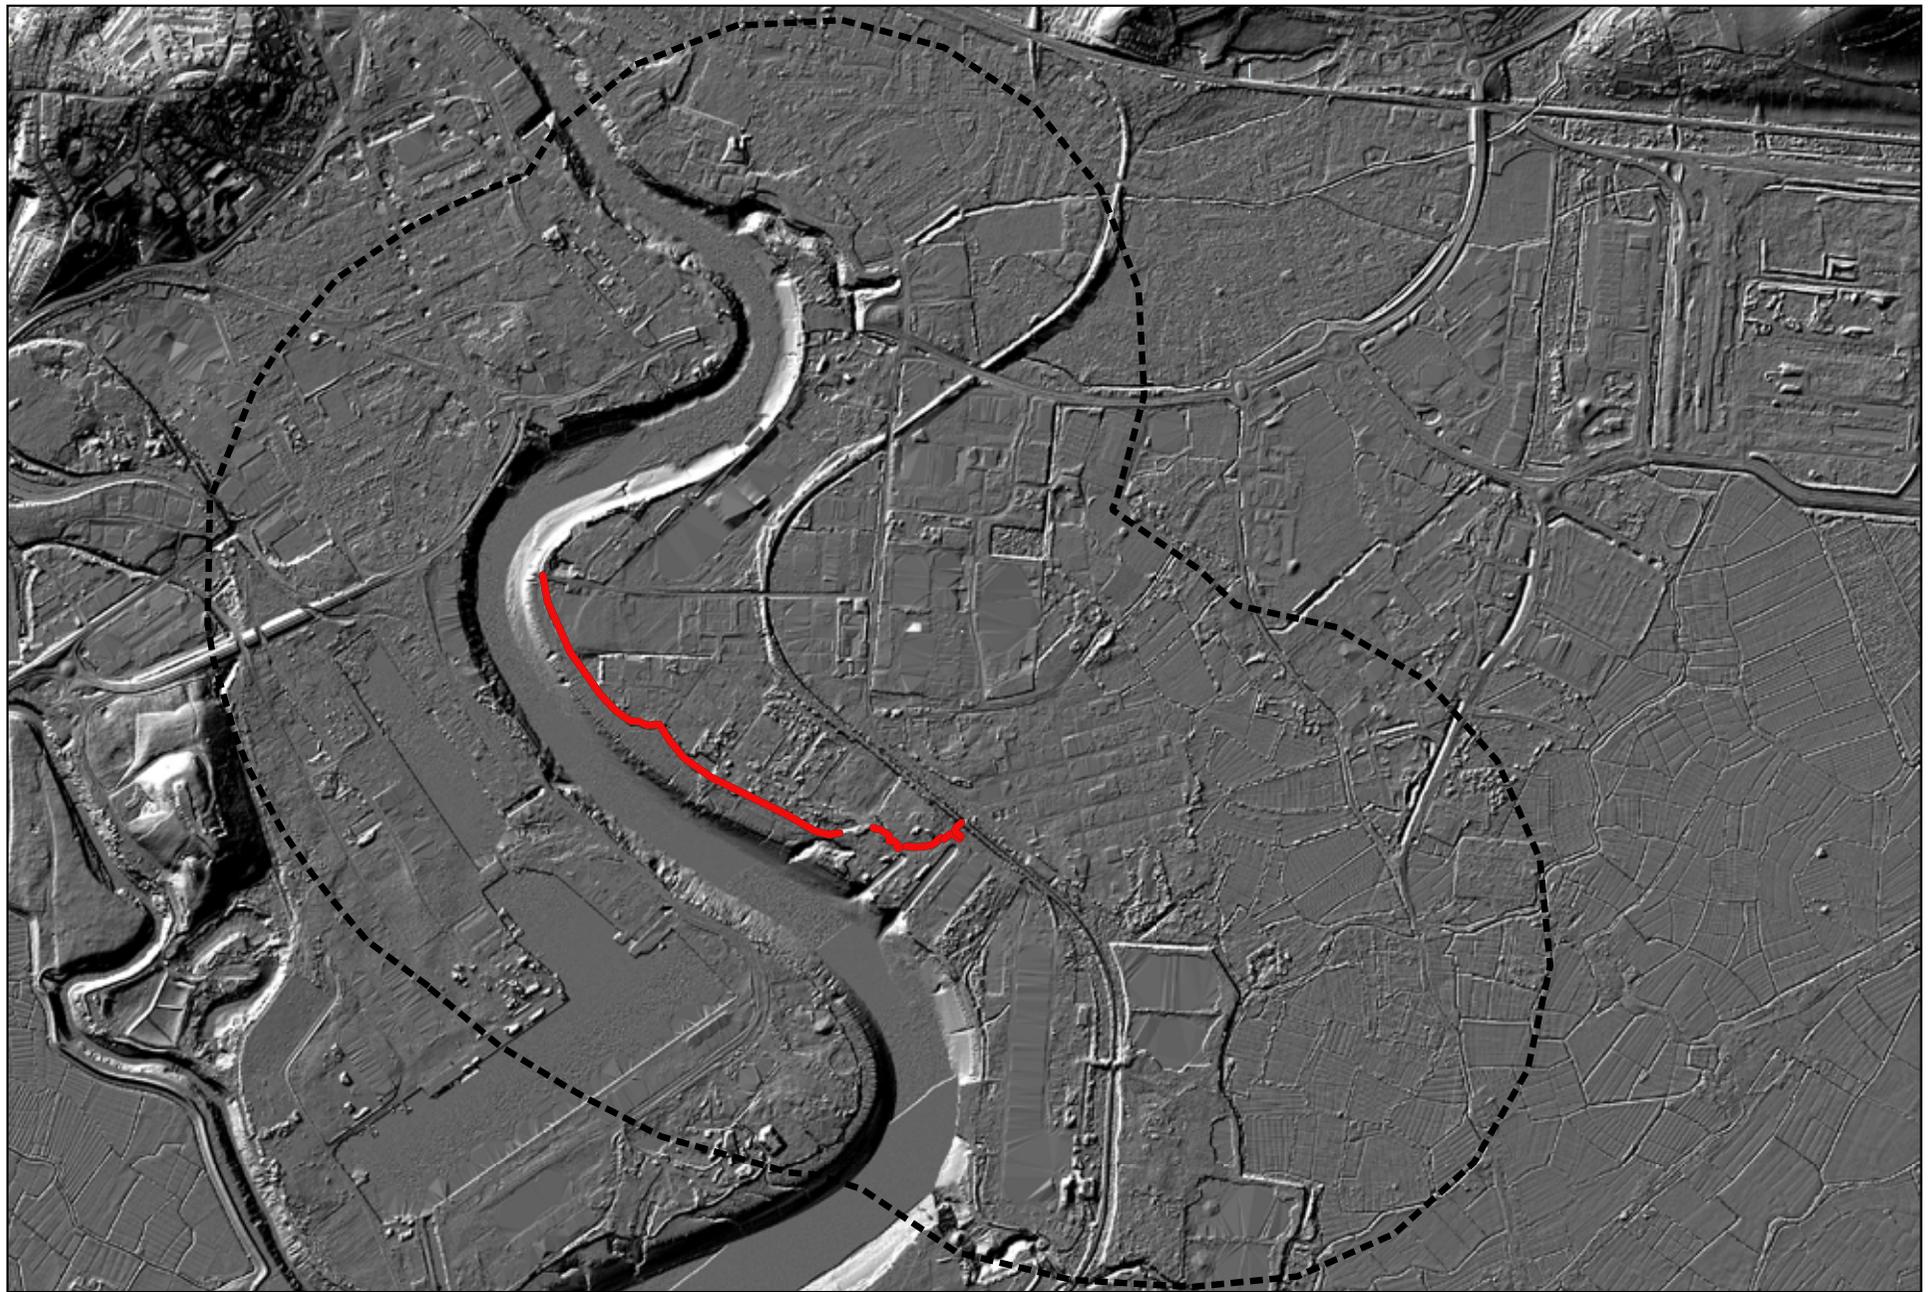
Figure 17. LiDAR 1m DTM, hillshade

- 6.21 LiDAR data 1m DTM was plotted and processed in order to identify possible subsurface features within and around the development area.
- 6.22 The existing embankment as well as the river outlets appear to be the prominent features documented by the LiDAR. No features of archaeological origin seem to be located within the areas of the embankment itself. However, a number of potential archaeological features are observed within the easternmost area of Coronation Park.

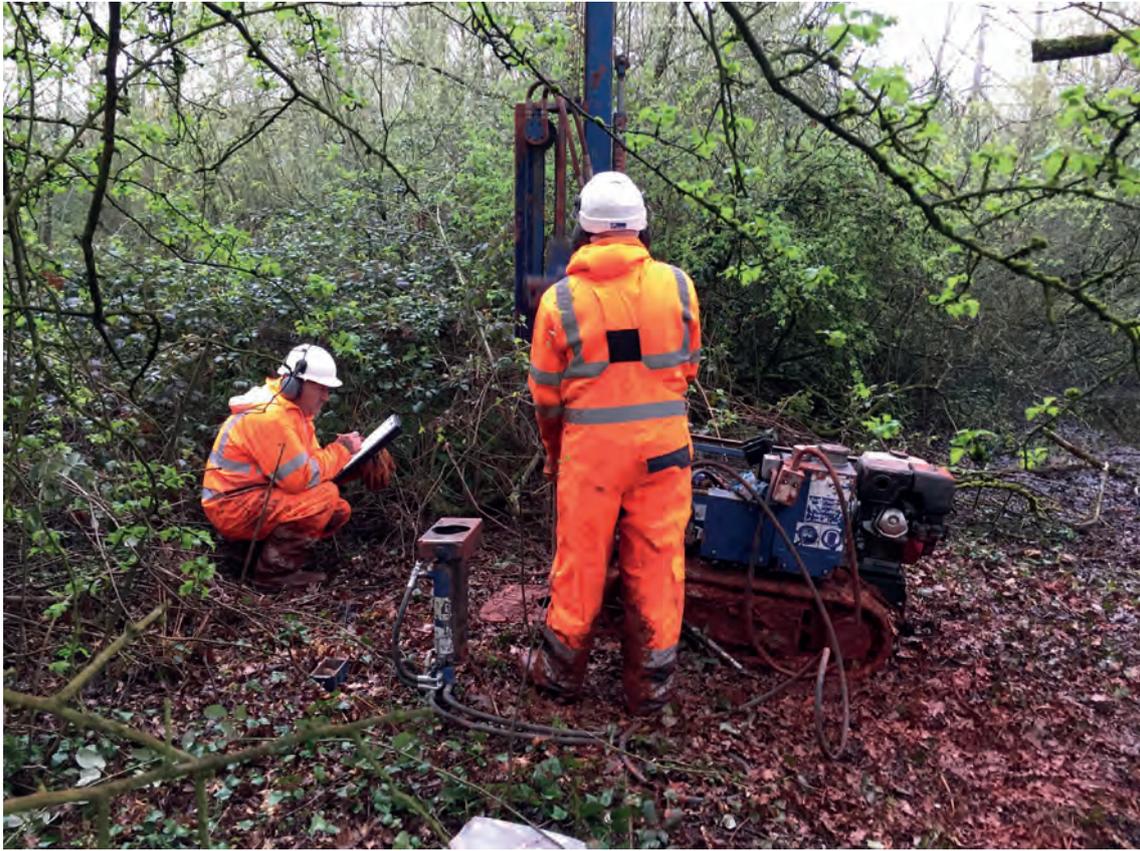
Plate 3 Working shot of dynamic probe drilling taking place. South facing.

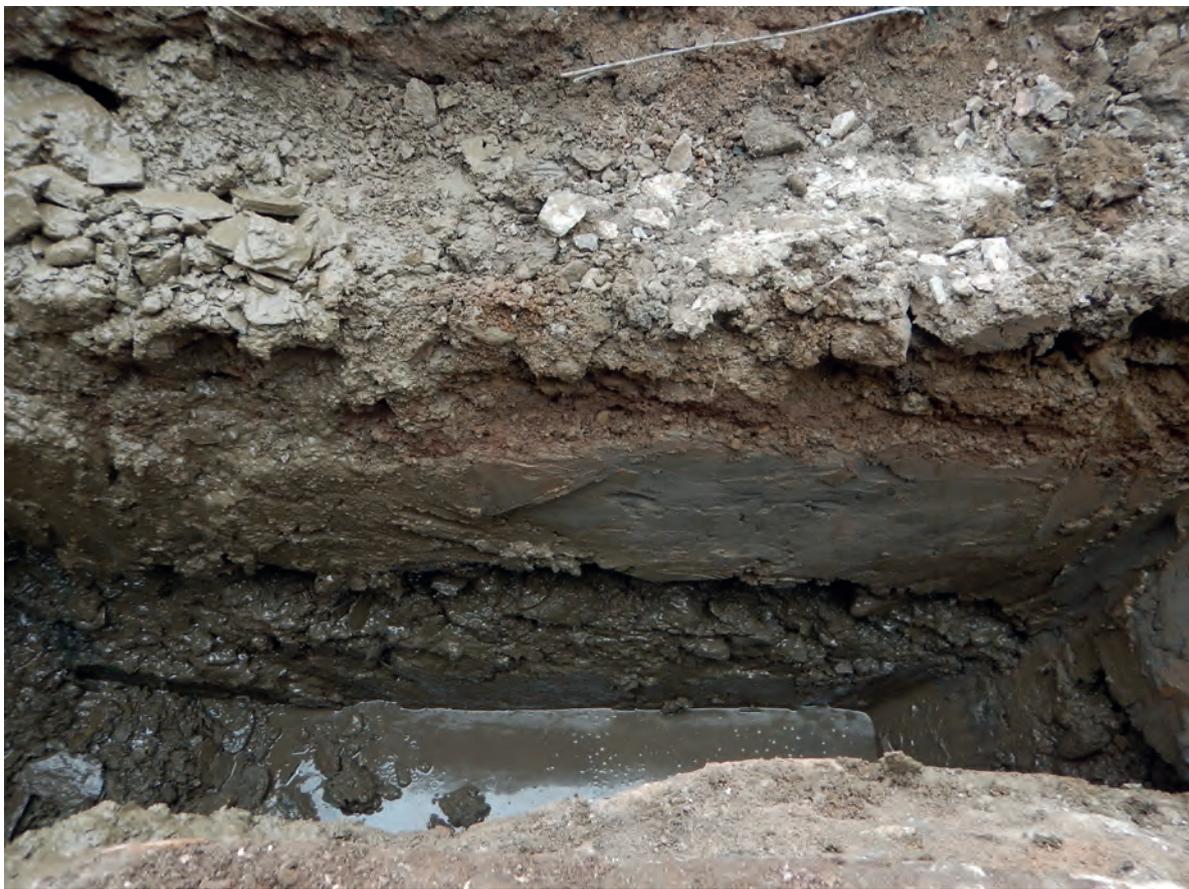
Plate 4 East facing section of TP008.

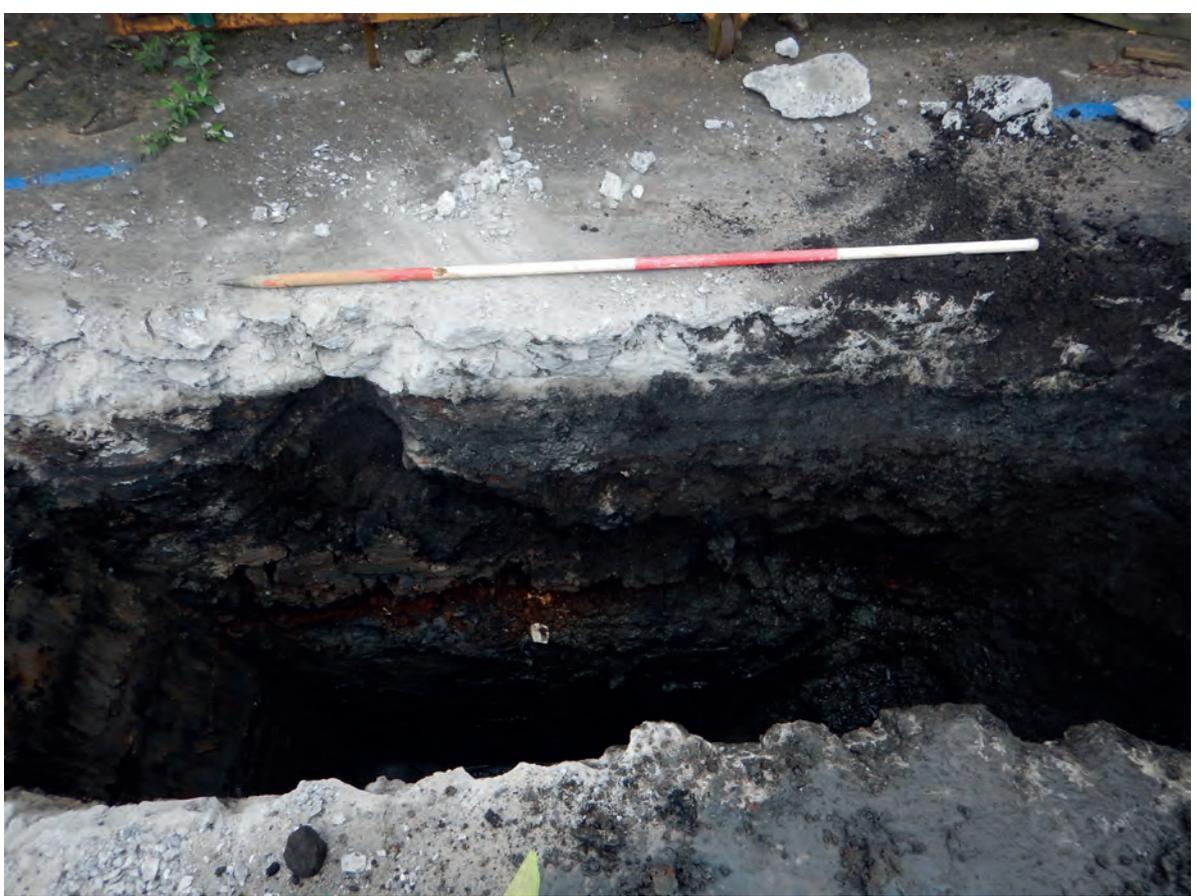
Plate 6 North facing section of TP007. 2m scale.

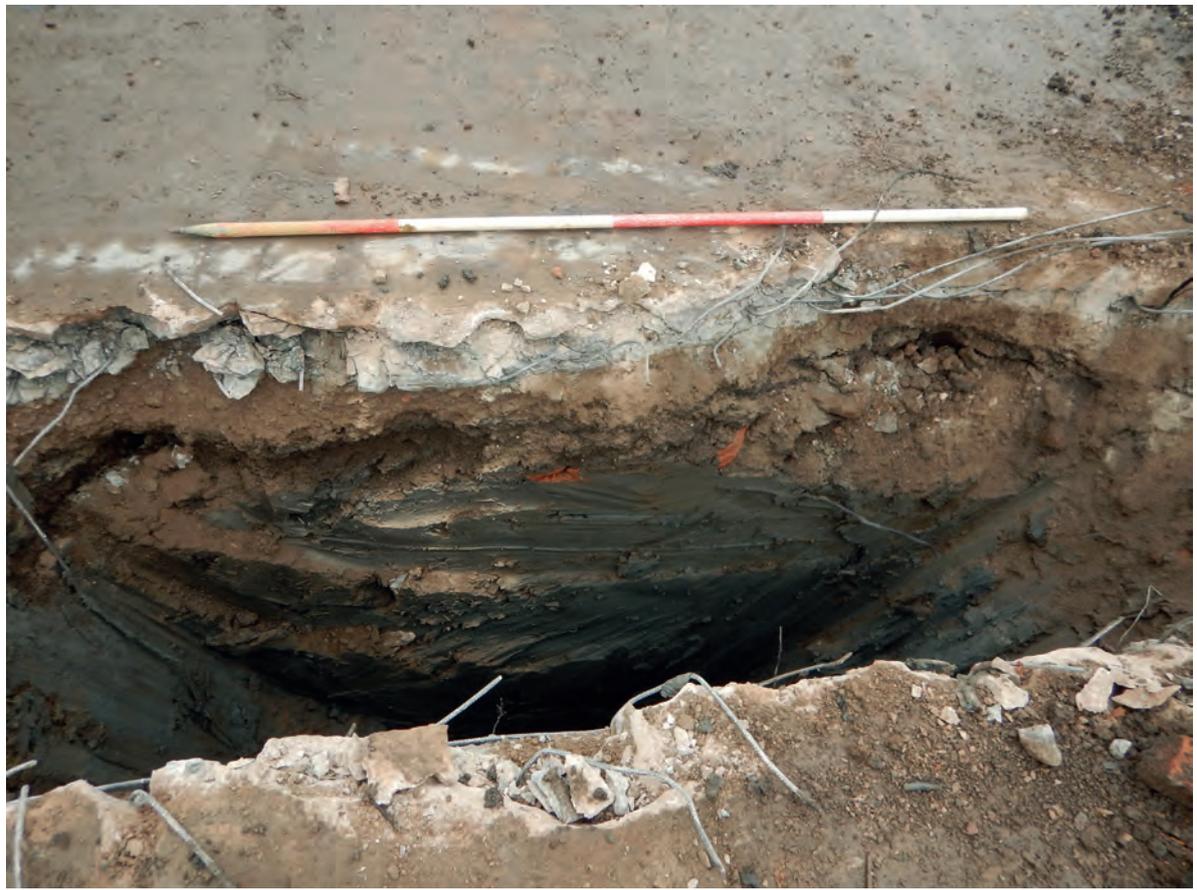
Plate 7 West facing section of TP013. 2m scale.

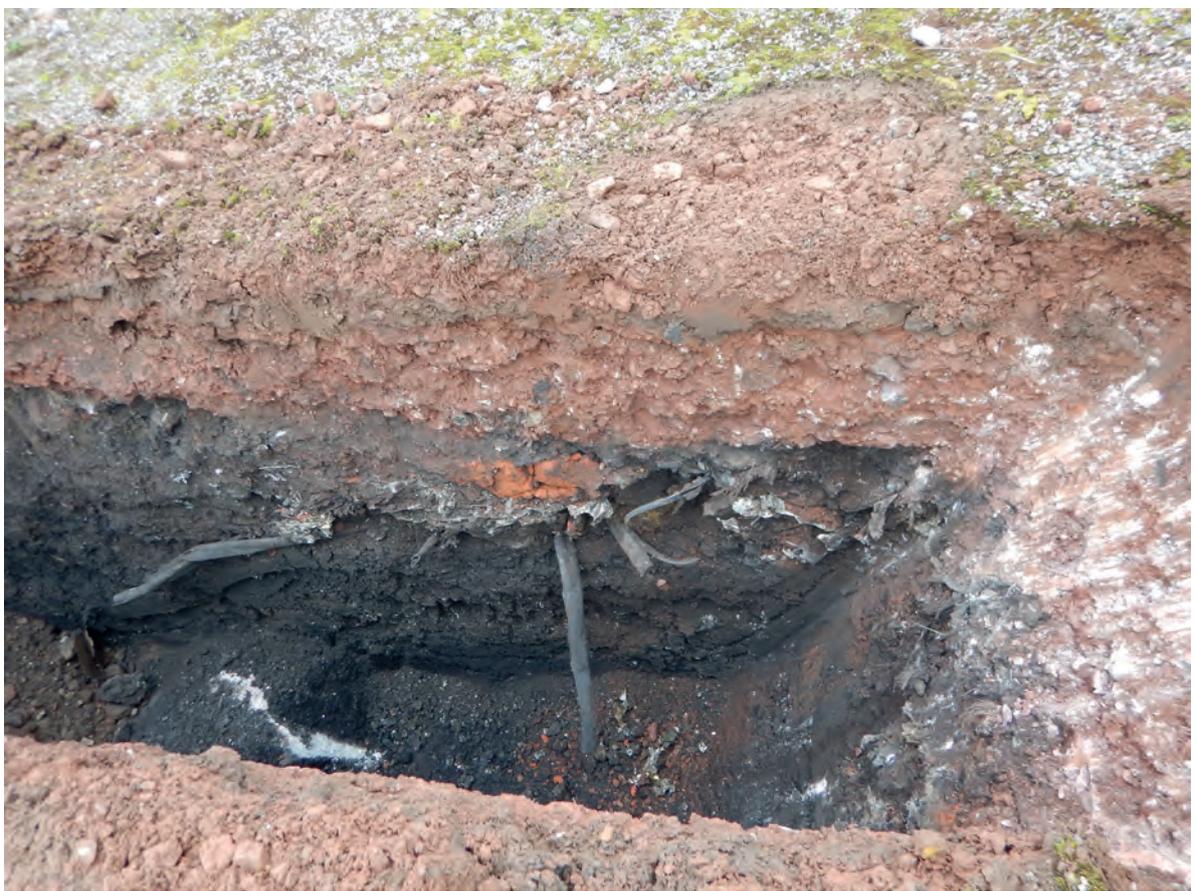
Plate 8 South facing section of TP011.

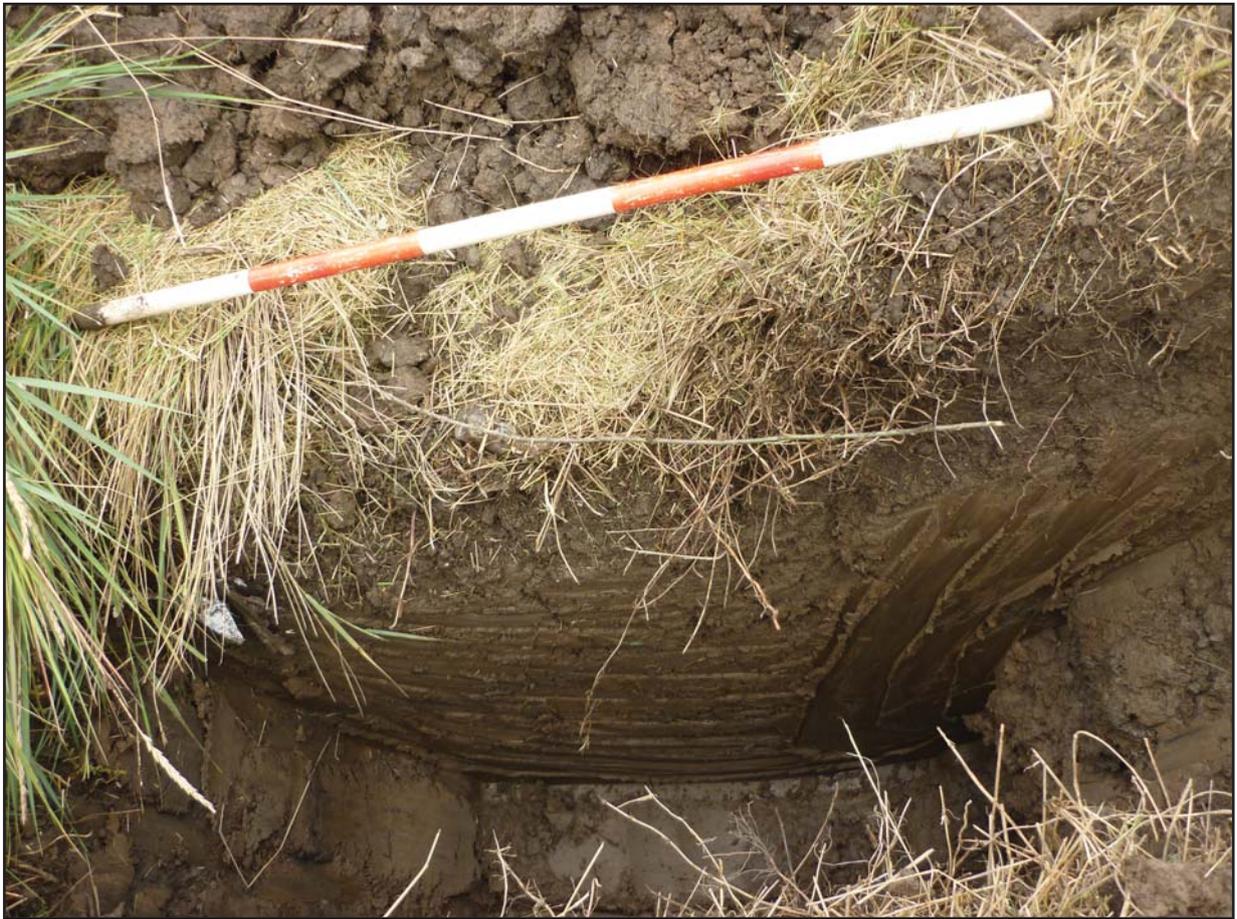
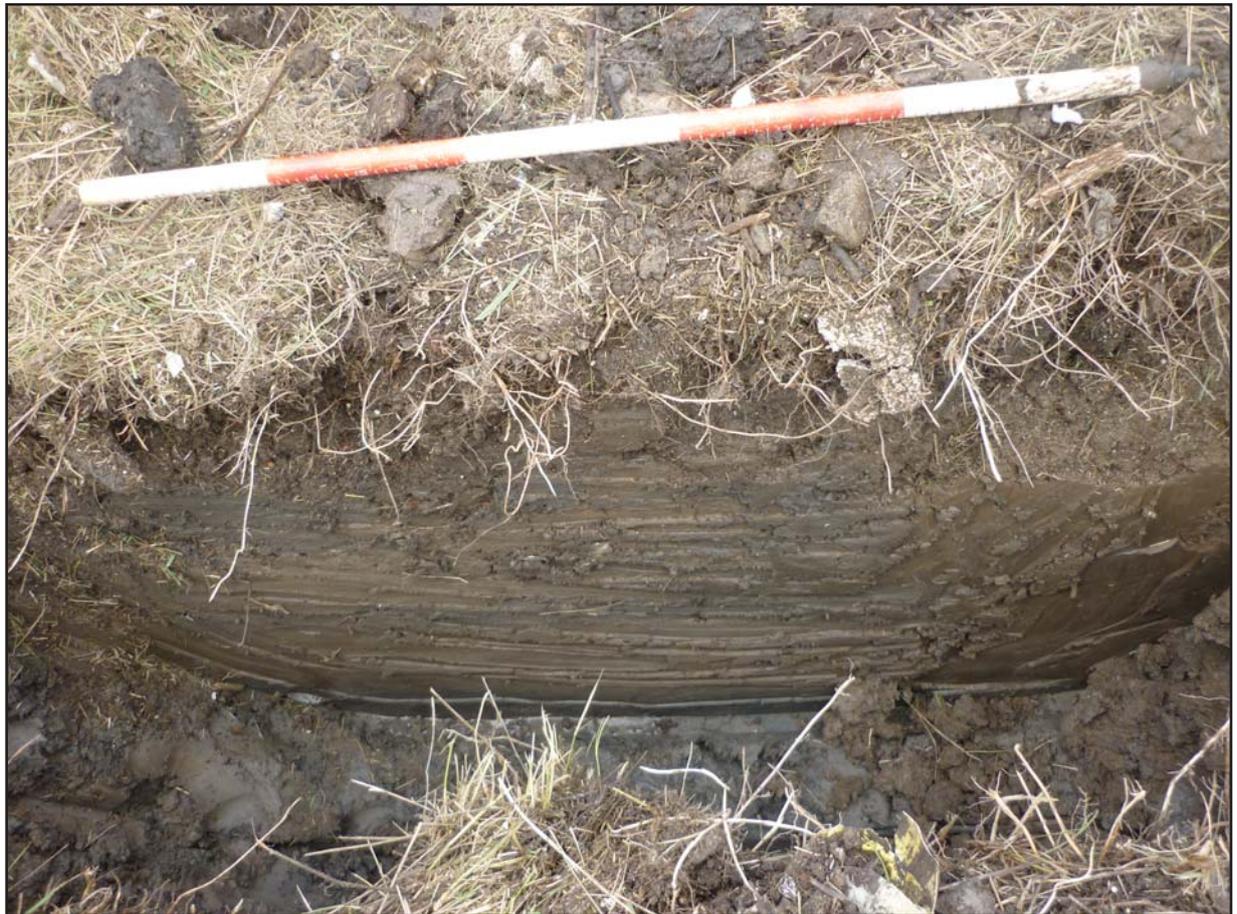
Plate 1. Southeast facing section of ground investigation pit 2.  
Plate 2. Southeast facing section of ground investigation pit 3.
