# **Stephenson Street Flood Alleviation Scheme**

WFD Compliance Assessment

274580-ARP-XX-XX-RP-EN-0003

Project title	Stephenson Street Embankment Appraisal	Job number
		246344
сс		File reference
		4-70
Prepared by	Candice Constantine	Date
		11 December 2015
Subject	Geomorphology and WFD technical note

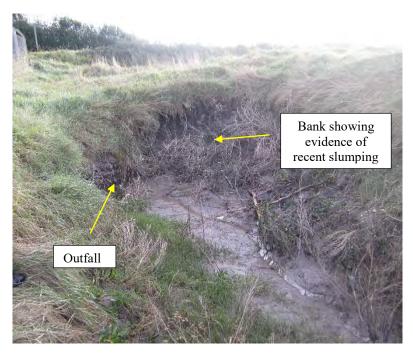
At the northern end of the scheme near the transporter bridge, there is an outfall situated approximately 18m from the toe of the embankment (see Outfall 1 on Figure 1 and Figure 2). Flow discharges from a pipe covered with a flap valve and runs along a channel eroded into the river bank. The head of the channel around the outfall shows evidence of recent slumping.

Figure 2 – Outfall 1 at northern end of embankment.

• Outfall 1: Some recent slumping at the head of the channel leading from the outfall was observed. The distance between the outfall and the embankment is such that the risk is considered low and could be managed through regularly monitoring with stabilisation work undertaken in the future should slumping continue. If stabilisation is desired immediately, a bioengineering solution should be developed such as installing rock rolls at the toe of the bank and reprofiling and vegetating the upper part of the bank;

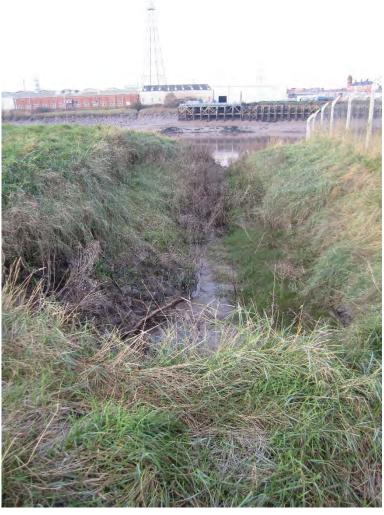
Although the bed of the channel is level with the outfall, the channel gradient is steeper downstream (Figure 3). Upstream progression of a head cut could result in further bank instability and slumping with headward progression of the channel towards the embankment. The vegetated nature of the channel suggests that changes are occurring slowly. There is no evidence of aggressive and widespread erosion in this area at present.

Figure 3 – Looking towards the River Usk from Outfall 1

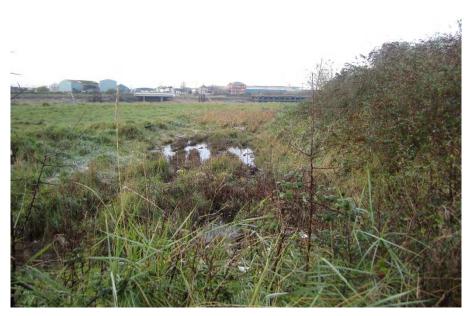
From approximately Point A to Point B indicated on Figure 1, the ground along the river side of the embankment appears to have been tracked by plant. Rutting has resulted in areas of standing water (Figure 4). These low areas contain a significant amount of fly-tipped rubbish, including tyres, brick and other debris as well as drift wood and plastic debris deposited during high tide. The presence of these features could result in a preferred flow path along the toe of the embankment during periods of high tide.

Figure 4 – Rutting and standing water at toe of embankment. View looking northwest along the embankment towards Point A.

- Plant tracking resulting in rutting and standing water at the toe of the embankment: If this low area along the toe of the embankment serves as a preferred flow path during high tide, locally elevated flow depths and velocities could result in scour of the embankment. No signs of scour were observed during the site visit, but as a precaution, these areas could be filled in when the embankment is raised. This would be subject to an assessment of the impacts on the SSSI. The implications of the low areas and standing water for the geotechnical stability of the embankment should also be considered;

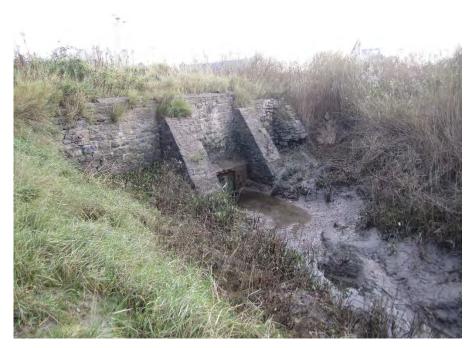
Outfall 3 discharges into a channel formed in the floodplain (Figures 5-7). The lower part of the channel is unvegetated (Figure 6) as a result of regular disturbance by the ebb and flow of the tide. The upper part of the channel is largely vegetated with the exception of the bed which shows signs of recent siltation (Figure 7). Some gullies were observed along the bank of the channel where the floodplain between the channel and the embankment is narrowest (see label on Figure 1). Grass growth along the gullies suggests that they are relatively stable.

Figure 5 – Outfall 3

- Channel at Outfall 3: Gullies were observed leading from the channel at Outfall 3 towards the embankment. These features could continue to grow, eventually posing a significant risk to the embankment. The gullies are vegetated, however, suggesting that they are evolving slowly. This risk could therefore be reasonably managed through monitoring with work undertaken in the future as needed or, if desired, bioengineering products could be installed within the gullies to help encourage siltation and stabilise the features.

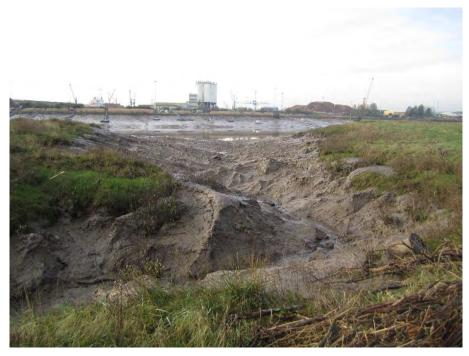
Figure 6 – Looking downstream towards the main river along the channel at Outfall 3.

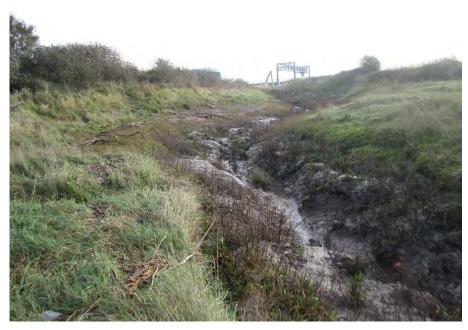
Figure 7 – Looking upstream along the channel towards Outfall 3.
