**Stephenson Street Flood Defence  
Scheme**

**Preliminary Ecological Appraisal  
Addendum - Railway Wall Access  
Route**

274580-ARP-XX-RW-RP-EN-0002

Issue 2 | 10 December 2020

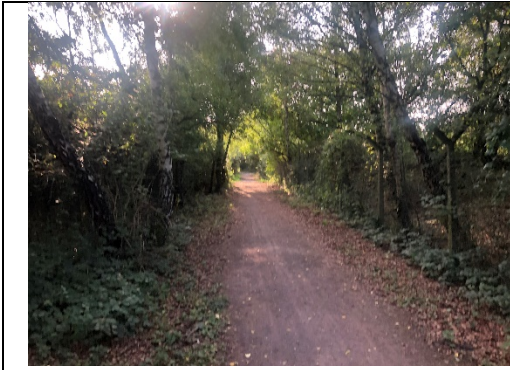
**Photograph 1** showing location of scrub and treeline either side of path.

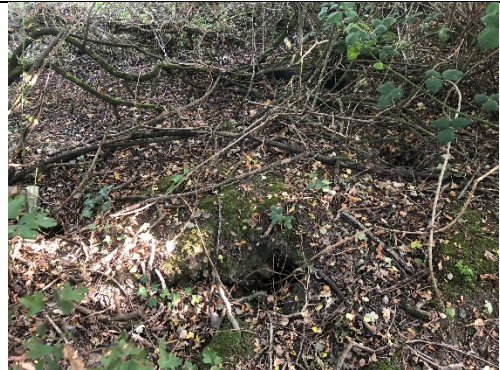
One disused badger sett was identified during the Extended Phase 1 Habitat survey, (TN1). This had four entrances, which were all blocked with debris and indicating that these were not active at the time of the survey. Badgers are known to be present within the Nash Wastewater Treatment Works and Uskmouth power station (approximately 1.45 km south of the Site). It was not possible to inspect all areas of dense areas of scrub within the Site, and therefore the presence of further badger setts within these areas cannot be ruled out.

**Photograph 2** showing disused badger sett with four blocked entrances (TN4).

Given the mobile nature of these species and dense scrub present, ecological supervision is recommended for any vegetation clearance ahead of construction to ensure no badger setts, or otter lay ups are present.

If any badger setts and or otter lay ups are found and could be damaged by the works, a licence will be required from NRW (for otter) and or the Welsh Government (for badger).

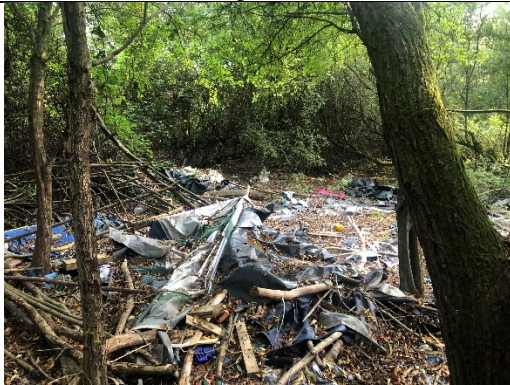
**Photograph 3** showing disused camp (TN3).

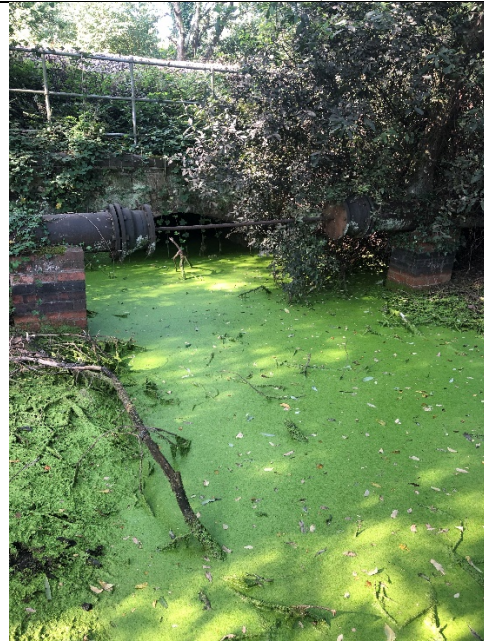
One watercourse was present on Site, a small culvert (TN6) that runs through dense scrub. The water was still with duckweeds (*Lemnoideae* spp.) present on the surface and the banks were made of brick. The culvert was shaded by trees and there was a dry ditch which ran through a disused camp (TN3). This was vegetated with bramble and is likely to be dry throughout the year. Photographs of the habitats are given in Appendix A.

The HSI score of the culvert in TN6 was 0.49. This score is considered as having poor suitability supporting great crested newts<sup>6</sup>. Since the culvert has slow running water it is considered unsuitable for supporting great crested newts; the lack of positive records from previous surveys<sup>Error! Bookmark not defined.</sup> further supports this. Photographs of the waterbody are given in Appendix A. Great crested newts are therefore not considered further in this assessment.

**Photograph 4** showing culvert (TN6).

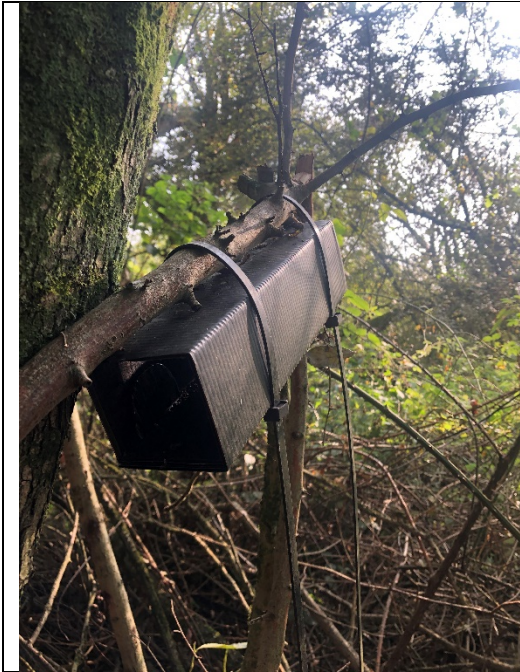
The brambles and scrub on Site provide suitable foraging and nesting habitats for dormice. However, fragmentation from other potential dormouse habitat including those with dormouse records within the wider area due to barriers such as roads, rivers and rail means dormouse are unlikely to occur within the Site. Furthermore, M4 surveys undertaken in the area of the Site did not find any evidence of this species being present.

**Photograph 5** showing old dormouse nest tube.

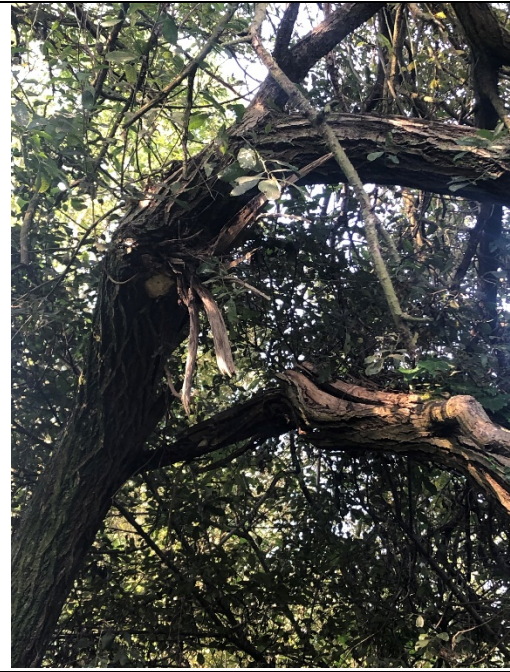
There were five trees with potential roost features identified on Site. Two had moderate suitability: TN8 and TN10; and three had low suitability: TN2, TN4 and TN9. Given that these are away from the proposed access route, shown in Figure 1, it is not anticipated these trees will be directly impacted by the proposed Works.

**Photograph 6** showing Crack willow with moderate bat roost suitability (TN8).

The Site provides potential roosting habitat in five trees, TN8, TN10 (moderate suitability) and TN2, TN4 and TN9 (low suitability). If any of these trees are to be removed or if there is potential for significant sources of noise and vibration that could disturb roosts (if present) within these trees, further surveys should be undertaken to confirm presence or likely absence of bats. In line with good practice guidelines<sup>10</sup>, a dusk emergence survey and a dawn re-entry survey should be undertaken on trees with moderate suitability (TN8 and TN10).

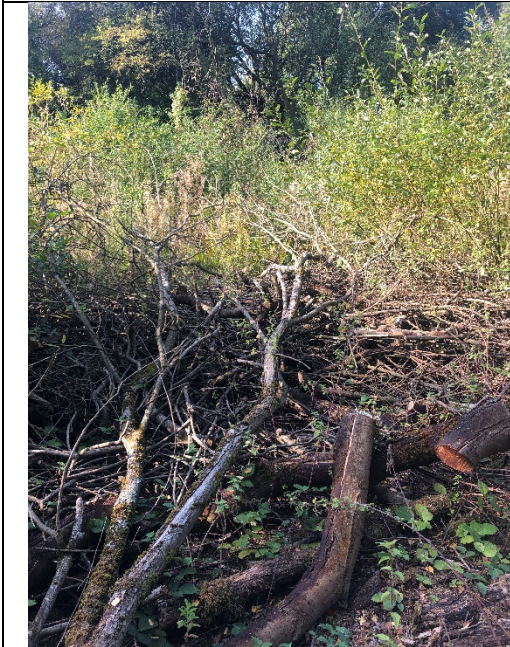
The mosaic of habitats, including scrub and brash piles (TN7), provide suitable habitat for reptiles including common lizard, slow worm and grass snake.

**Photograph 7** showing brush piles underneath overhead power lines (TN7).

Clearance of vegetation should be undertaken in a sensitive manner: two-staged directional strimming towards retained habitat and will be avoided or kept to a minimum during the hibernation season (November to February). If required during this time, clearance will be subject to a Toolbox Talk and Precautionary Methods of Working written and overseen by a suitably experienced ecologist.

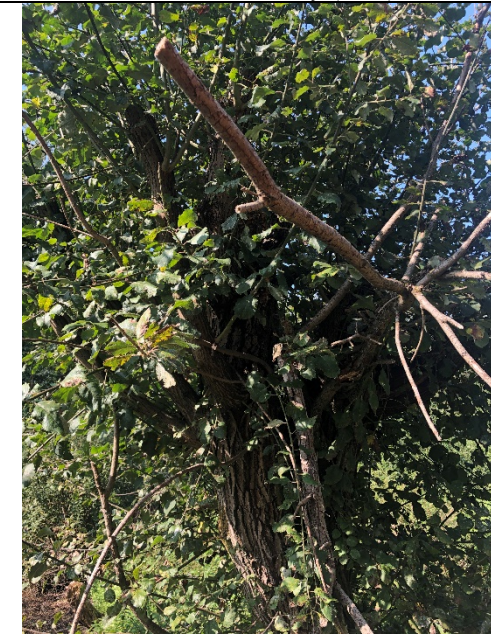
**Photograph 8** showing willow tree with moderate bat roost suitability next to culvert (TN10).

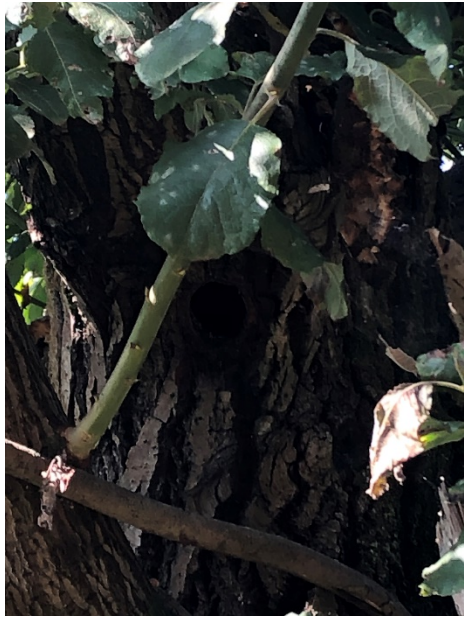
**Photograph 9** showing woodpecker hole and cavity (TN10).

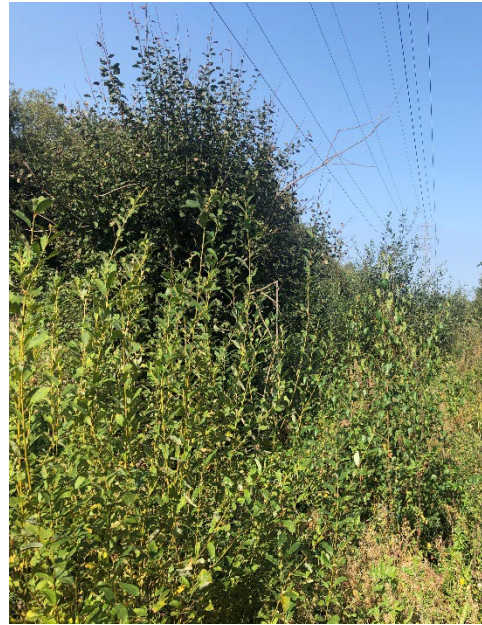
**Photograph 10** showing scrub and woodland habitat.
