Natural Resources Wales

Stephenson Street Embankment, Newport

Vegetation survey 2019 update

August 2019

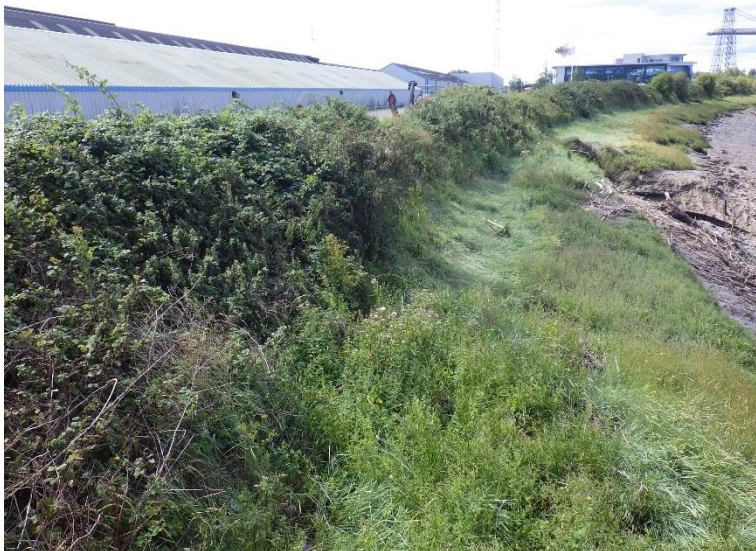
Most of the saltmarsh in the study area was readily accessible. However, permission could not be obtained to gain access down the bank from Orb Electrical Steels to the central portion, due to safety concerns about the condition of the jetty and erosion of the banks in this area. It was also forbidden to walk under the jetty to access the saltmarsh from the north. The only approach that was permitted for surveying the central area was to gather as much information as possible by looking down from the top of the bank. This allowed broad description and mapping of the habitats, but no detailed investigation or quadrat data could be collected. Unfortunately it was not possible to see much of the upper margin of the saltmarsh from the top of the bank because of the wide belt of tall Bramble scrub.

The inaccessible saltmarsh section adjacent to Orb Electrical Steels.

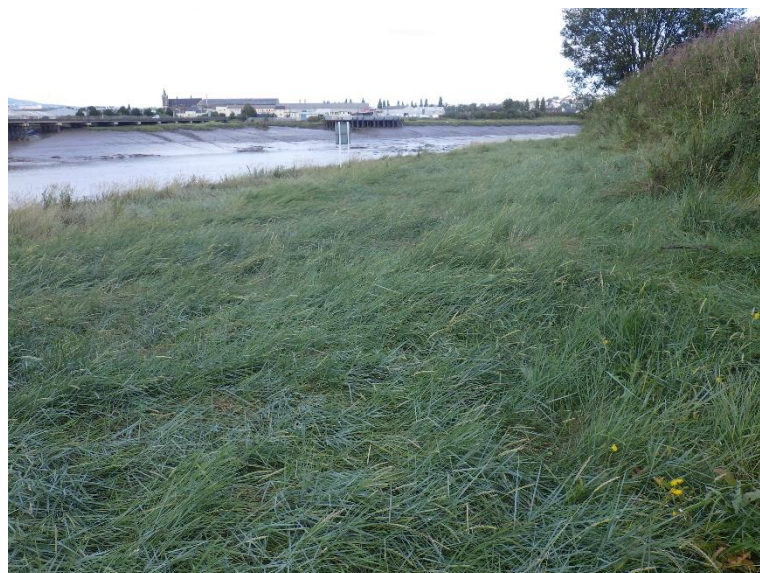
The most prevalent plant community within the study area is a belt of Sea Couch on the upper part of the saltmarsh. This has a very low diversity sward typically limited to a few sparse plants of Spar-leaved Orache. No species of special nature conservation significance were found in this community.

The overall diversity seen in the SM24 quadrats recorded in 2019 was very slightly higher than those recorded downstream in 2018. This is probably because the width of the Sea Couch belt is much narrower in this location so that the quadrats are more affected by transitions with adjacent communities higher and lower on the shore.

*SM24 saltmarsh (at Quadrat 7)*

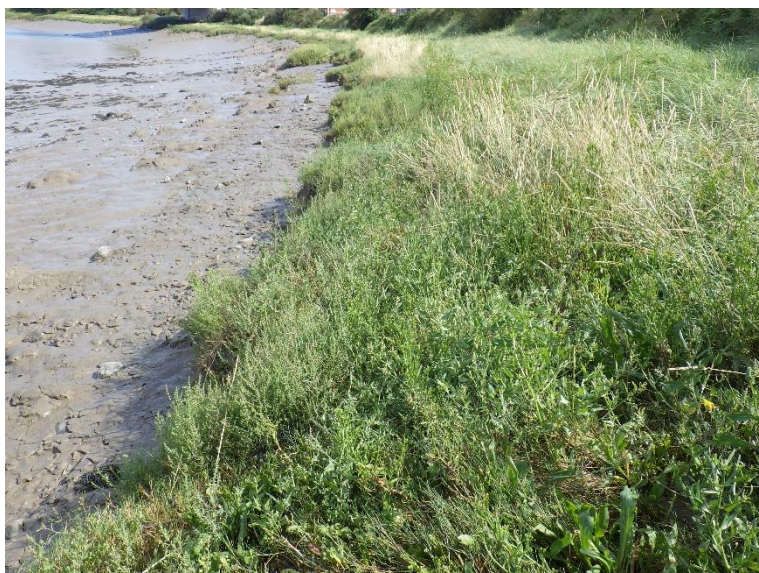
The lower part of the saltmarsh supports a mostly narrow strip of Sea Aster, Common Saltmarsh Grass and Annual Sea-blite. Common Cord-grass occurs patchily within this zone; mostly as small, dense stands of 2-4m diameter (e.g. Quadrats 2 & 19). These would best fit with SM6 *Spartina anglica* saltmarsh, although the patches are generally too small to map and often intergrade with the adjacent communities.

Narrow strip of SM13 Puccinellia maritima saltmarsh (with SM24 in right of picture), near Quadrat 16).

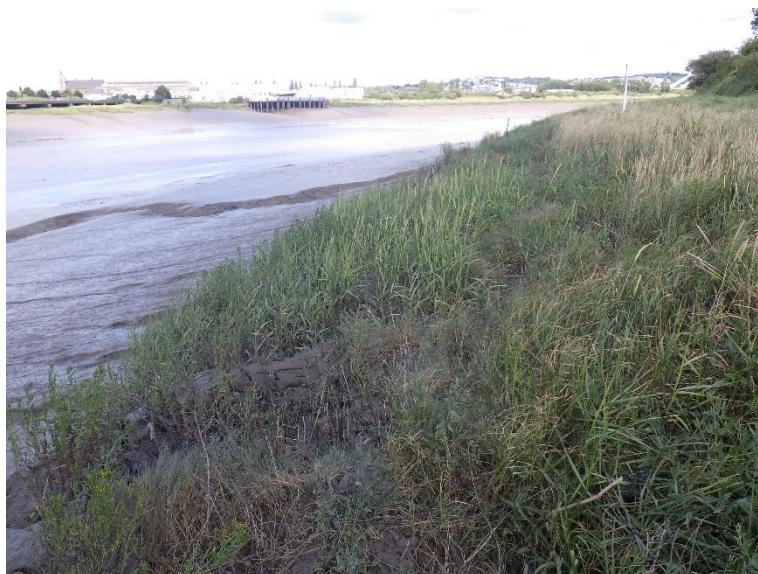
SM13 *Puccinellia maritima* saltmarsh with patches of SM6 *Spartina anglica* saltmarsh (near Quadrat 6).

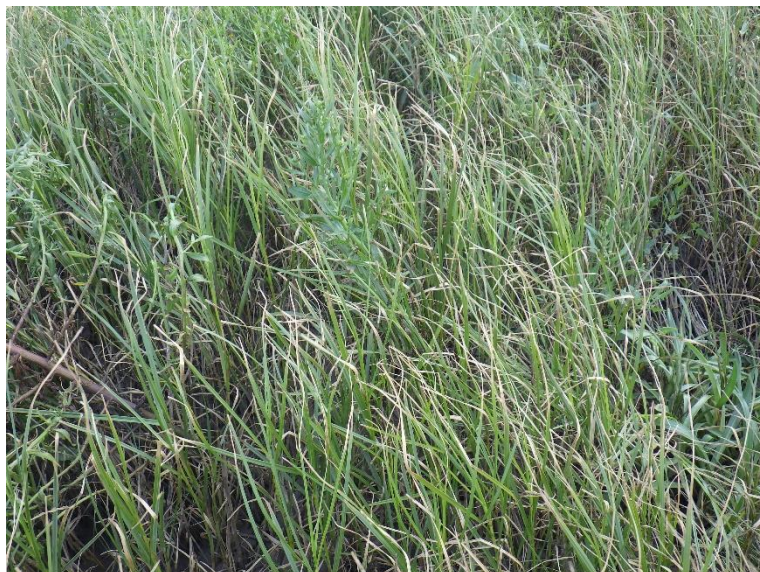
Two patches within the middle shore were dominated by Sea Clubrush. The only one that was accessible is described by Quadrat 5. No frequency data is presented for this because the patch was not large enough to record more than a single quadrat. The small patch of this community that was visible from the jetty appeared to be similar in species composition to Quadrat 5.

S21 Bolboschoenus maritimus
swamp vegetation (at Quadrat
5).

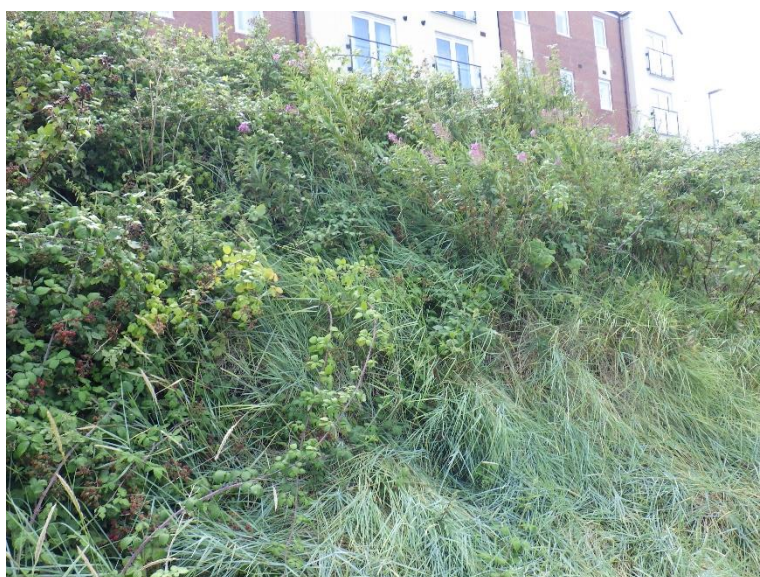
The upper edge of the saltmarsh along the whole of the survey section is defined by a steep bank that is largely covered by dense Bramble (TN1, TN5 & TN6). The Bramble scrub is accompanied by a relatively low diversity of coarse grasses and tall ruderal herbs; particularly False Oat-grass, Couch, Yorkshire Fog, Nettle, Hogweed, Rose-bay Willowherb, Hemp Agrimony and Yarrow. A slightly less heavily scrub-covered part of the bank is present at the north of the Orb Electrical Steels site. This contains sparsely vegetated rubble with a slightly higher plant diversity that includes Black Medick, Fern-grass, Maidenhair Spleenwort, Mugwort and Butterfly Bush.

Dense Bramble on flood bank
(east of quadrat 6).

The proposed flood defence works would involve increasing the height of the flood bank in certain sections. Because the work would primarily involve altering the height of the bank it should be feasible to do this without any need to widen the bank towards the river. If this is possible the only habitats that would be affected would be the Bramble scrub with tall herbs and the adjacent mown grassland. Both of these low value habitats would be expected to regenerate within a few years of the disturbance and no specific mitigation to translocate or reinstate rare plant communities would be required.

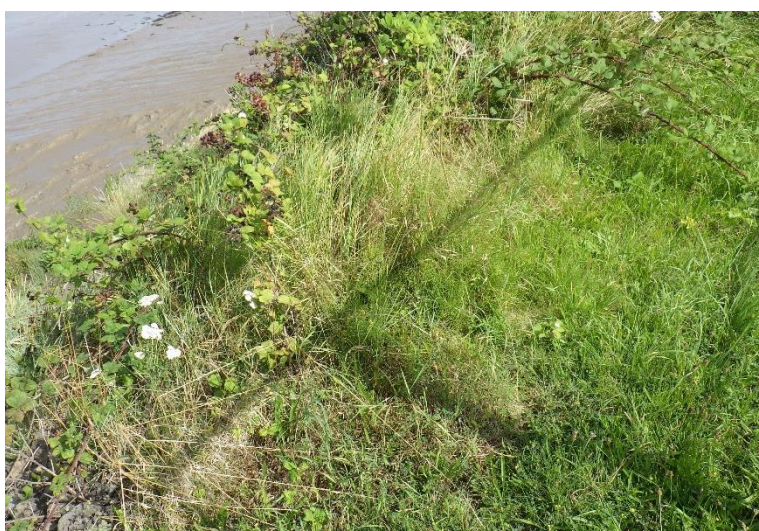
The occasionally mown grass area at the top of the flood bank within the Orb Electrical Steels site (TN3, and a small patch at Q14) lies outside the saltmarsh study area but was sampled by means of 2 quadrats to describe it and investigate whether it supported any species of nature conservation significance.

Fragmentary MG1
Arrhenatherum elatius
grassland at top of bank (at
Quadrat 14).

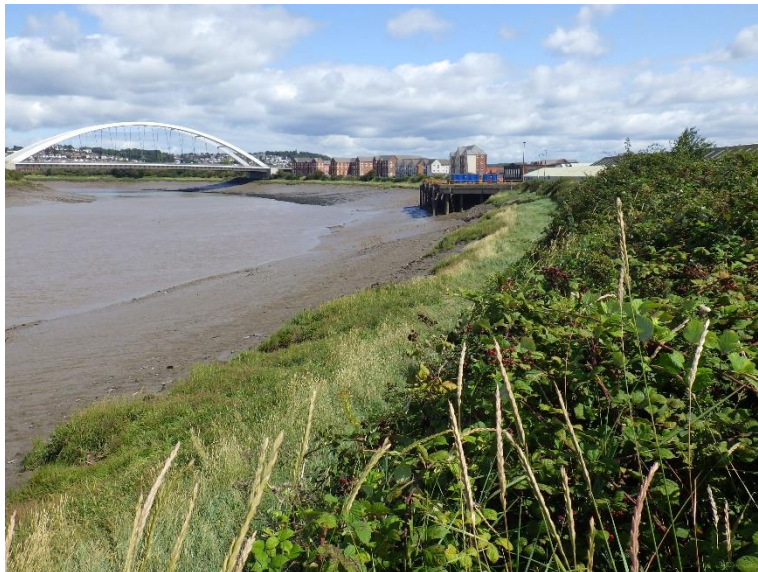
The central section of the saltmarsh immediately south-east of the jetty could not be accessed. However the plant communities were viewed from the top of the bank, and partly from the jetty. There were no indications from these positions that there were any different communities present. The zonation of plant communities and range of species appeared very similar to the habitats investigated more fully to the north-east and south-west.

The main block of the saltmarsh at TN2 is a strip of SM24 Sea Couch, with a mix of SM13/SM6 along the seaward edge, dominated by Sea Aster and Common Saltmarsh-grass. The width of the SM13 belt appears wider than the belt to the north-east of the jetty, and there are several larger blocks of SM6 Cord-grass saltmarsh towards the south-eastern end. The Bramble bank adjoining the upper part of the saltmarsh appears to be steeper than the other parts, so it was not easy to see the vegetation at the foot of the bank. Two species that were observed at the foot of the bank which were not seen elsewhere in the study area included the wetland herbs Marsh Woundwort and Hemlock Water-dropwort. It is feasible that there be other, lower-growing wetland species that were not visible from the top.

Looking north-east along the inaccessible section (TN2) towards the Orb Electrical Steels jetty.

If there is likely to be a potential for impacts on the central section of saltmarsh habitat (at TN2 and TN4), rather than just the flood bank, it would be appropriate to carry out a further survey to clarify whether there are any rare species that would be affected, so that specific mitigation measures can be developed if necessary (e.g. protecting or transplanting locally uncommon species before the work commences).

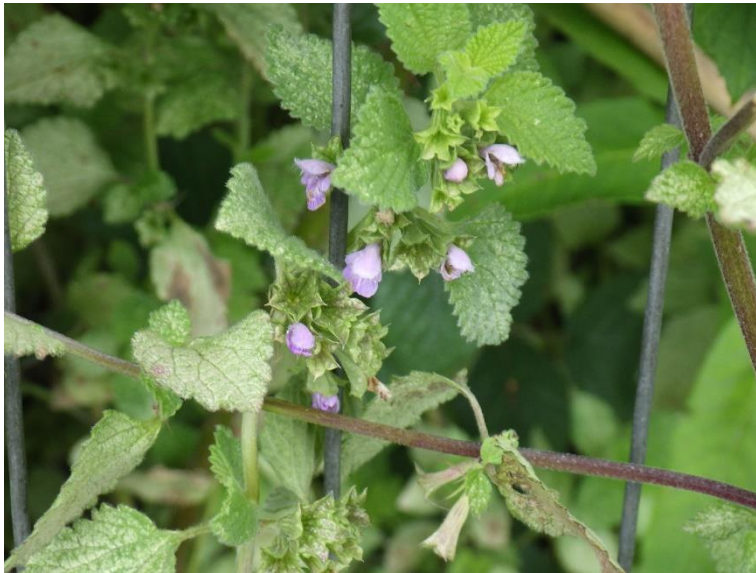
No rare species were found in this community, although a few plants of the locally notable Black Horehound were noted in the roadside scrub immediately east of the Transporter Bridge (but this outside of the study area and not part of the saltmarsh community).

Black Horehound in roadside scrub East of Transport Bridge.
