ABERMULE BUSINESS PARK

Geo-Environmental and Geotechnical Assessment Report

MAY 2019

Report No 10026414-ARC-00-XX-RP-ZZ-0003-02

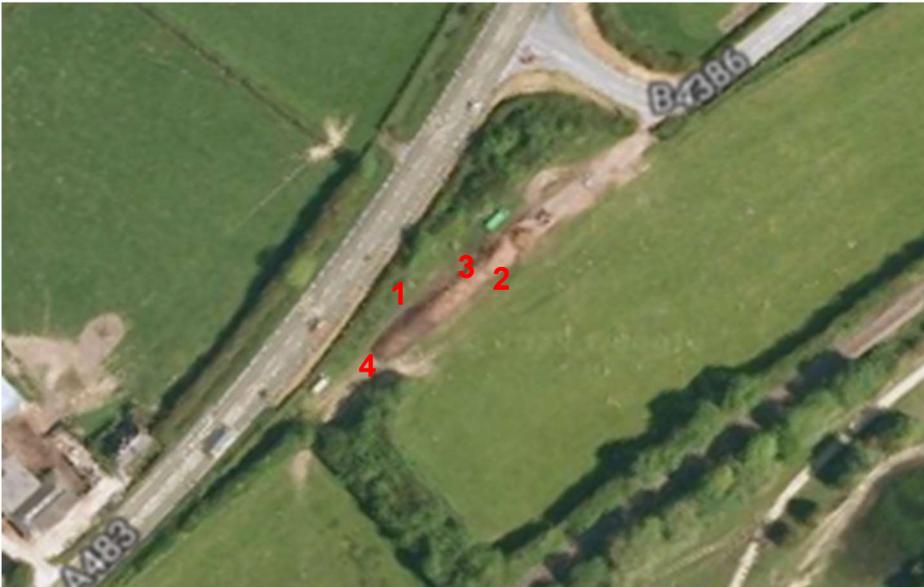
Figure 9.1 - Locations of Stockpiles

In addition, there are a number of stockpiles of material along the north western boundary of the site (along the former road). Asbestos has been identified in these stockpiles by another Consultant (Middlemarch Environmental). The results of the Middlemarch testing are discussed within Section 7.3.3. Consequently additional samples were collected of stockpiled material to test against standard soil chemical suites (including asbestos), to be able to classify the material and to inform whether the material in the fly tipped stockpiles has hazardous properties and may require disposal as hazardous waste.

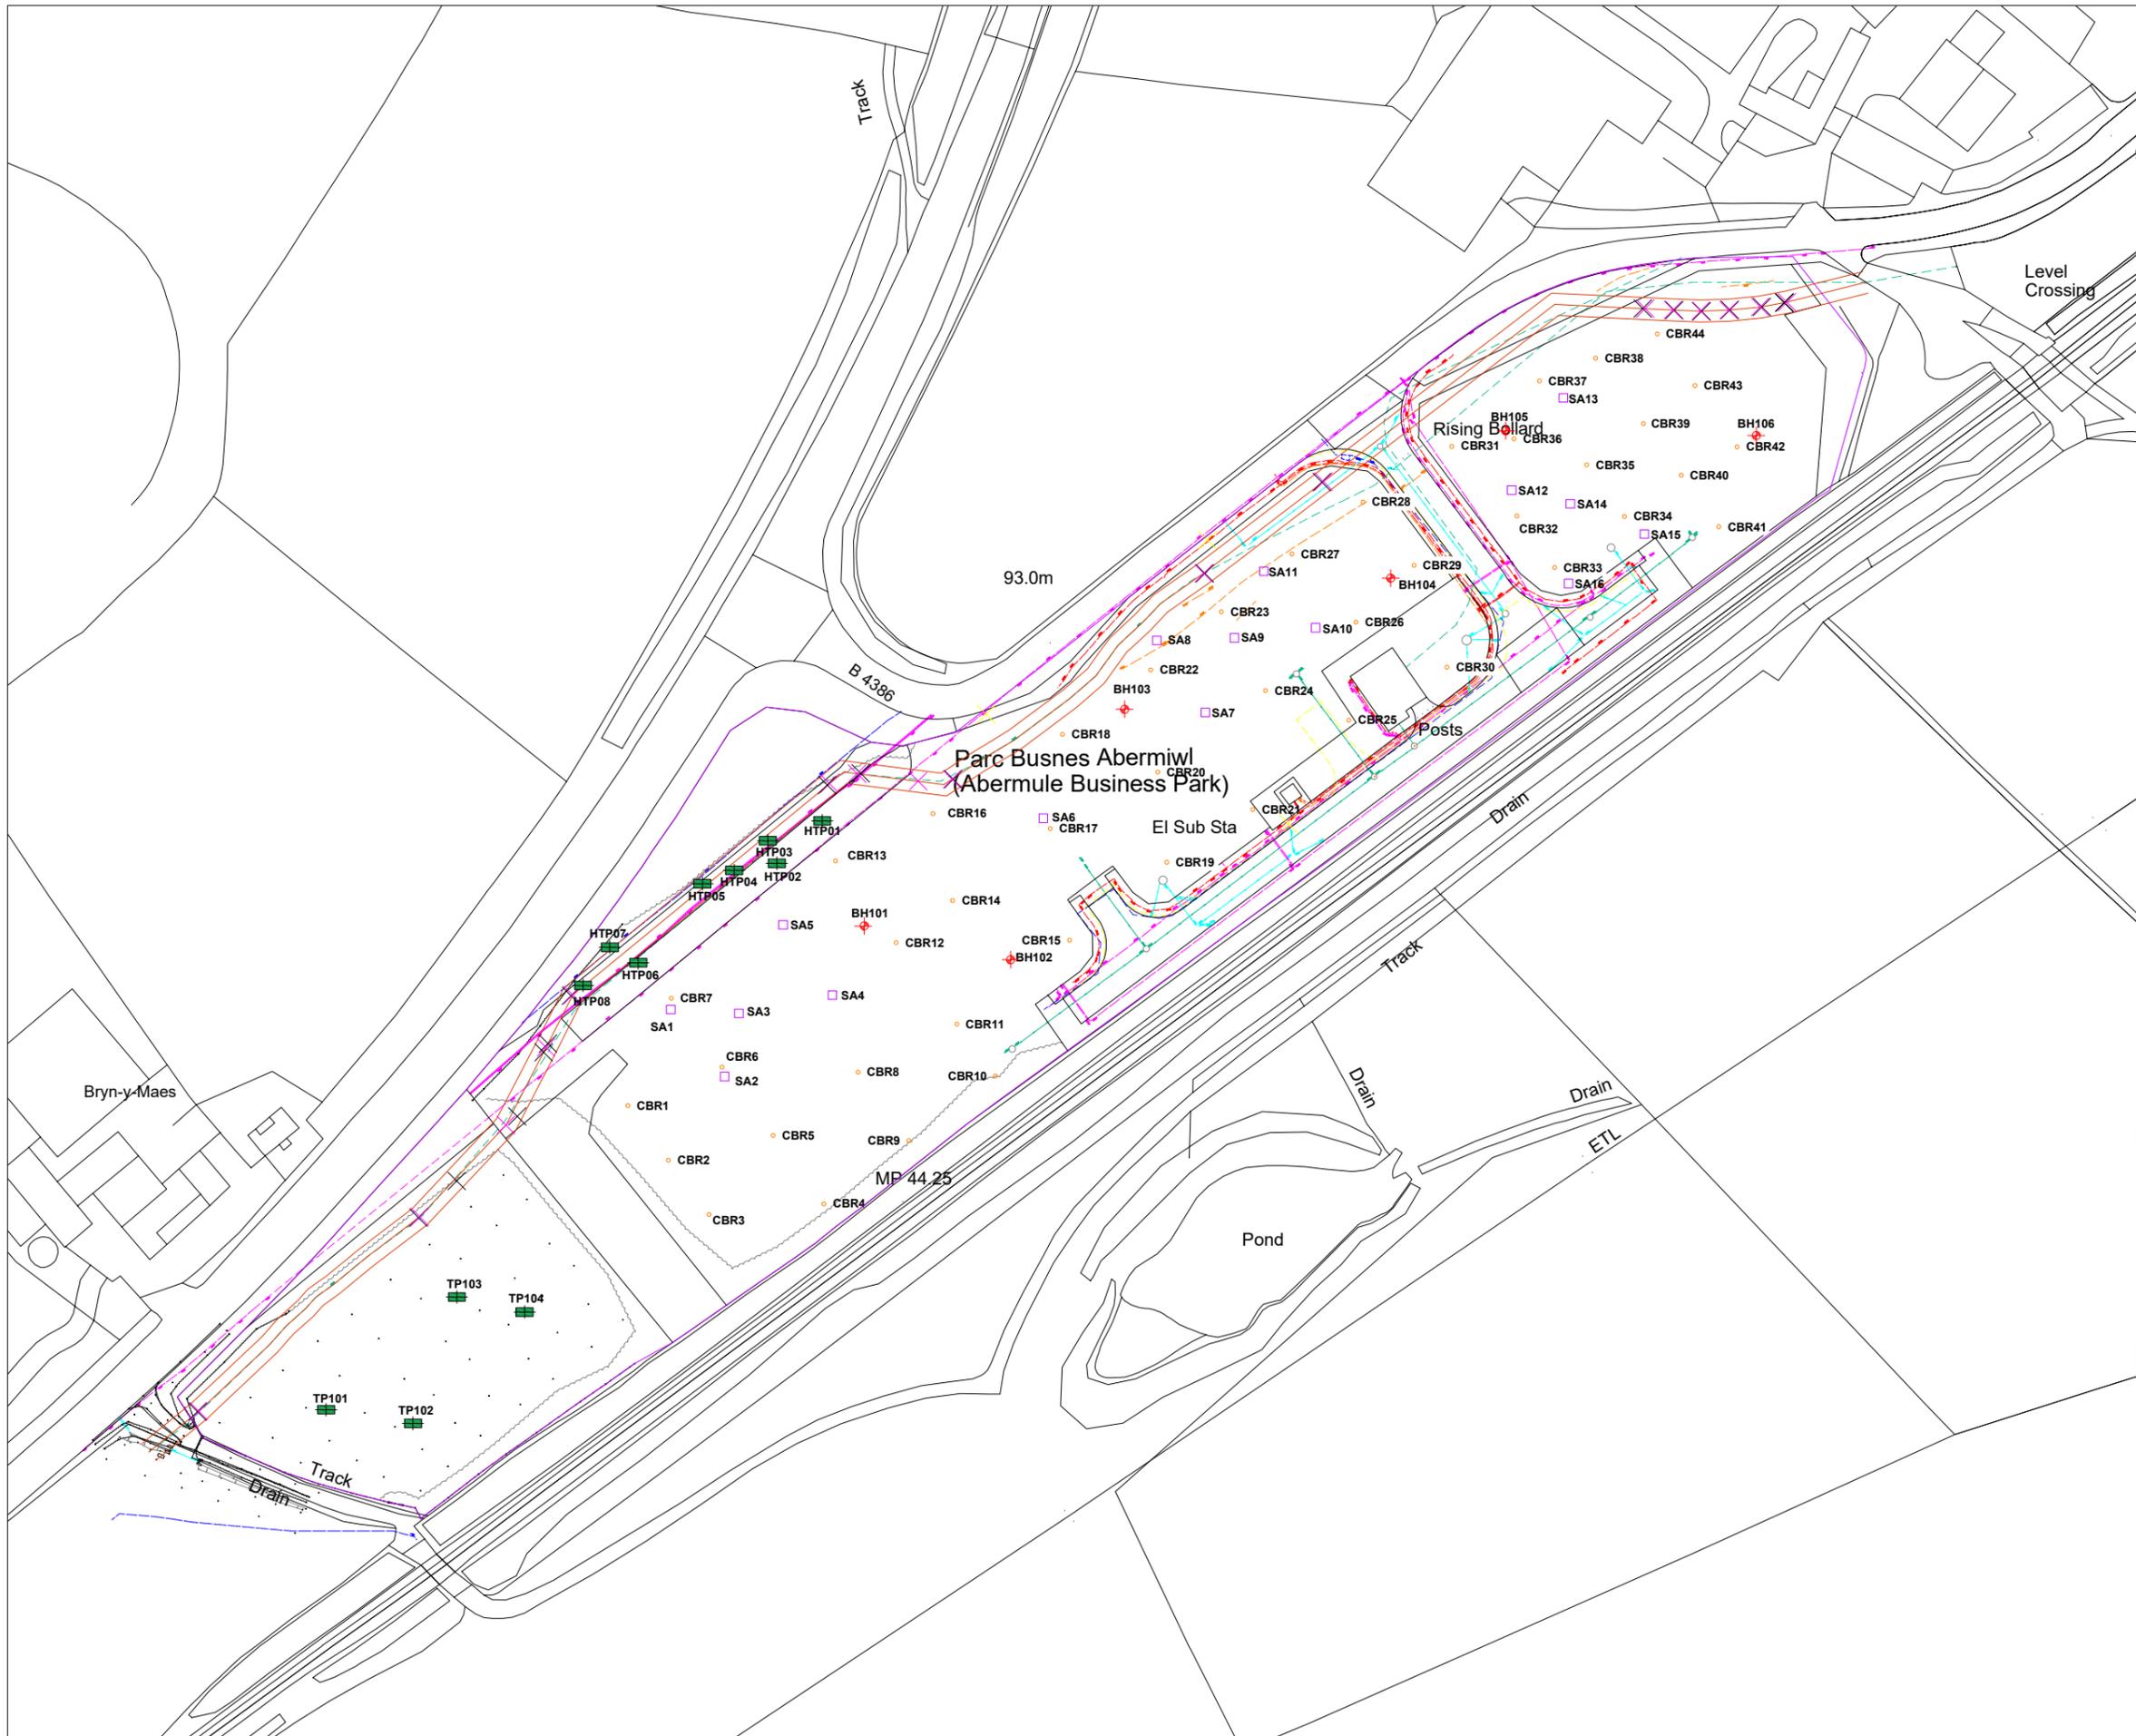
Exploratory Hole Location Plan

- Existing Rising Main
- Site Boundary
- SA Percolation Test Location
- CBR CBR Test Location
- ✦ BH Borehole
- TP Trial Pit
- HTP Hand Dug Trial Pit
