Arboricultural Impact Assessment

Pen Yr Englyn

Date: August 2025

ADAS Reference: 1052590

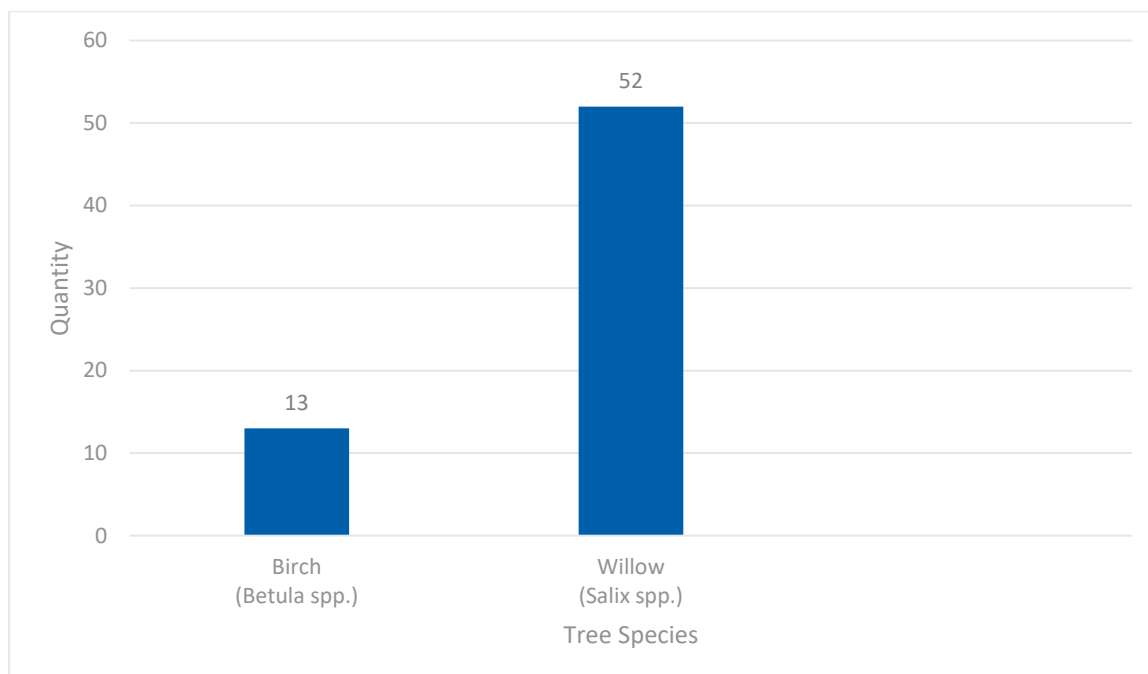
Figure 4: Range of Tree Species on site (Species recorded >10 occasions)

The range of tree species recorded on greater than 10 occasions within the survey is demonstrated in **Figure 4** below, with those tree species recorded on fewer than 10 occasions demonstrated in **Figure 5**.

As can be seen from **Figure 4** the most abundant species recorded was willow. The willow (*Salix* spp.) genera is a fast growing primary colonising genus which is typically associated with deep moist soils.
