# River Kenson River Restoration

## Cultural-Heritage Desk-Based Assessment

January 2026

Prepared for:  
Natural Resources Wales

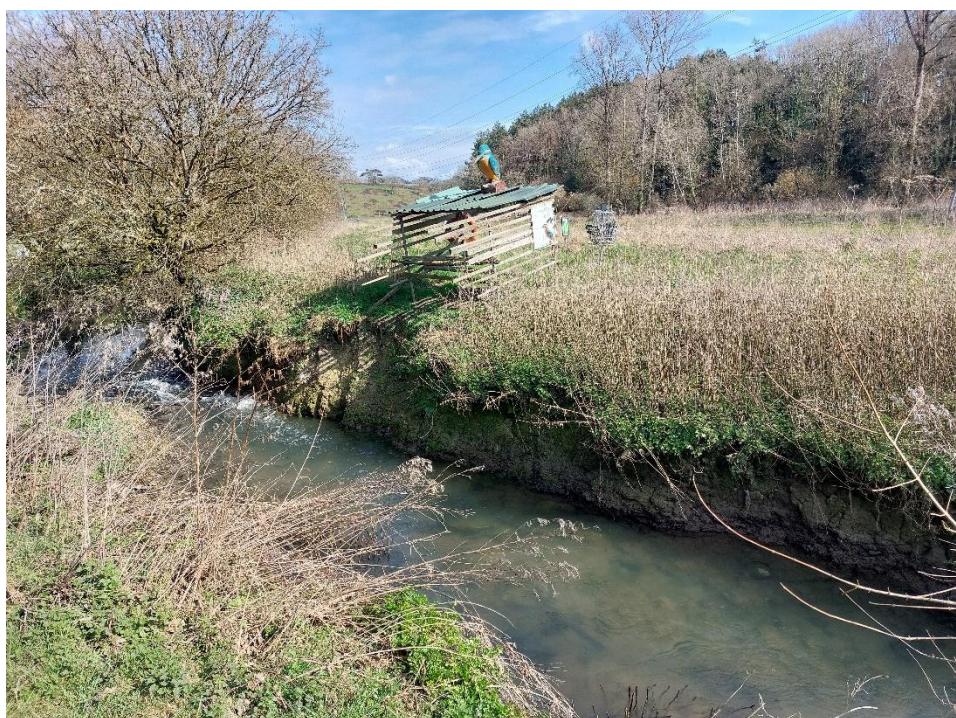
Plate 2 - Example of the steep and unstable banks present along the River Kenson, facing south-east.

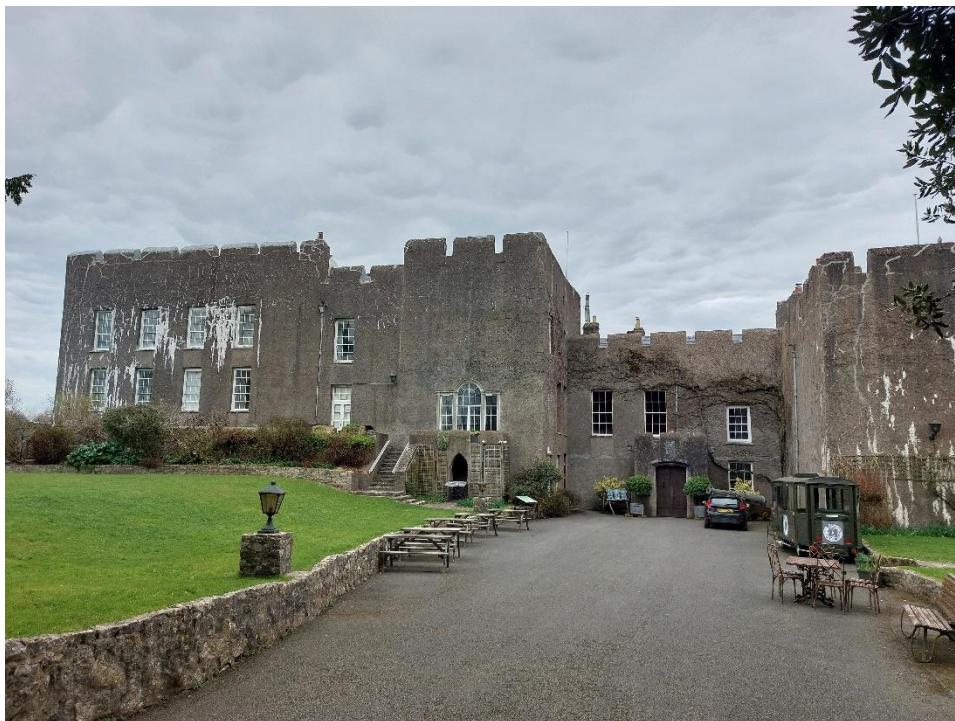
Plate 3 - The south facing elevation of the Grade I Listed Building Fonmon Castle (13597), facing north.

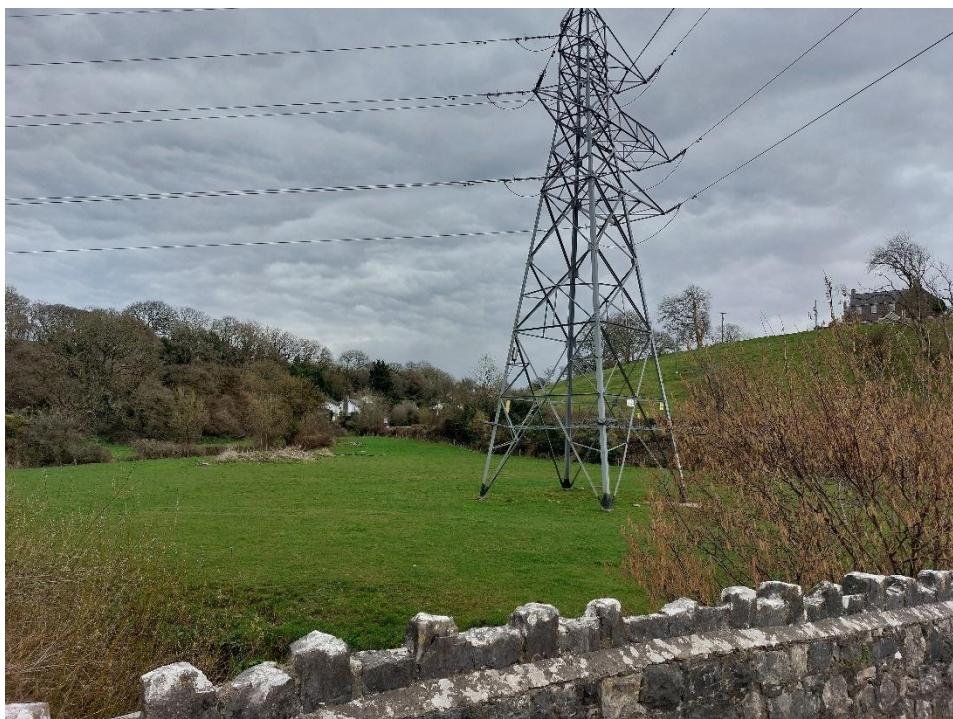
Plate 6 - The view into Penmark CA as seen from the Grade II Listed Kenson Bridge (83154), facing east.

The Penmark CA AMP identifies that the Penmark village constitutes the core of the settlement, with a strong sense of enclosure, characterised by its narrow lanes and confined spaces. However, the western edge of the CA there is significantly more dispersed settlements, with clear views from the Kenson Valley from Kenson Bridge (83154), which constitutes a key view into the CA (VoG 2009b) (Plate 6).

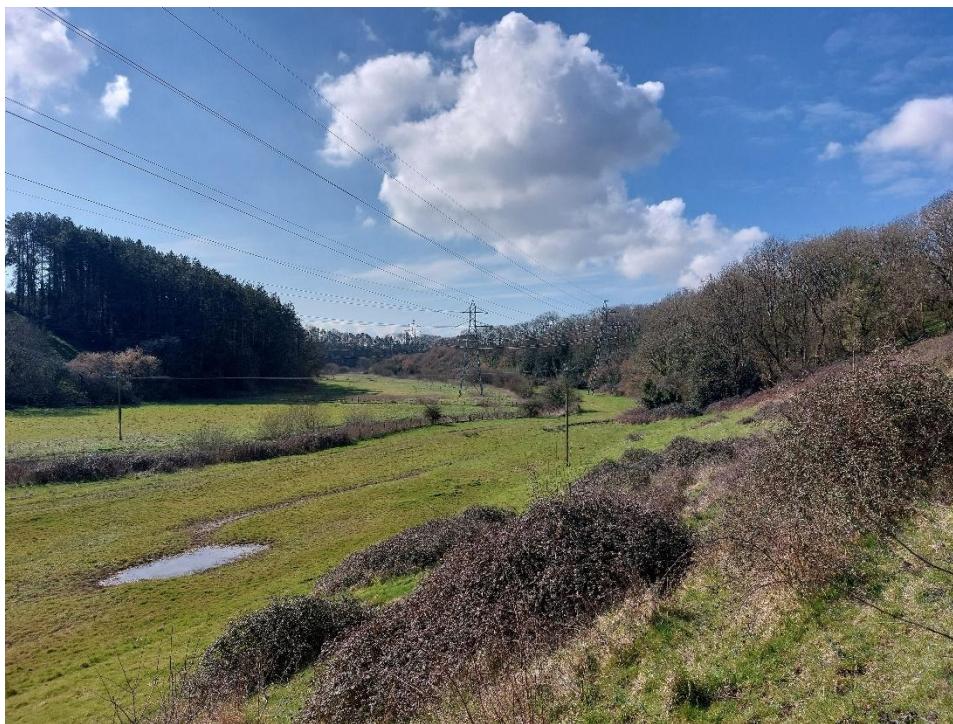
Plate 10 - A view of the flat-bottomed floodplain present in the Kenson Valley, facing west.

Nonetheless, the geomorphological context of the Kenson Valley does suggest that there is a medium to high potential for palaeoenvironmental remains to be present within the Site. The floodplain may preserve peat layers, or waterlogged sediments, containing organic materials such as pollen, plant macrofossils, or preserved wood, which could provide valuable insights into the palaeoenvironmental history of the valley. These remains are likely to be of particular interest for reconstructing past land-use patterns, climate conditions, and river dynamics.

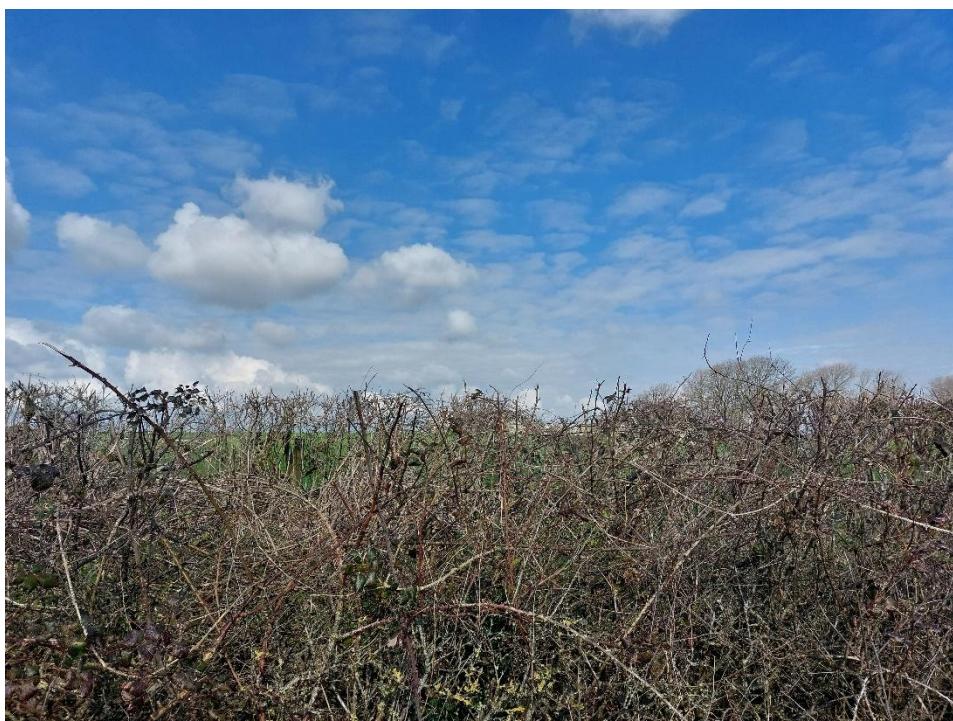
Plate 12 - The view towards the Grade II Listed Cliff Farmhouse (16410), which does not have intervisibility with the Site, facing north.

In the 18th century the Grade II Listed Cliff Farmhouse (16410) was constructed (Plate 12). This is thatched farmhouse which stands in within an expansive agricultural area, situated to the high ground to the north of the Kenson River. High hedge rows in the immediate area only allow for glimpsed views of this property, creating a physical barrier with the surrounding landscape. It is also within the Vale of Glamorgan (HLW (SG) 1) Registered Historic Landscape area. Located directly to the north Cliff Farmhouse (16410) is an enclosure identified from aerial photography (PRN 03127s). It has been postulated that this enclosure (PRN 03127s) is related to Cliff Farmhouse (16410). In 2008 a watching brief was undertaken in Cliff Barn (E001388), located 15m to the west of Cliff Farmhouse

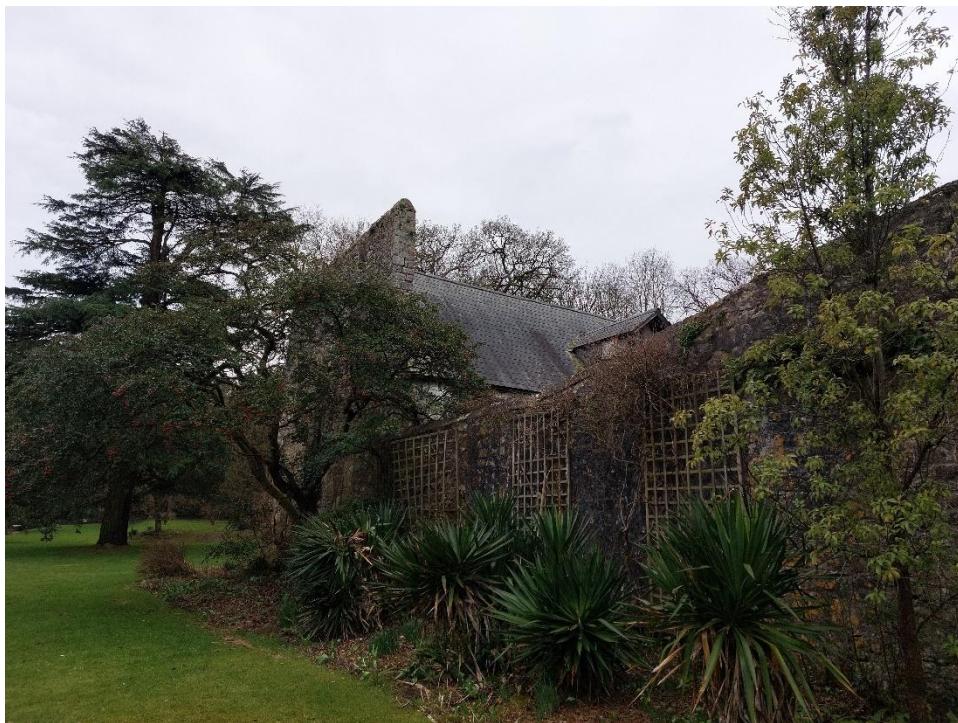
Plate 13 - The Grade II Listed Stable Block (13616), facing north east.

In 1834 Robert Oliver Jones succeeded his father Jones IV as the owner of Fonmon. During his tenure new woodland was created to the west of the Grade II Listed Stables (13616) through which the main driveway is still located (Plate 13). Additional woodland was also created in within the ravine of Fonmon Brook. Located within the woodland to the west, south and east of the castle, formal paths were established. Far fewer paths appear to have been established to the north near the Kenson River, highlighting how the Kenson did not historically form a core part of the designed landscape. The overall effect of this planting gave the Fonmon estate a distinctively enclosed character, with expansive views to the west becoming closed off by establishing woodland, which remains a key characteristic of how the HPG is experienced today (EDP 2023).

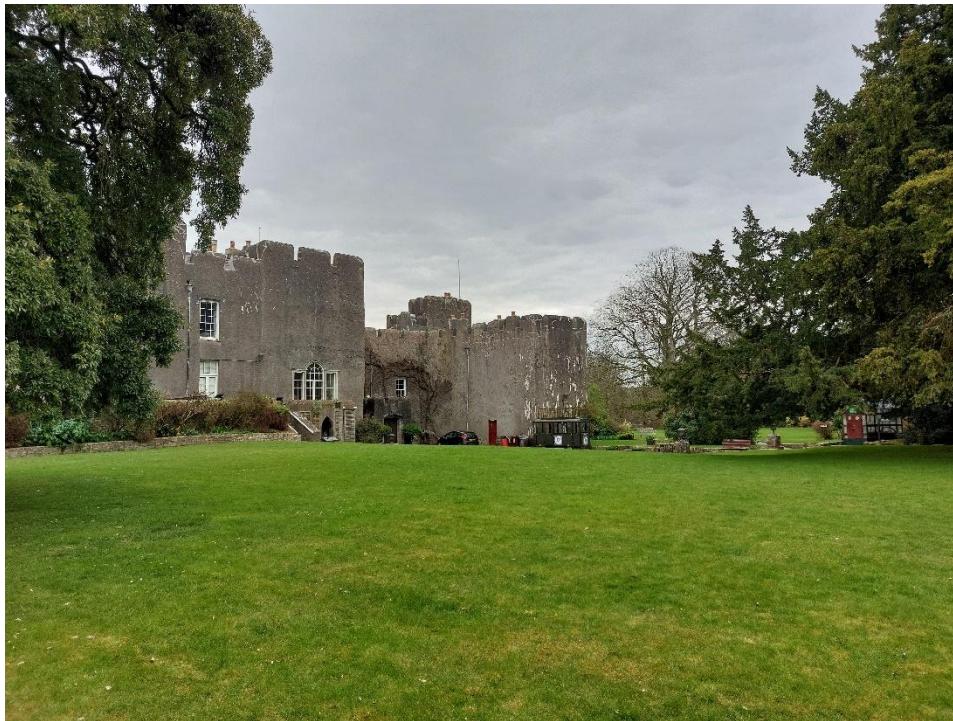
Plate 14 - The east facing elevation of the Grade I Listed Fonmon Castle (13597), with the 18th century alterations apparent, facing north-east.

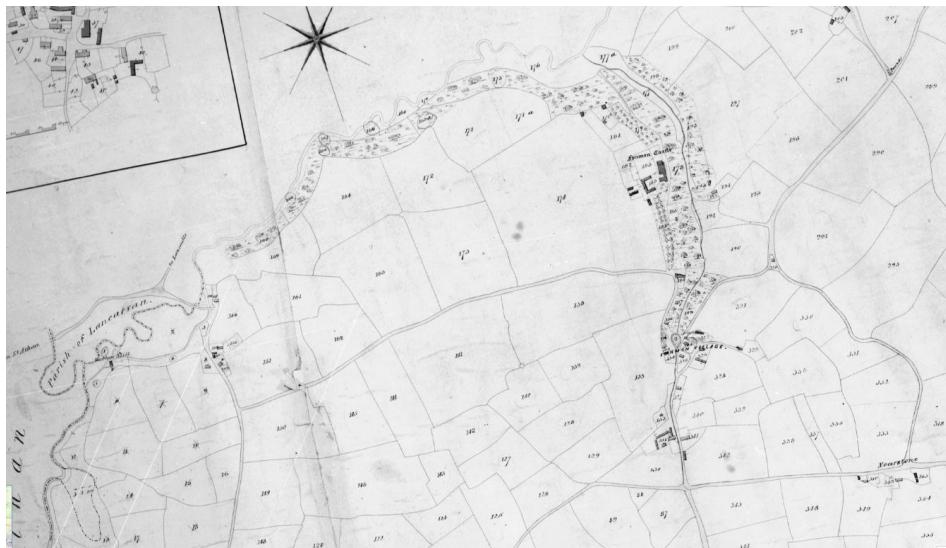
Plate 15: Tithe map of 1840 (ref: IR 29/51/106, Genealogists 2025)

The development of the surrounding landscape is understood mainly from the estate map, from the 1830's and the Tithe map from 1840. (Plate 15). The designed elements from this period are themselves relatively simple, consisting of:

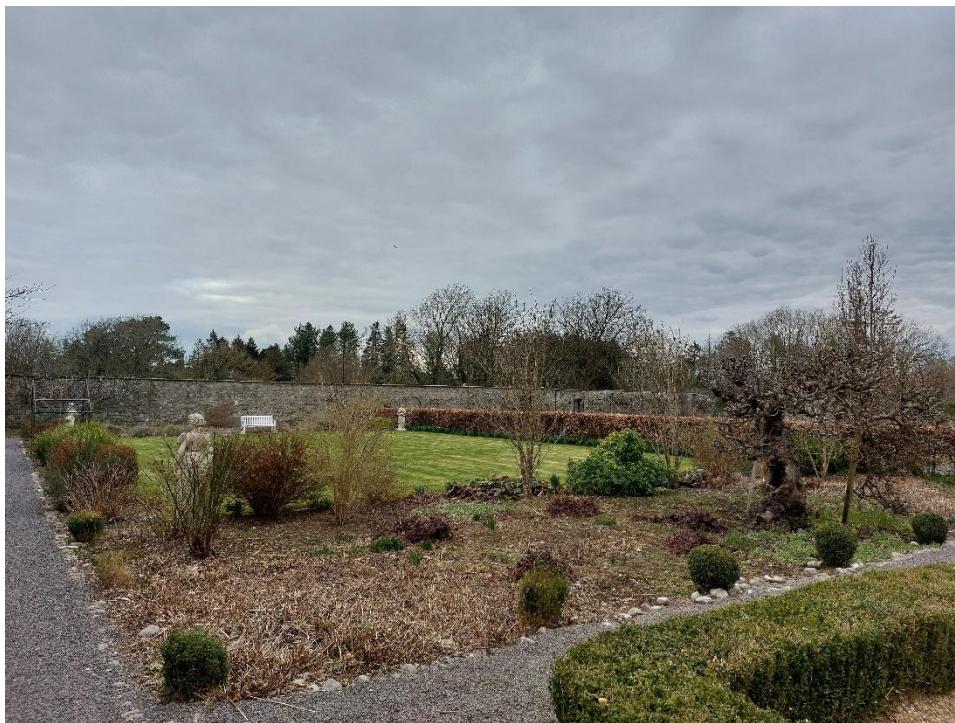
Plate 16: View of the ornamental garden to the south of the Castle. The retaining wall for this ornamental garden is a Grade II Listed Building (83159), facing north-west.

- the main approach from the south which is flanked by ornamental planting;
- an area of managed woodland to the east surrounding Fonmon Brook;
- a ha-ha running southwards from the stable block (PRN 02337s);
- the walled gardens situated to the north and west of the castle which is a Grade II Listed Building (83164); and
- the ornamental garden to the south of the Castle. The retaining wall for this ornamental garden is a Grade II Listed Building (83159) (Plate 6).

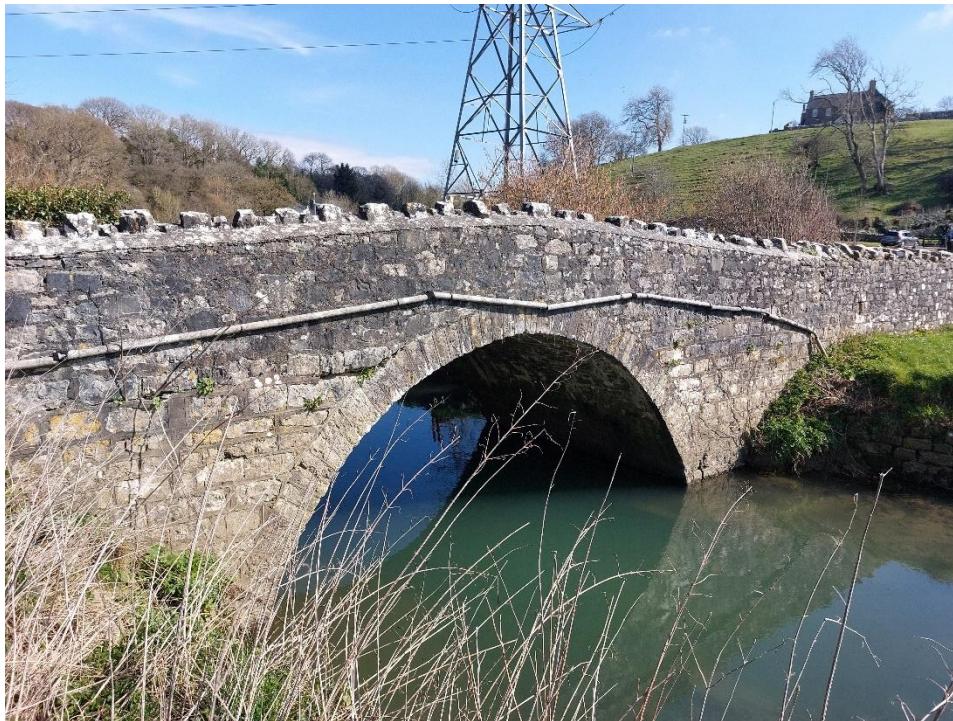
Plate 18 - The Grade II Listed Kenson Bridge (83154) as view from the Site, facing south-east.

Located approximately 3m to the east of the Site is the Grade II Listed Kenson Bridge (83154) (Plate 18). Constructed of local limestone rubble in the early 19th century, this narrow single span bridge appears to be unaltered from its initial construction other than minor repair work. Although this bridge crosses the Kenson River, it is a relatively small structure within the landscape. There is clear visibility to the south-east from the Bridge into the Site (Plate 6). Kenson Bridge also forms the boundary between the Site and the Penmark CA to the east, while not being within the CA itself.

83154	Kenson Bridge	Grade II Listed Building	ST 05152 68747	A probably early 19th century bridge which appears to be as built except for minor repairs. Bridge built of local limestone rubble with dressed voussoirs to the segmental arch ring. Narrow single span bridge which was originally more hump-backed but has been flattened out by the addition of a stone causeway at either end.

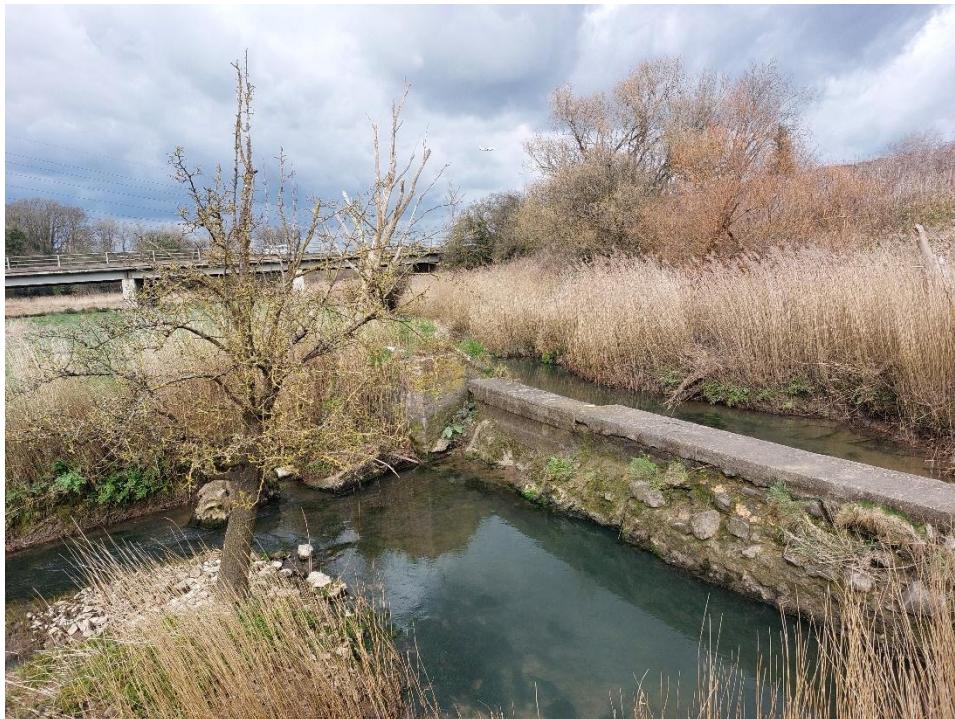
Plate 20 - The post-medieval Weir (06933s), facing north-west.

At the south-western end of the Kenson Valley is the location of a post-medieval weir (PRN 06933s) (Plate 20) which has been considered within a previous DBA undertaken by JBA Consulting (JBA 2025b, River Kenson Weir Removal Cultural Heritage Desk-Based Assessment. OVQ-JBA-XX-XX-RP-HE-0001-S3-P02-Weir\_WSI). The weir was previously recorded as part of a wider historic water management system serving Burton Mill and later the Aberthaw Cement Works. The existing fabric comprises a rubble core, dressed stone, cast concrete, and modern brick elements, indicating multiple phases of repair and modification from the late 19th to 20th century. Cartographic evidence suggests the weir was constructed between 1885 and 1900 to improve water supply to the mill. Further alterations likely occurred in the 1930s in connection with water abstraction schemes for the cement works. The weir appears to have fallen into disuse by the mid-20th century following the site's connection to the National Grid and cessation of water-powered operations. Post-medieval activity in the Kenson Valley is predominantly agricultural and industrial (mills, water management, quarrying), with limited structural remains within the Site itself.

Reference Number	Name	Period	NGR	Description
06933s	Weir, Burton	Post Medieval	ST 03394 67731	The weir is a composite structure incorporating a range of construction materials and techniques, reflecting multiple phases of repair or modification. The first cartographic evidence of a weir at this location appears on the 1900 OS map, where a solid line is depicted across the river channel at the site. This feature marks the division between the main course of the River Kenson and the leat feeding the mill, suggesting the initial construction phase of the weir was between 1885 and 1900 to further raise water levels and increase flow to the mill. exclusively via the weir. The weir is approximately 20m in length, and 1m in width. On the south-west facing elevation, the irregular rubble core of the weir is exposed. This core comprises unworked

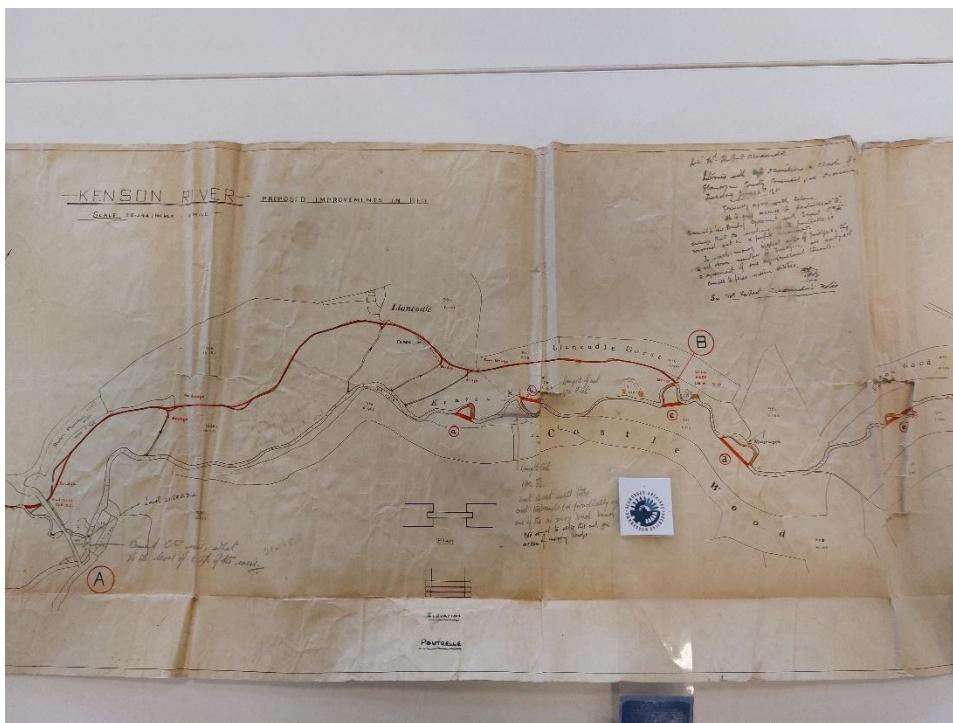
Plate 22 - Plan of the "Proposed Improvements" to the Kenson River dated to 1931, as provided by Glamorgan Archives.

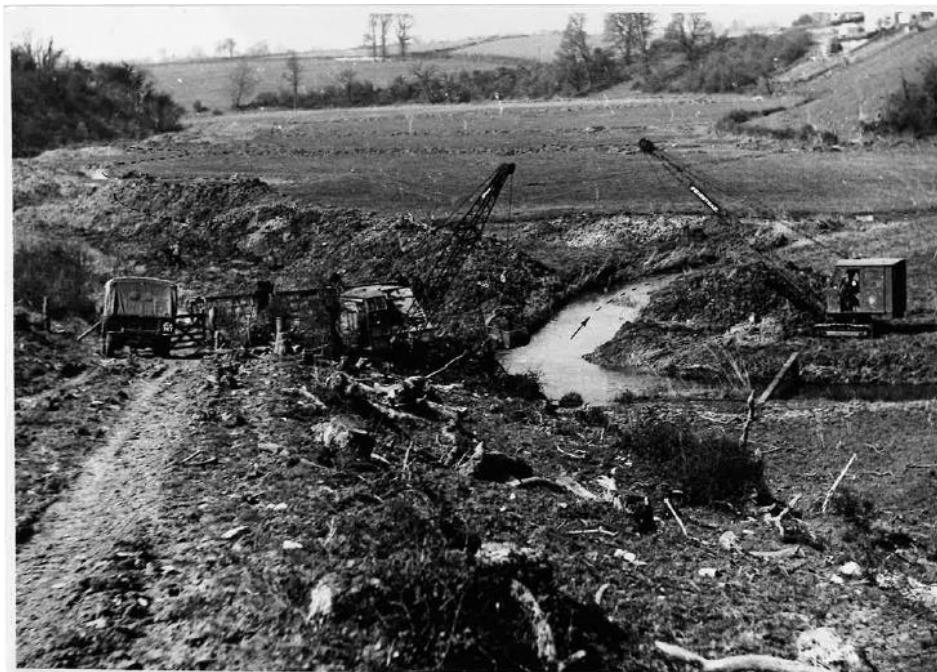
Plate 24 - A photograph from the Glamorgan River Board highlighting the River straightening works were underway by 1951.

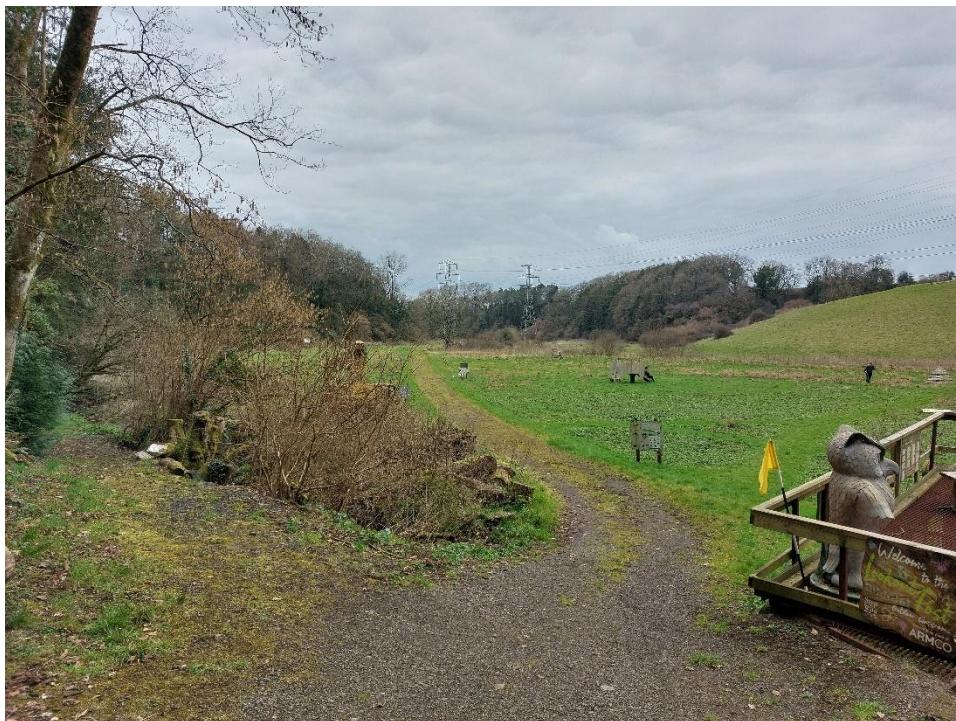
Plate 26 - The location of the "withy beds" depicted as present in the 1885 OS map, which are no longer present, facing north-west.
