## TECHNICAL NOTE

2025s0023 – NRW Kenson River  
Restoration  
NRWWCS00037  
Natural Resources Wales  
28/05/2025  
Jon Howard  
Michael McDonald  
Ground Investigation –  
Contaminated Land Tech note

Waste Classification Assessment Report for Soils

Natural Resources Wales River Restoration, Kenson River, Rhoose, Barry, CF62 3BL

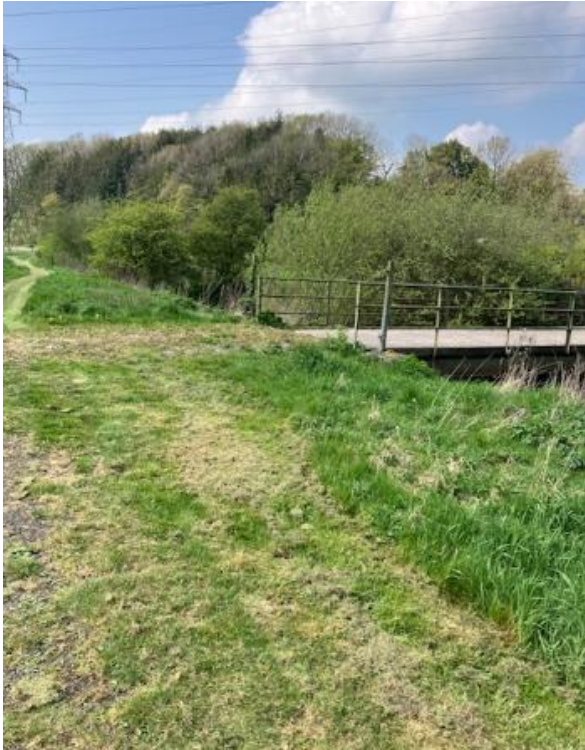
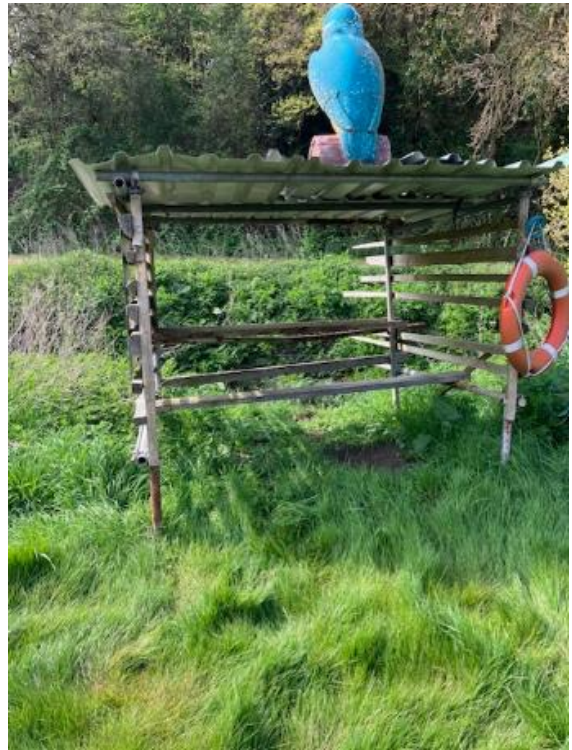
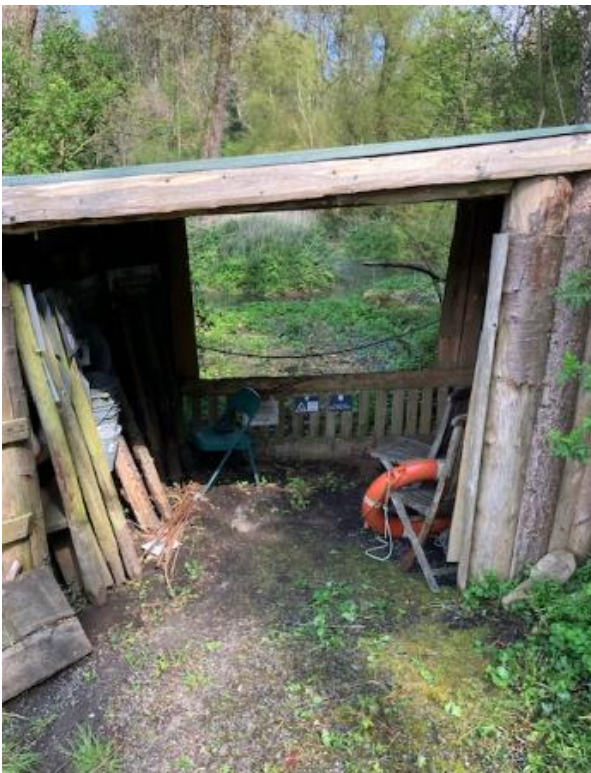
## Site Photographs

Material type:	Brown Clayey Loam with Gravel and Vegetation.
Material Volume:	2KM of Riverbed Still in Situ
Number of representation samples:	3
Historic:	River Kenson in the Vale of Glamorgan Due to be Re-meandered
Sample by:	Ralph McHugh - Ecofficiency
Sample date:	24/04/2025
