# PENYRENGLYN LANDSLIDE RISK MANAGEMENT WORKS

Landscape and Visual Appraisal

Project no. 4021526

Natural Resources Wales

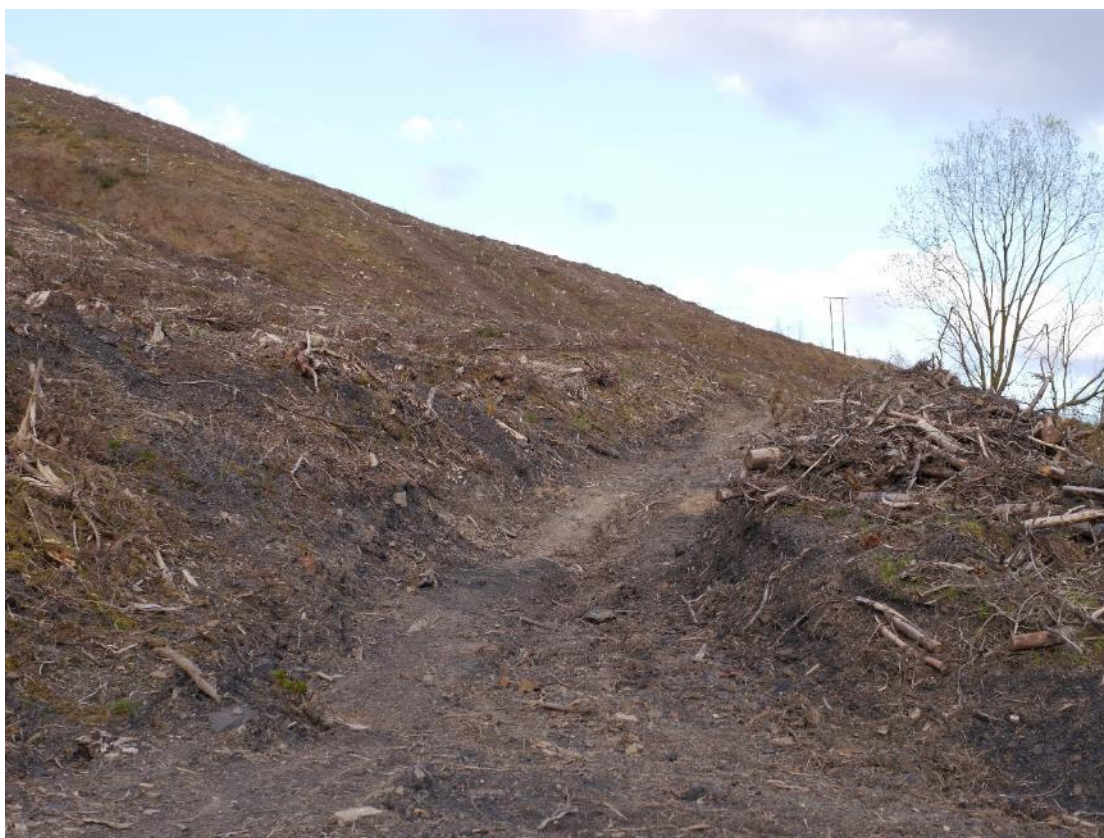
*Image 1: View within the site, of felled plantation and forestry track, taken April 2024.*

At the time of the site visit, although the woodland was felled and timber cleared, many low level tree stumps remained as did brash, the ground was uneven and had not been cultivated (see image 1). The ground was predominantly bare, with only occasional bracken having germinated since the felling, and infrequent patches of moss. The felled woodland was dissected by forestry tracks which are steep in places and heavily rutted by forestry machinery. The PAWS had also been felled.

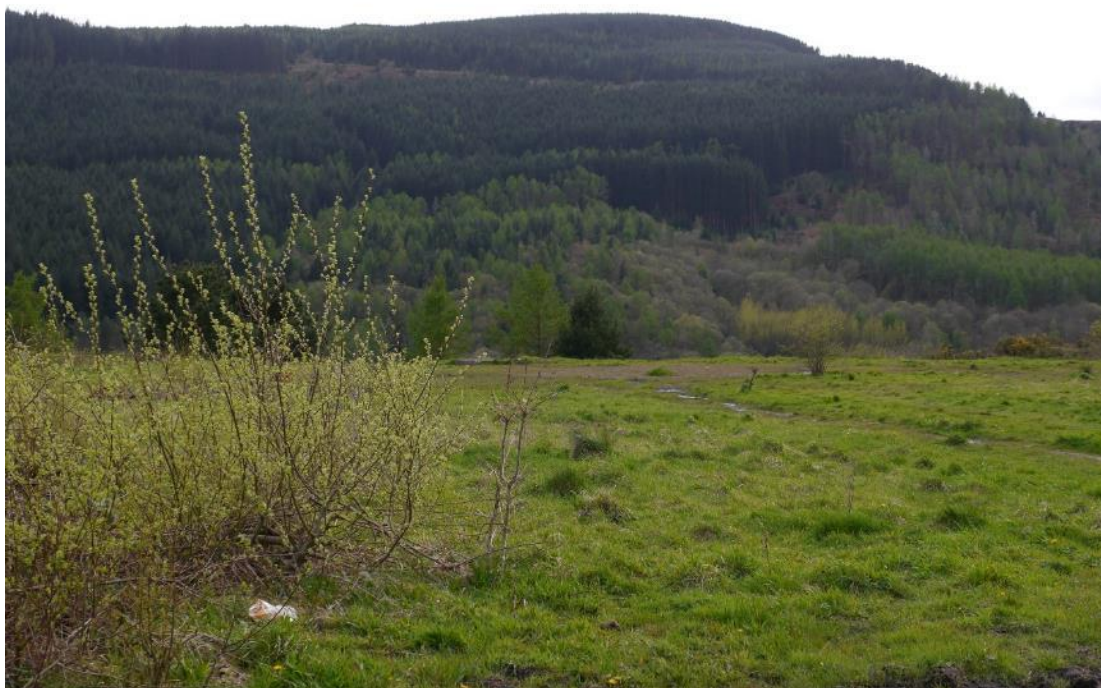
*Image 2: View southwest from the vehicular access track across the plateau. The wooded slopes of the opposite valley side can be seen in the background.*

The plateau at the southern edge of the site is predominantly improved grassland with some self-set scrub concentrated around the edges (see image 2). The grassland is short and tussocky. The plateau is crossed by informal tracks / desire lines, and there is a vehicle access track (although unsurfaced) between Herbert Street (west) and the allotments (east). The plateau is separated from the felled plantation by this access track, by a ditch which runs along the north side of the track, and by a band of wet woodland which is predominantly willow. Whilst the forestry tracks provide informal access from this plateau up through the woodland and onto the felled plantation area on the slopes, the woodland does provide a visual barrier between the plateau and the felled plantation.

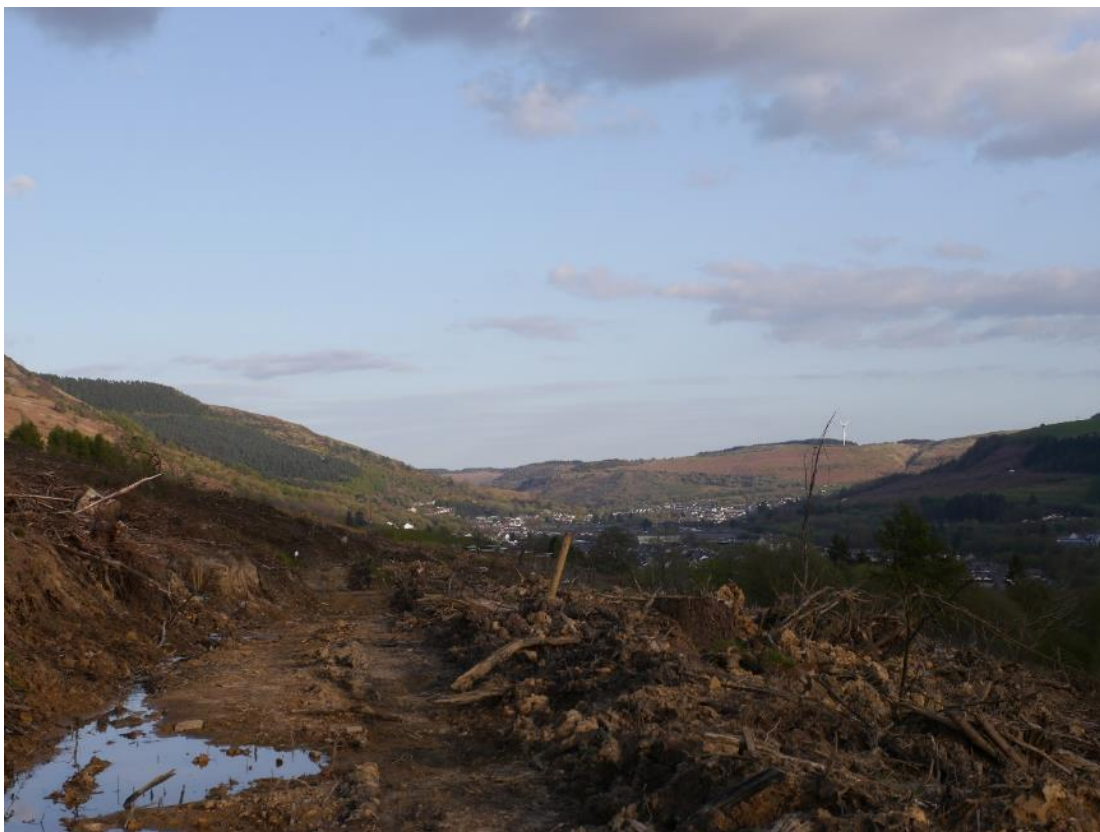
*Image 5: View east from the eastern site boundary, of the largely open character of the eastern slopes, with some plantation woodland and some felled plantation, but largely open grassland with bog and heath.*

There are long-reaching views from the site along the Rhondda Valley and to the hill slopes on the opposite side (see image 5). The settlements of Treorchy, Penyreglyn and Treherbert, which join together in a ribbon development in the valley bottom, can be seen. Views of the settlement include residential and recreational areas, commercial and industrial units, and transport routes. The railway line, associated infrastructure and surrounding industrial units are prominent in views, giving the settlement an industrial feel. On the lower slopes above the urban area of the settlement is a fairly continuous band of broadleaved woodland, above which the upper slopes and hilltops are populated by either forestry plantation (generally to the west) or open upland (generally to the east).

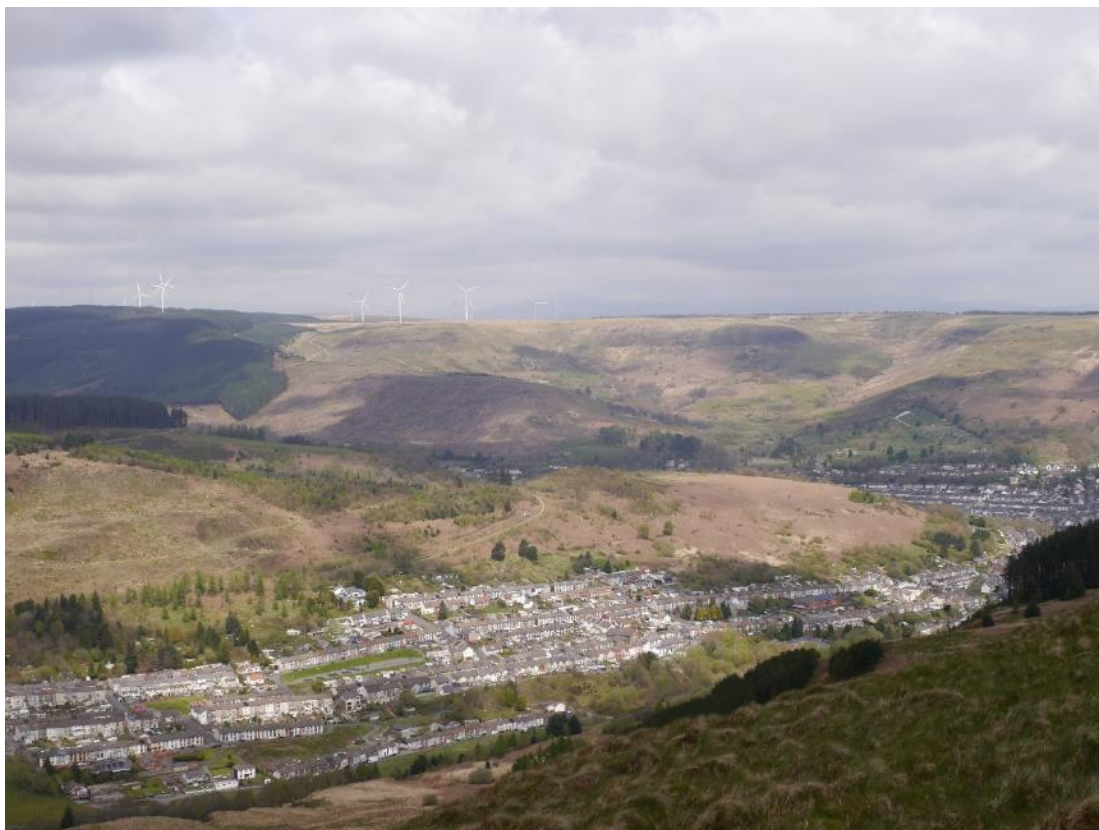
*Image 6: View towards the site from the south, showing the site in the context of its surroundings. The surrounding open upland can be seen, with ribbon development in valley bottoms and a band of intermediate trees and scrub. Plantation on the western slopes can be seen on the left of the view.*

The eastern slopes (see image 6) are open in character, with a mosaic of marshy grassland, bog, heath and scree. There are some pockets of plantation woodland remaining among the open slopes, as well as ribbons of broadleaved woodland in the valley bottoms which is consistent with descriptions in LANDMAP of a mosaic of open upland habitats and some wet woodland. The band of woodland above the urban area is less well defined than in the western plantation slopes, being less dense and more scattered. LANDMAP's Landscape Habitats: Coastal and Marine, Mosaic area, in which the site partially falls and which extends to the east of the site, states that there has been some decline in the area due to conversion to forestry. Settlement is largely confined to the valley bottoms although there is other evidence of industry on the slopes including wind turbines, a mast, and former colliery workings. The sense of place/ local distinctiveness, scenic quality and character to the east, which lie in the Cultural Landscape Services area of Cefn y Rhondda, are evaluated as weak and low within LANDMAP due to urban influences, extensive light pollution and the influence of wind turbines; however during the site walkover the area to the east appeared no less attractive, tranquil or urbanised than the western plantation slopes.
