Incline Haulage Tramway (4056m)

Rhondda Cynon Taf

Archaeological Survey

**Incline Haulage Tramway (4056m), Rhondda Cynon Taf
Archaeological Survey**

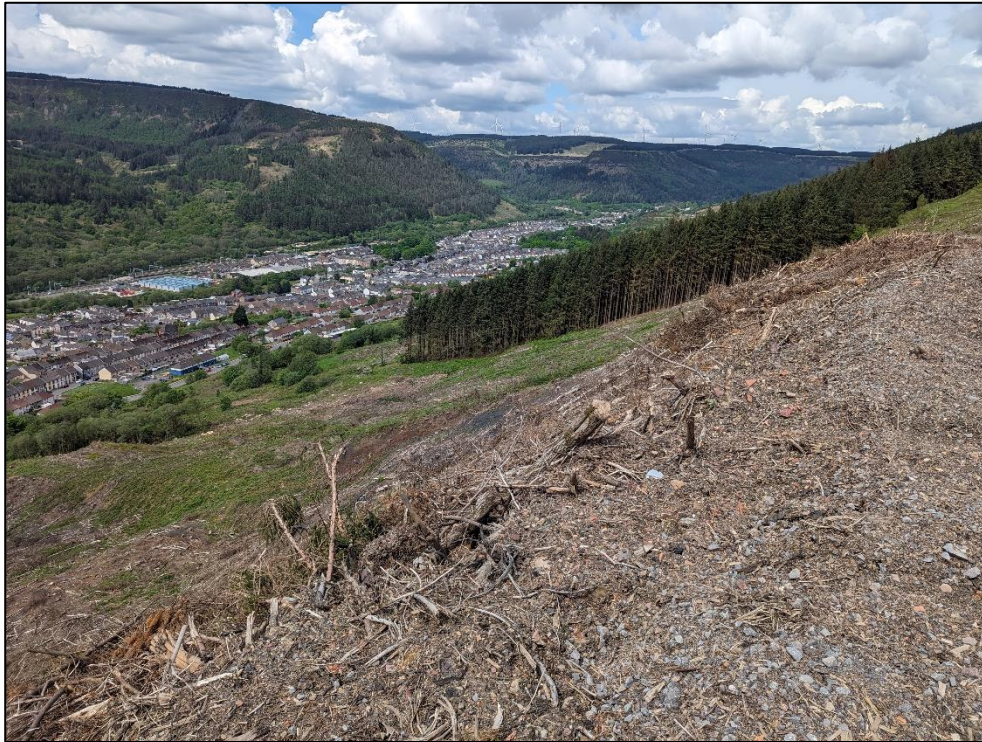
Plate 1. Oblique view of the upslope side of the tramway. Camera facing west.

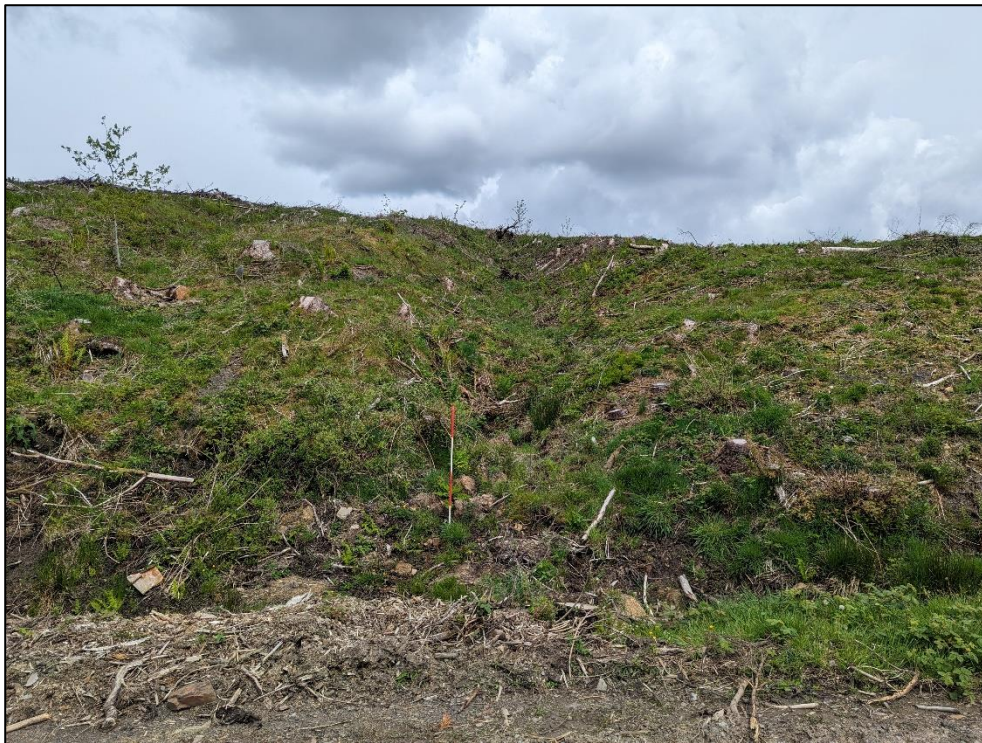
The segment of tramroad between the haulage system (GM508) and the southern side of the access road is concave with a broadly 'V' shaped profile (Plate 2). This levels out closer to the haulage system to the north and becomes less defined as the tramway crests the slope. This length was photographed, though was not surveyed due to poor access (felled trees etc.). The access road truncates the tramway and the surrounding spoil heaps, though the gradient either side of the road remains consistent.

**Plate 2. View to former incline haulage location (north of access road), camera facing northwest.
2.0m scale, 0.50m divisions**

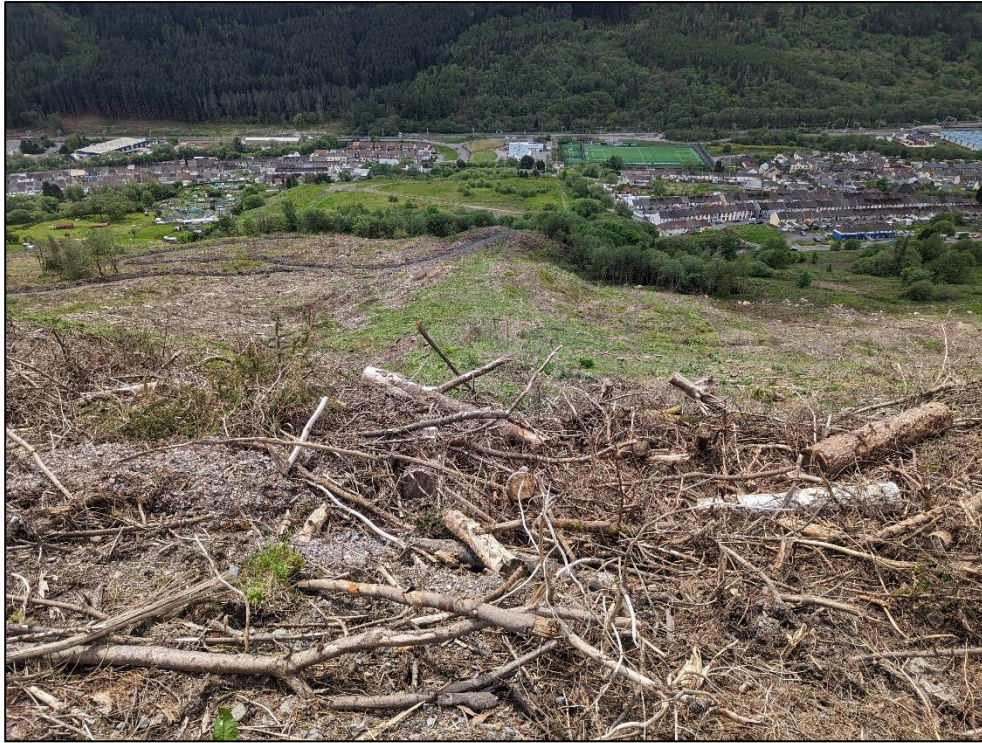
The profile of the tramway and the series of spoil heaps were only clearly perceptible south of the National Resources Wales access road toward the top of the slope. From this vantage (Plate 3) the linear aspect of the spoil heaps and tramway trajectory are clear. However, the definition of the mound quickly becomes diffuse when walking along its length. The area immediately south of the access road was still intact, though had undergone extensive erosion, bioturbation associated with the woodland cover and had been truncated by works associated with the roads at the top of the slope. This segment (Plates 3-7) was a maximum of 60m in length (profiles A to E) and a maximum of 9m in width. At approximately SS 94942 98178 the definition of the mound becomes increasingly imperceptible, which is to the immediate southwest of Profile E (Figure 1 and 2; Plate 7). This segment was convex in profile, though the ground levels in the immediate area were very irregular, therefore true dimensions may be distorted.

Plate 3. View to tramway downslope (from access road). Camera facing southwest

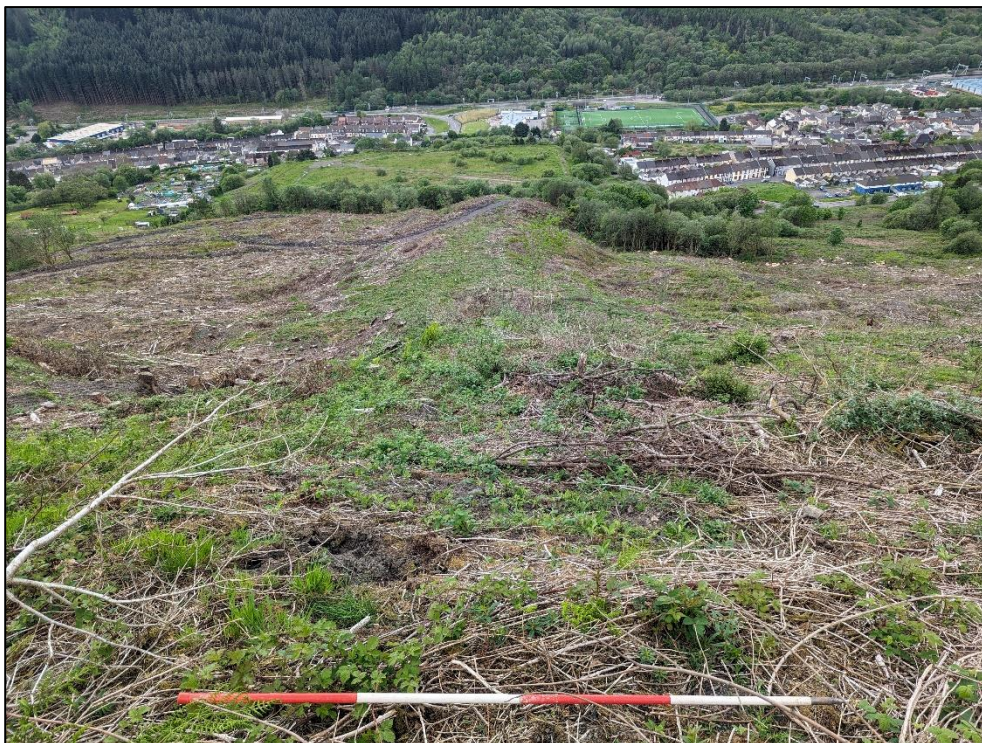
Plate 4. View to profiles A and B. Camera facing southwest. 2.0m scales with 0.50m divisions

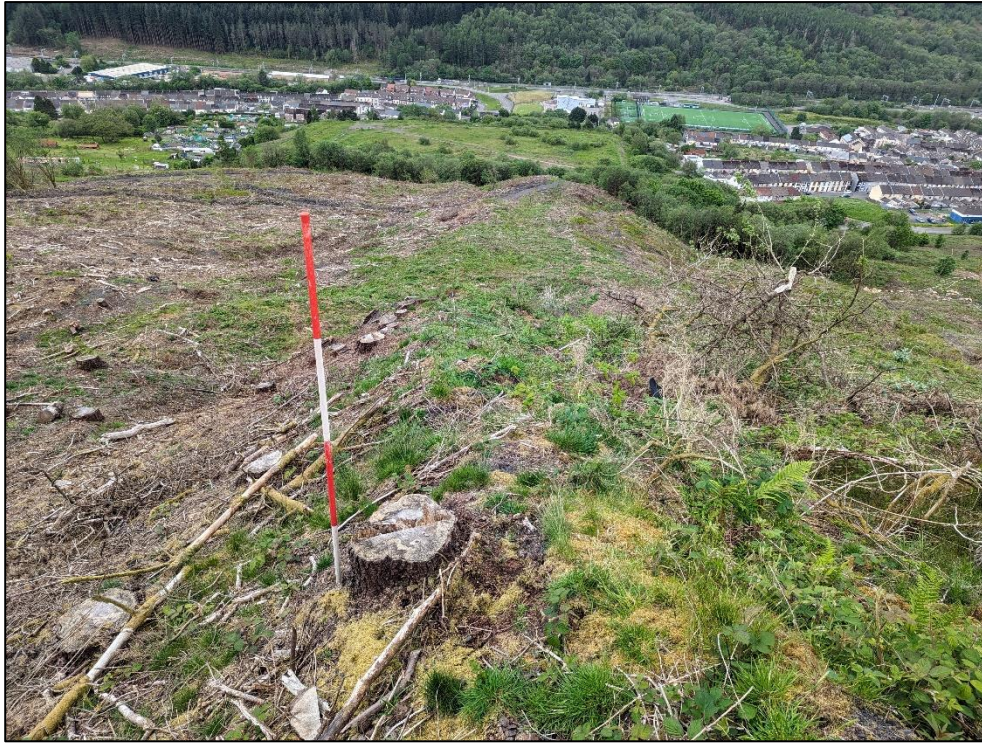
Plate 5. View to profile C. Camera facing southwest. 2.0m scale, 0.50m divisions

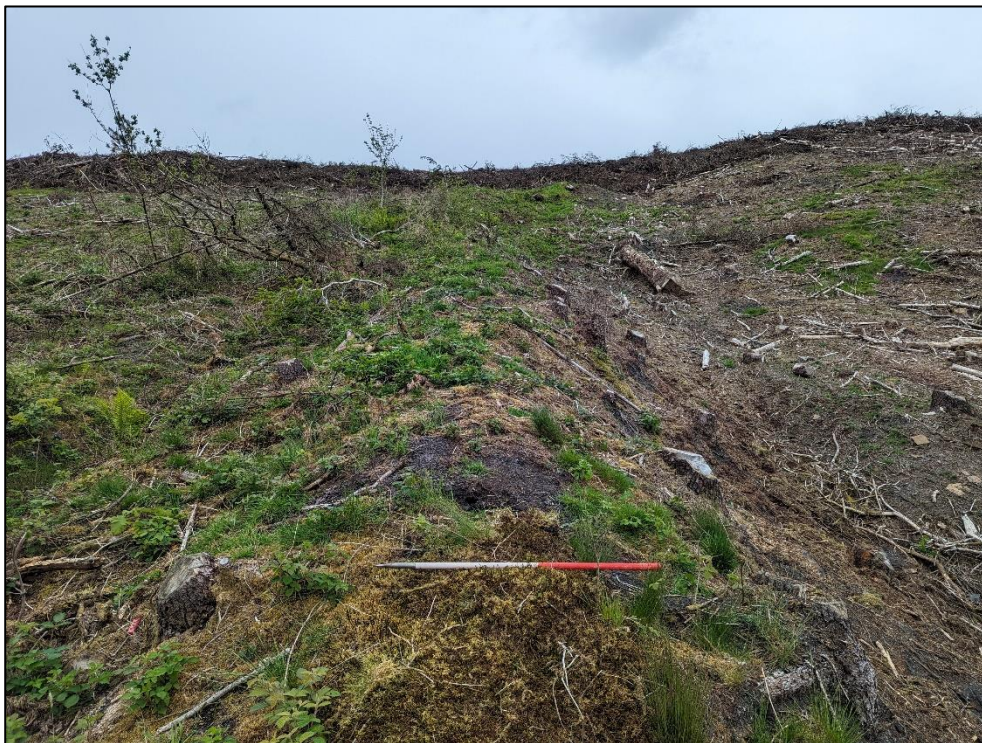
Plate 6. View to remains of the upslope segment of the tramway mound (Profile D). Camera facing northeast. 1.0m scale with 0.50m divisions

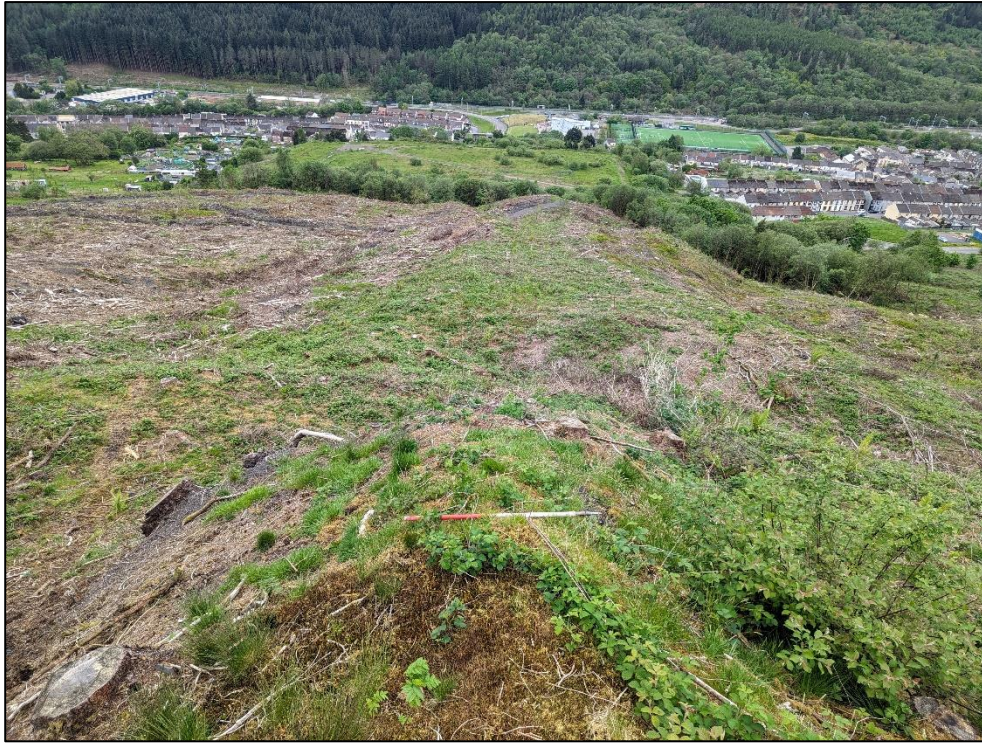
Plate 7. View to end of visible tramway earthwork, with Profile E visible. 1.0m scale with 0.50m divisions.

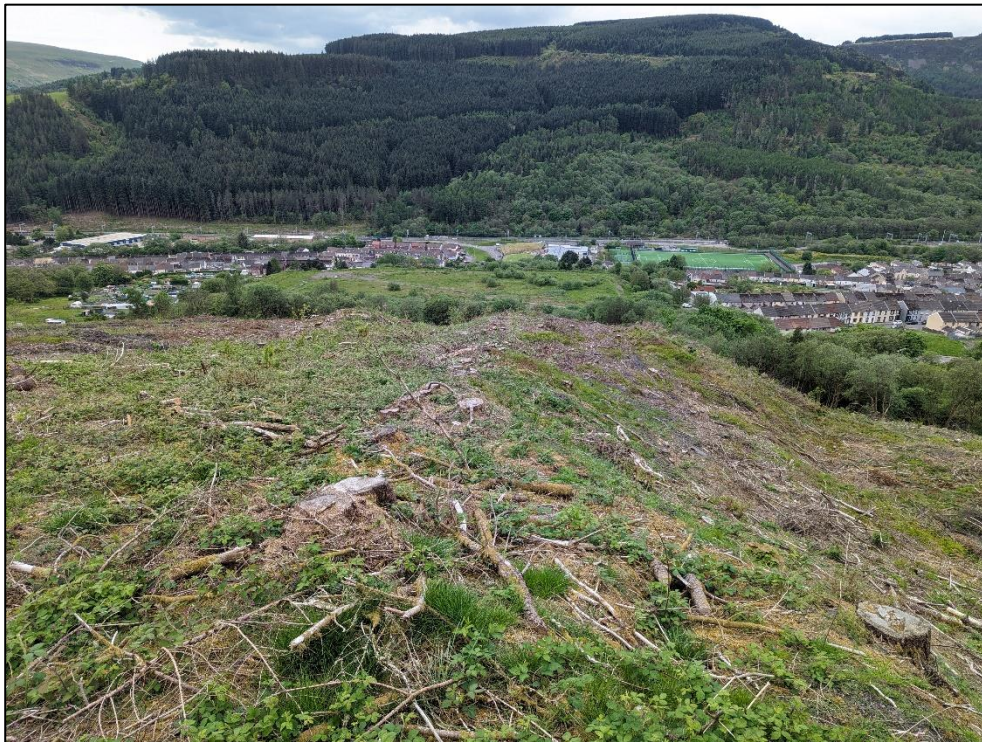
Past this point, there is no visible 'exact' tramway location, though the trajectory of the spoil tips are still clear. There is flatter area along the spoil heaps centreline though no identifiable earthwork survives along its axis, as is evident along profiles F and G, and as seen in plates 8 - 10. Very little is discernible past NGR: SS 94865 98086, at which point the spoil heap is truncated by a track curving to be orientated northwest-southeast. At this point, large gaps are present in the spoil heaps and by extension the alignment of the tramway (Plate 11). The trajectory of the pathways and former landscaping works along the southern side of the slope have further distorted any feature that may exist. The perspective looking up-slope (Plate 12) demonstrates how diffuse the incline feature is, as the abrupt changes in elevation and the gaps between spoil heaps are able to be seen more clearly.

Plate 8. General shot of western spoil tip slopes (Profile G visible along centreline). Camera facing southwest.

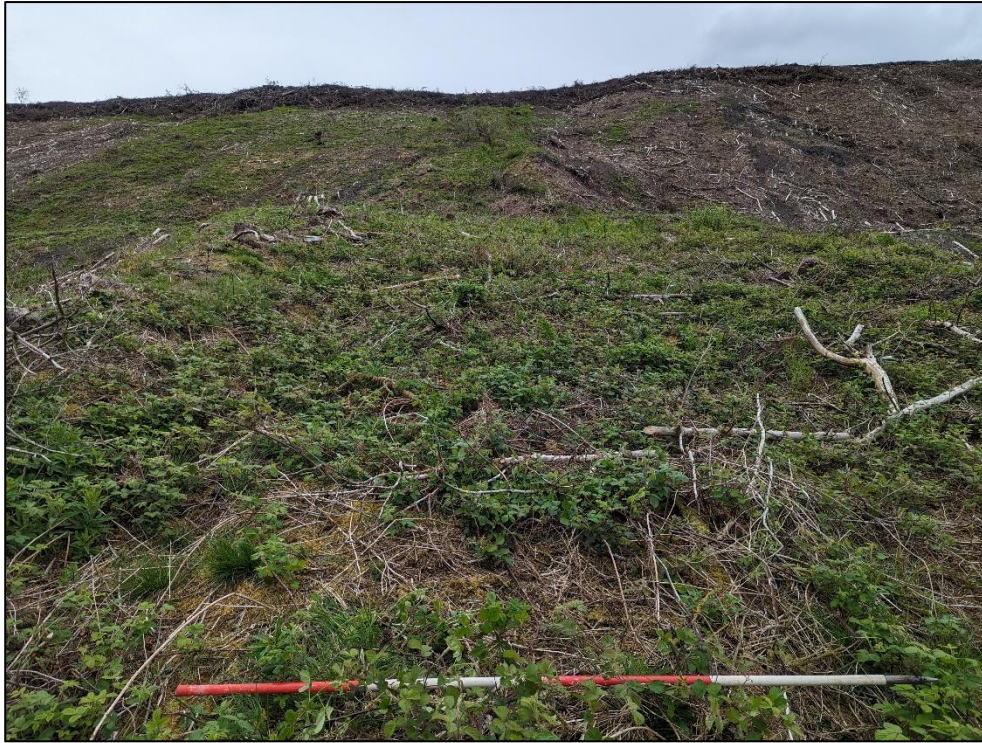
Plate 9. View to flat area in-between mounds representative of the probable tramway route (Profiles F and G). Camera facing northeast. 2.0m scale with 0.50m divisions

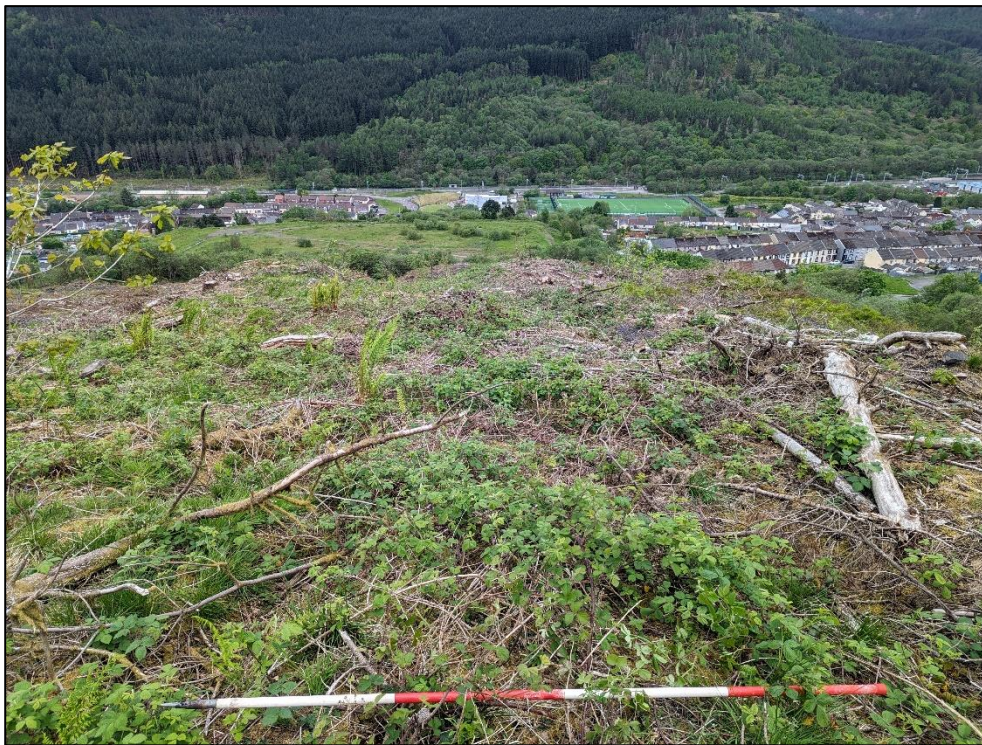
Plate 10. View to flat area in-between mounds representative of the probable tramway route. Camera facing southwest. 2.0m scale with 0.50m divisions

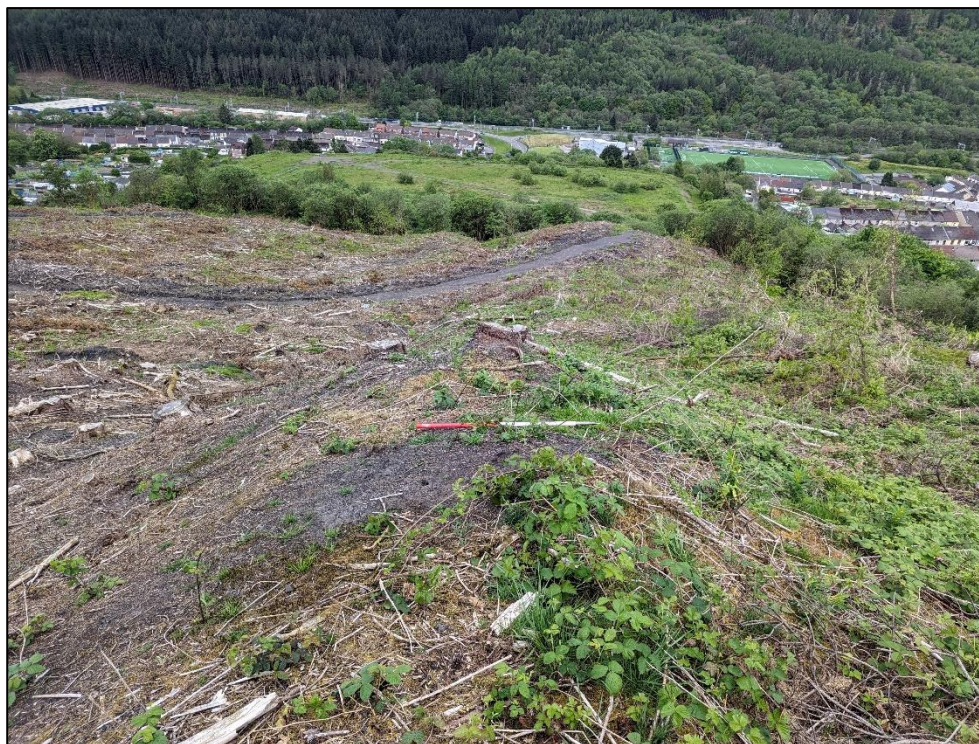
Plate 11. General view downslope showing the gaps in the spoil tips. Camera facing southwest. 1.0m scale with 0.50m divisions

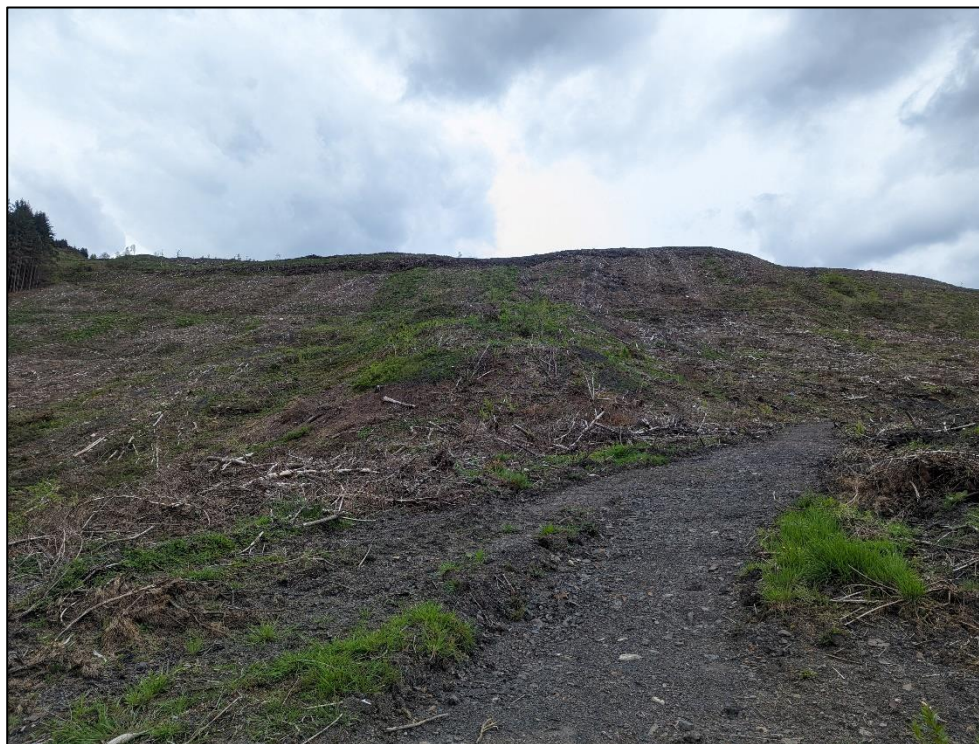
Plate 12. General view up-slope from track. Camera facing southwest

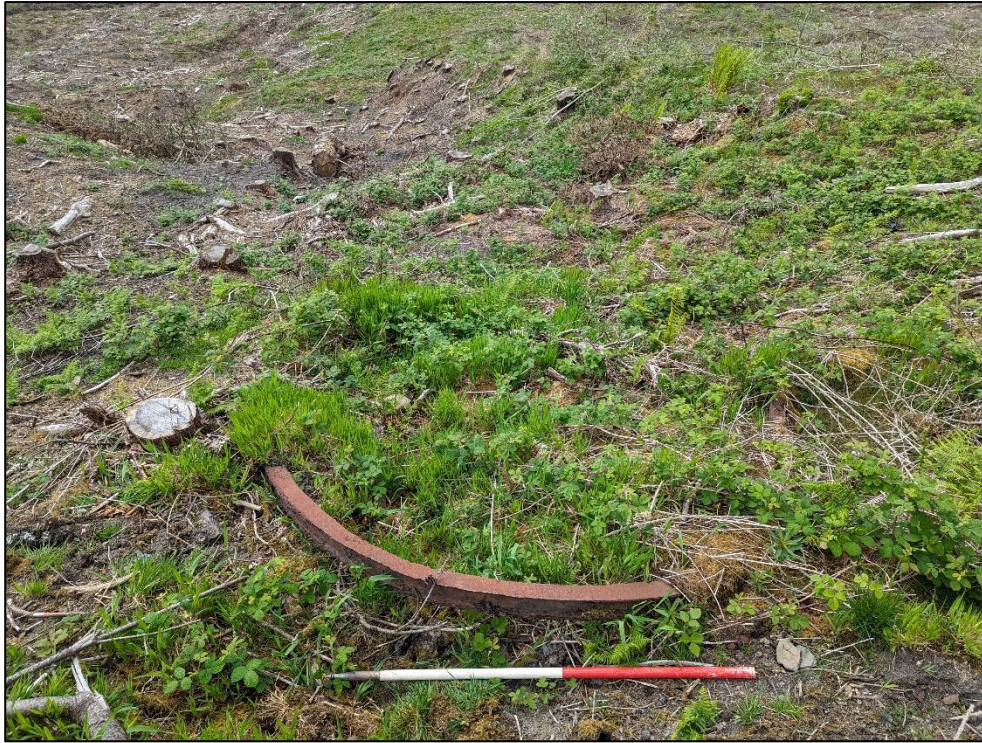
Very little material evidence was observed along the tramway aside from the eroded remains of the earthworks, particularly upslope. However segments of tram track (Plate 13) were identified at NGR: SS 94979 98216 to the east of the tramway. This was bent out of shape and was not found in-situ. Approximately 6.0m of length was visible, and it was 0.08m in width and depth.

Plate 13. View to tramway track to the east of the tramway orientation. 1.0m scale with 0.50m divisions

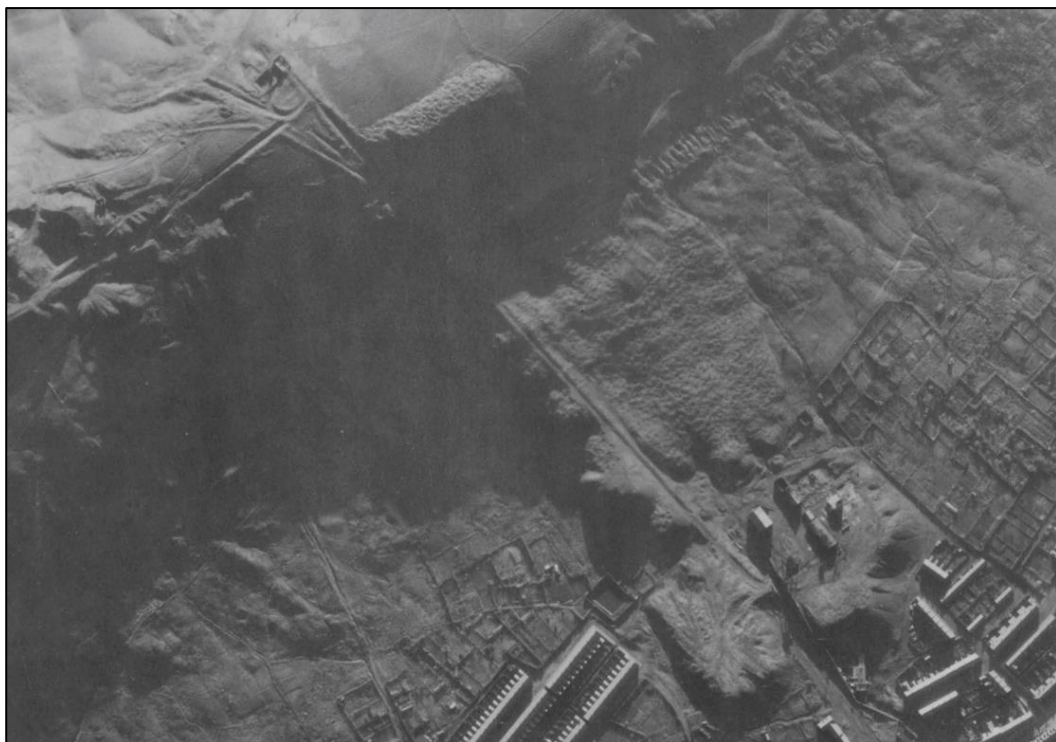
Plate 14. 1947 Aerial photograph (Sortie: 1947 4714 RAFCPE UK_2081 4245) showing the former appearance of the spoil tips bisected by the tramway

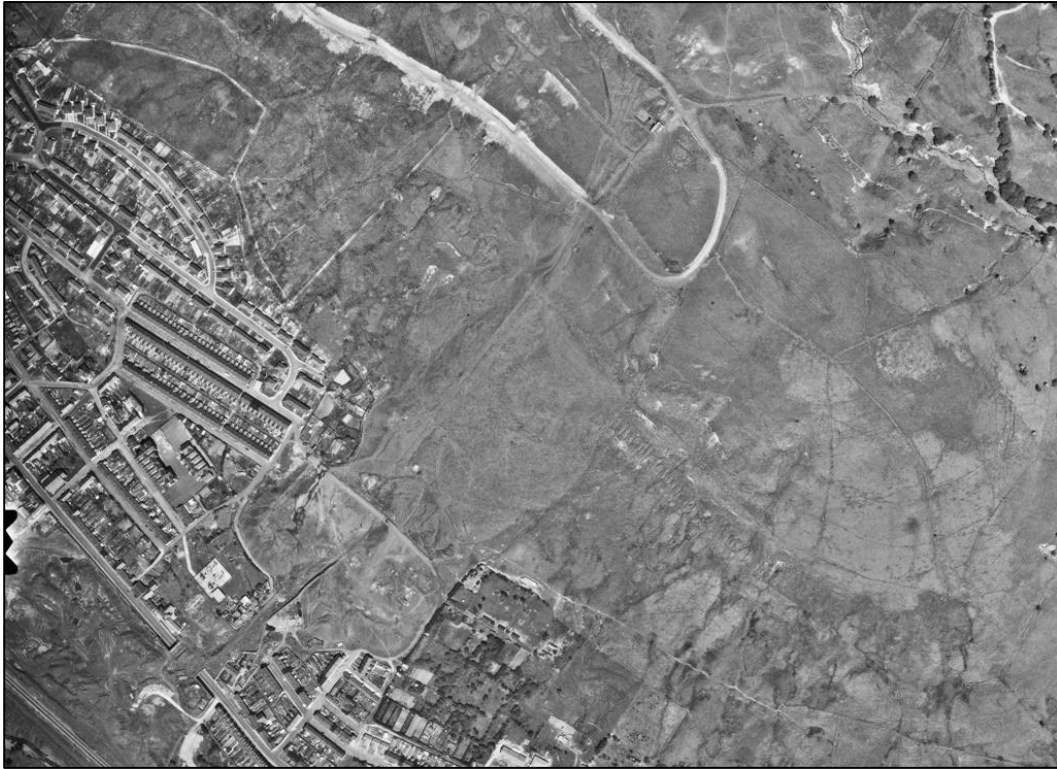
Plate 15. Aerial photograph (Sortie: 1967 6742 OS 67_186 221) showing the abandonment of the Ynysfeio Colliery

Review of the historic mapping and aerial photography show that by the 1960's the landscape encompassing the site was undergoing change (Plate 15) with industrial features being abandoned (buildings of Ynysfeio Colliery were gone by this date, with only the spoil heaps remaining) and the incline feature appears increasingly diffuse.

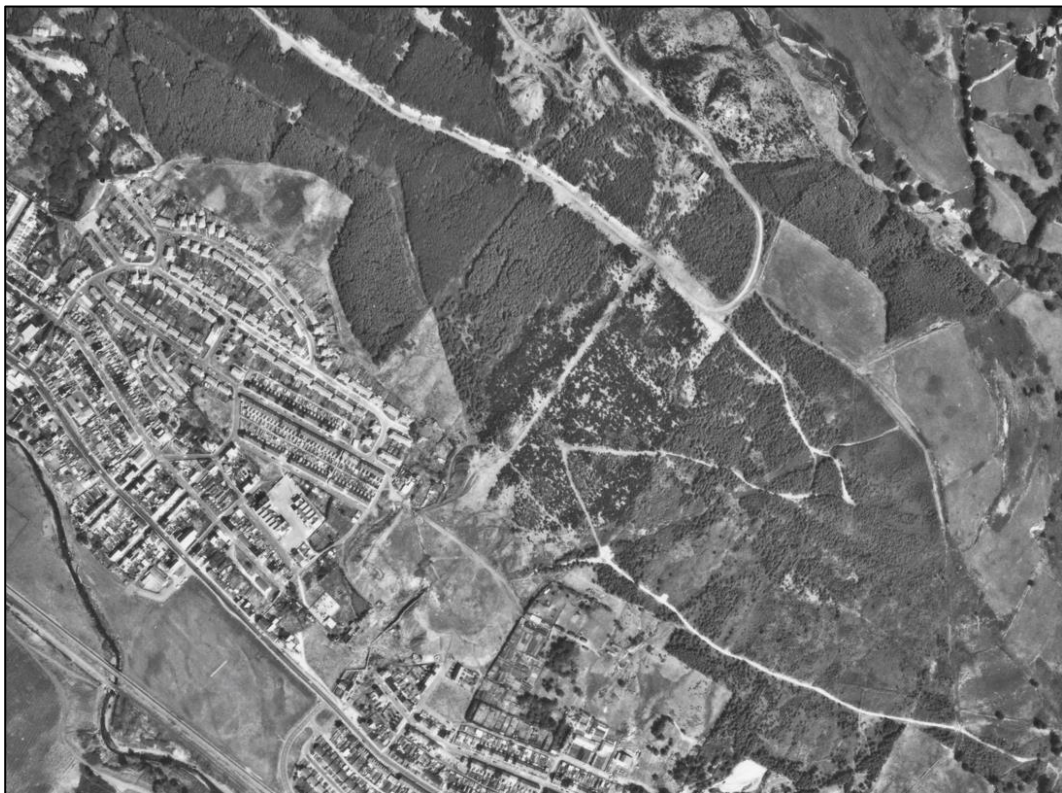
Plate 16. Aerial photograph (Sortie: 1983 8311 ADAS170_020) showing the rapid afforestation across the development area.

As noted in the initial desk-based assessment, there was rapid afforestation by 1983 which persisted up until the recent land clearance (Plate 16-17). This, along with any landscaping that may have occurred after the decommissioning of the tramway, is likely what caused the tramway features to become increasingly imperceptible.

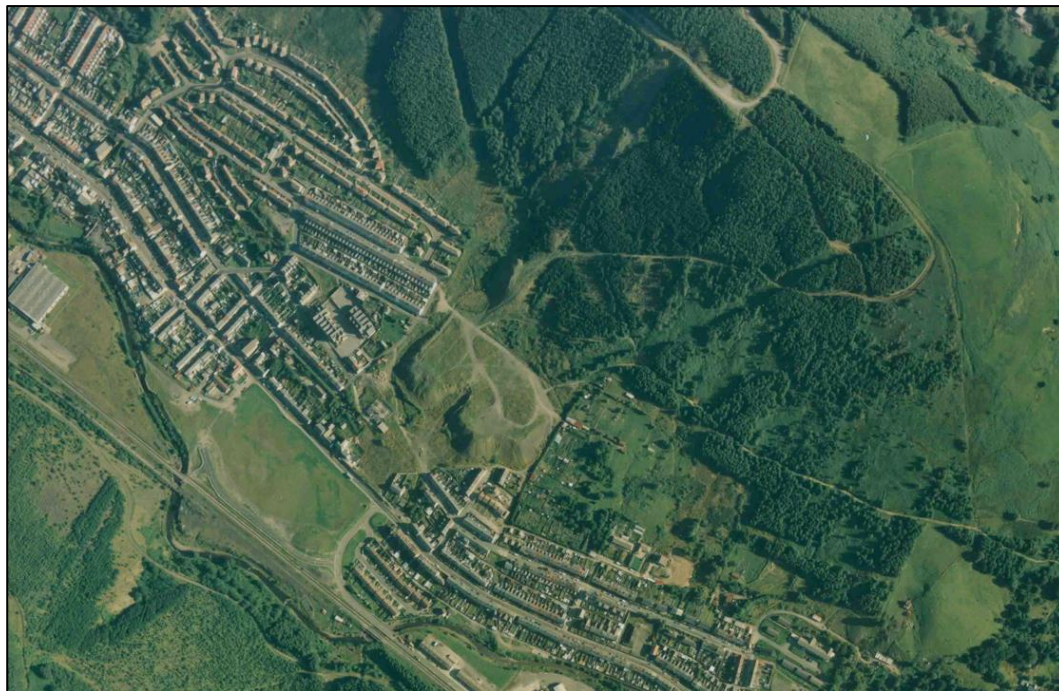
Plate 17. Aerial photograph (Sortie: 1991 Geonex7991 137) showing continued afforestation and pathways linking and truncating the southern slope of 04056m.
