PEN-YR-ENGLYN

Interpretive Ground Investigation Report

Project no. 4021526

Natural Resources Wales

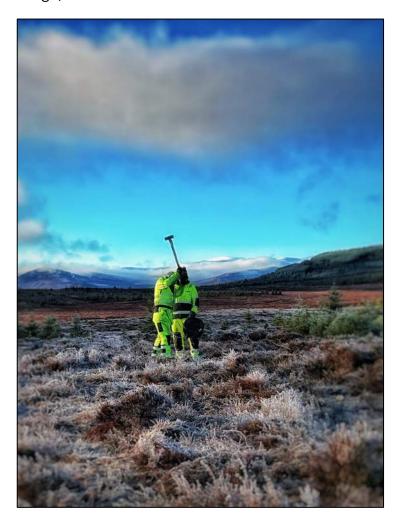
Figure 7: Example of seismic data acquisition.

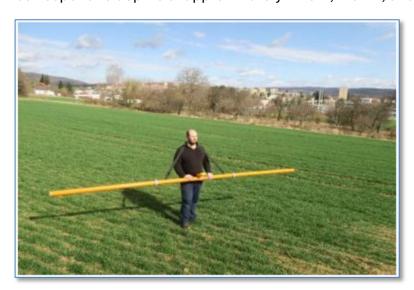
Figure 10: GF Instruments CDM Explorer
