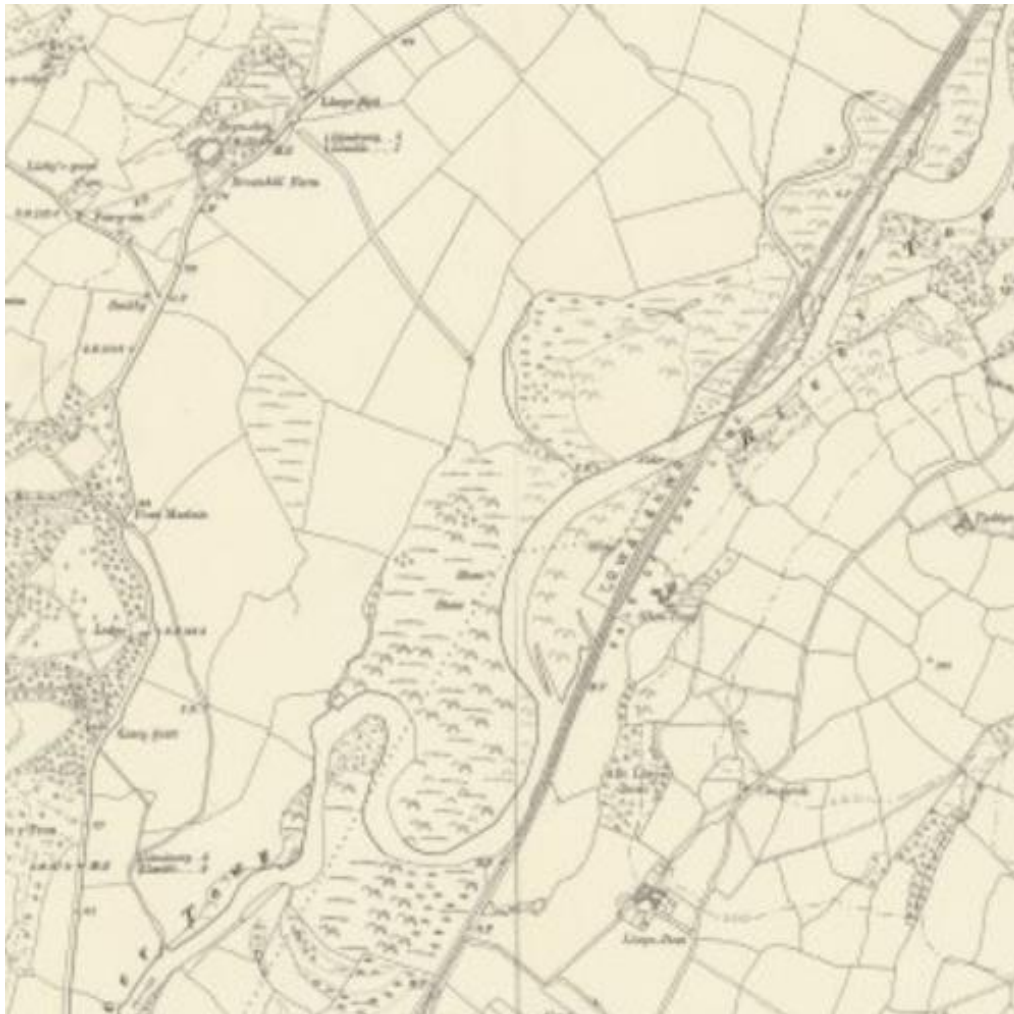
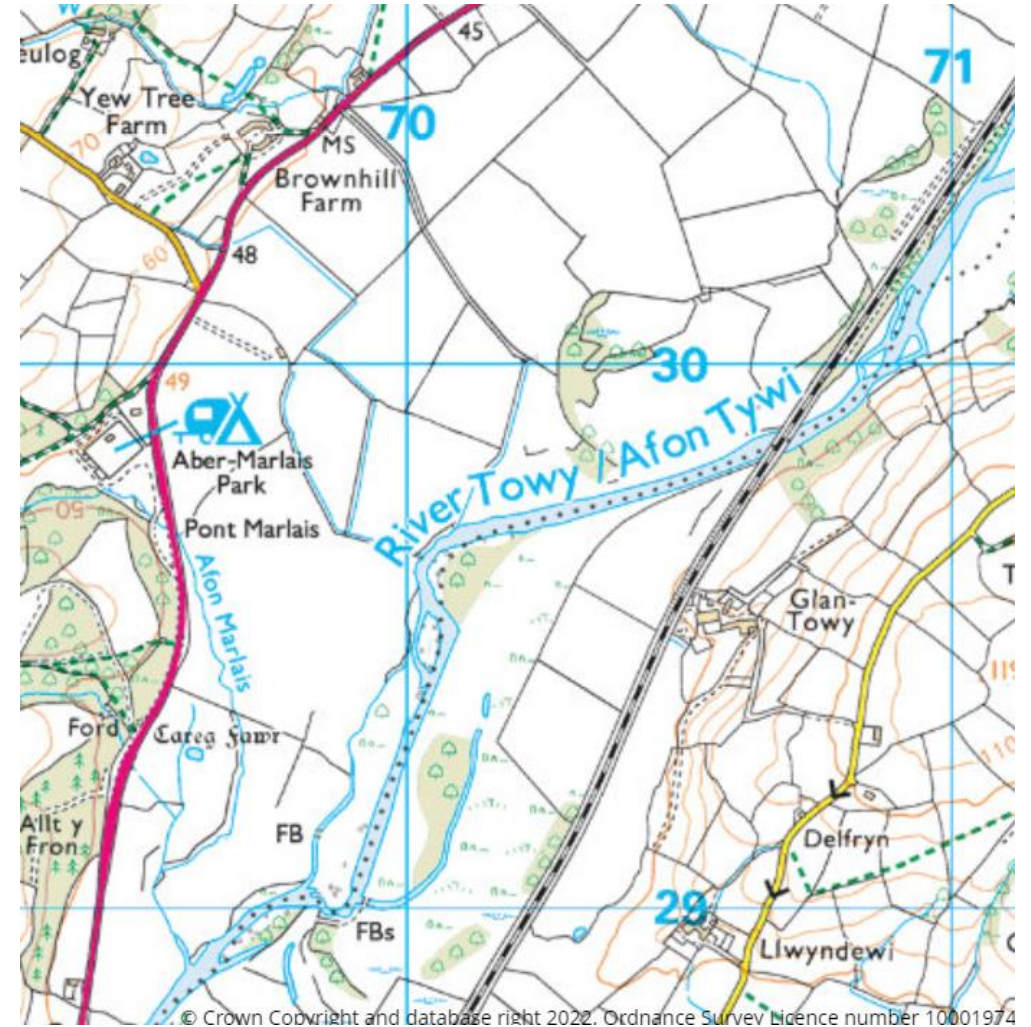
**Figure Three** shows the Ordnance survey map from 1888-1913 compared to that of today. The course of the river has altered significantly and many of the historic field boundaries are no longer present. This map illustrates the opportunity to restore the Afon Tywi to a more natural course, providing benefits to the SAC condition and for water management in the floodplain.
