# **PEN-YR-ENGLYN**

## Geotechnical Desk Study

**Project no. 4021526**

Natural Resources Wales

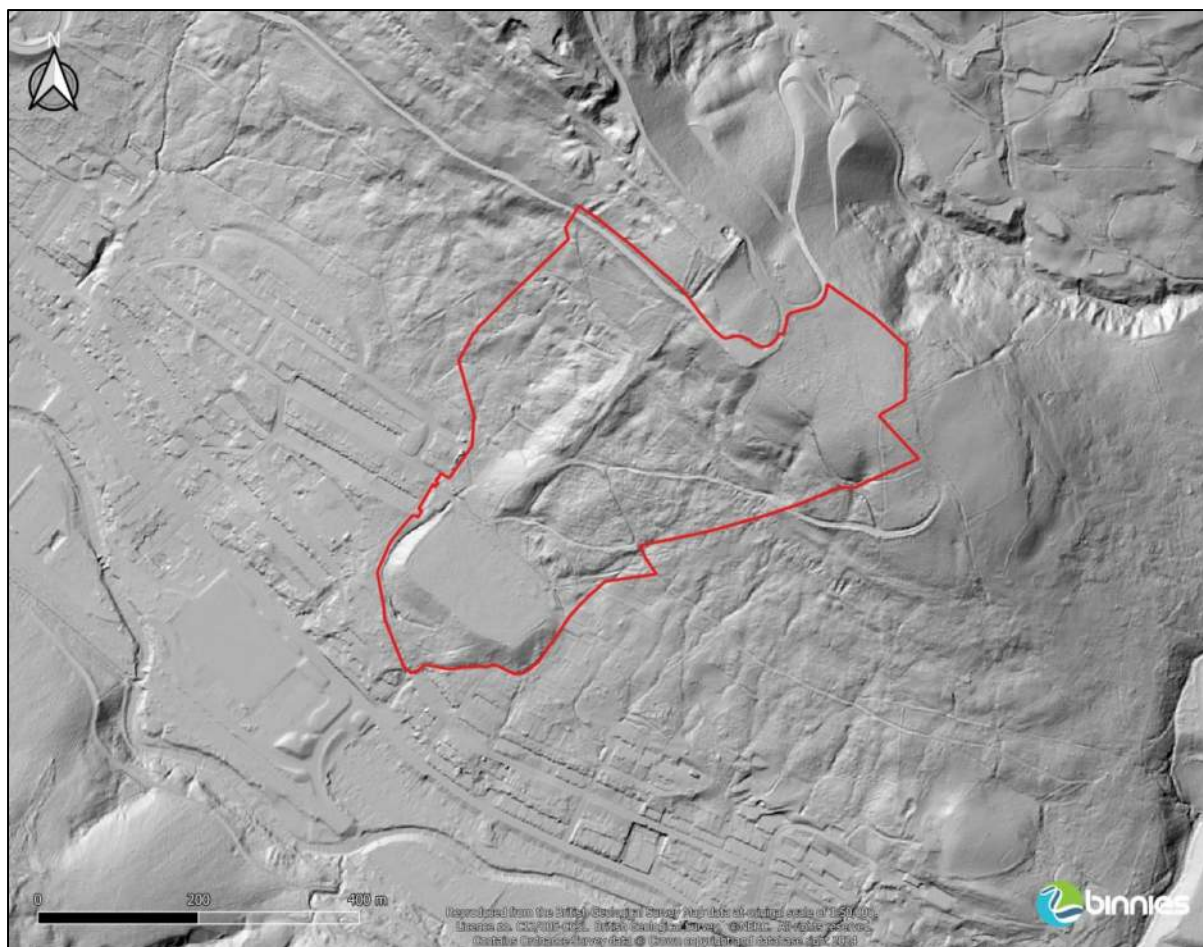
**Figure 3: DTM Lidar (1m) 2020 hill shade mapping, 1:5,000**

Figure 1 presents Ordnance Survey (OS) mapping with 10-metre contours, revealing the hillside's varied topography, including flat areas and a steeper gradient on the northeast side. The one-meter LiDAR survey in Figure 3 outlines the plateau and identifies a mound along the hillside, correlating with the historic tramway route used for spoil transport (further discussed in section 3.1.1). The LiDAR data, validated by site walkover observations, offers a precise depiction of the site's terrain at a 1m resolution. It shows two steep areas on the upper hillside and a smaller flat 'plateau' region at the base. North of the dismantled tramway and associated spoil deposits, a notable bulge can be seen, possibly related to the 'debris flow' area mapped by Halcrow in 2007.

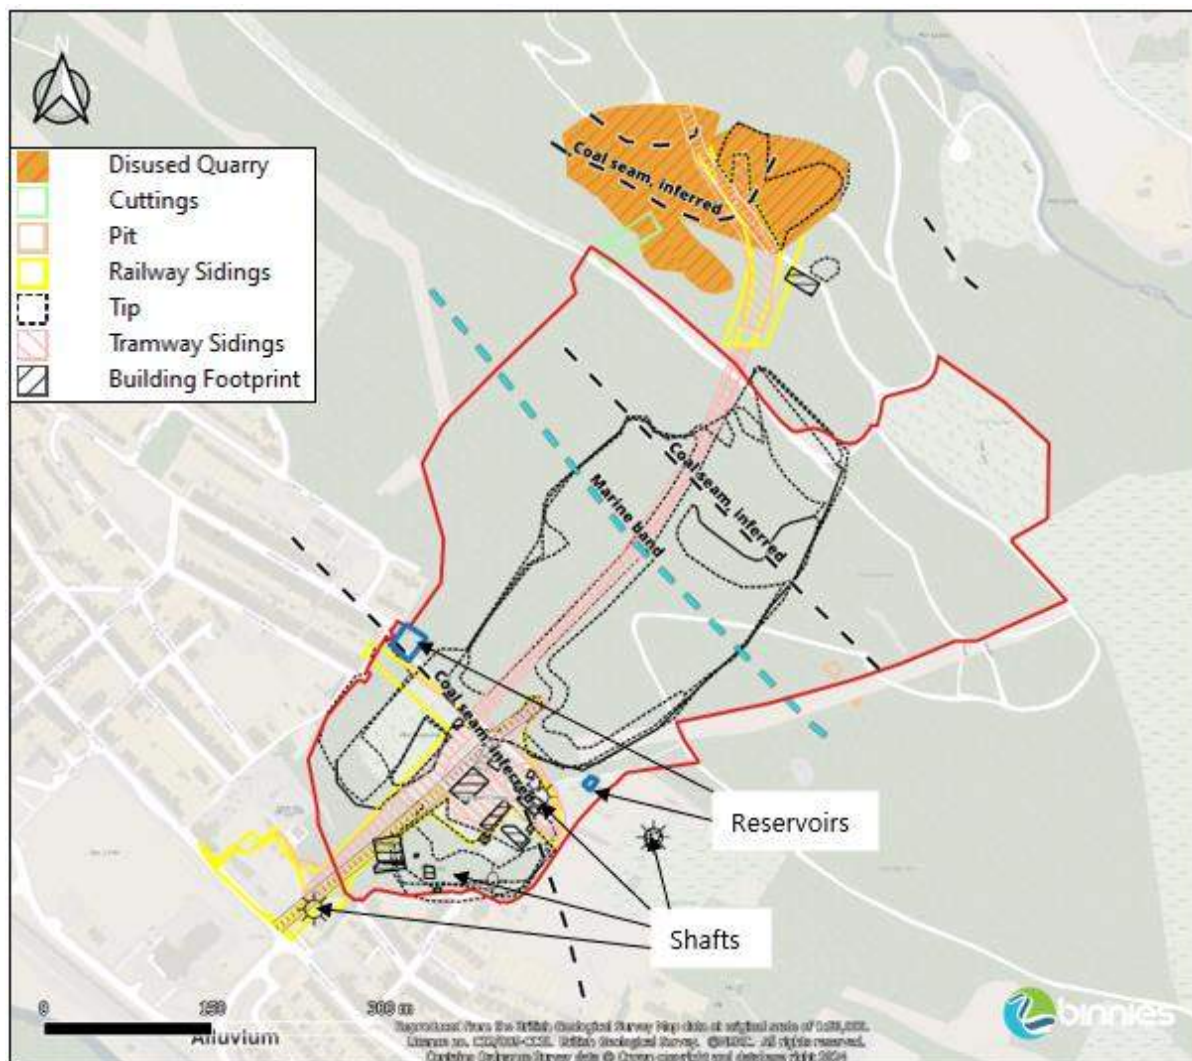
**Figure 4: Historical above-ground industrial land use extents including indicative locations of abandoned shafts, adits, reservoirs and historic building footprints.**

| Date | Source and Scale | Historical Land use (on-site) | Historical Land Use (off-site) |
|---|---|---|--|
| 1877 | Ordnance survey 1:2500 | An "Old level (coal)" is marked at the southernmost point of the site which is likely linked to the engine house and air shaft previously mentioned. The remainder of the site remains undeveloped. | No significant changes were noted. |

| Date | Source and Scale | Historical Land use (on-site) | Historical Land Use (off-site) |
|---|---|---|---|
| 1920 | Ordnance survey 1:2500 | The tipped spoil is mapped at a higher resolution and includes four sloping terraces on the western side of the tramway and three broader sloping terraces on the western side. | No significant changes were noted. |
| 1960 | Ordnance survey 1:1250 | All colliery spoil buildings are no longer present within the footprint of the plateau. The slope-tipped spoil has been mapped in further detail and comprises several terraces on either side of the dismantled tramway. A footpath is mapped following the tramway and diverting towards the east halfway up the slope. | No significant changes were noted. |

| Date | Source and Scale | Historical Land use (on-site) | Historical Land Use (off-site) |
|---|---|--|---|
| 1987 | Ordnance survey 1:1250 | A zig-zag forestry track is now present cutting into the eastern side of the spoil tip. | No significant changes were noted. |

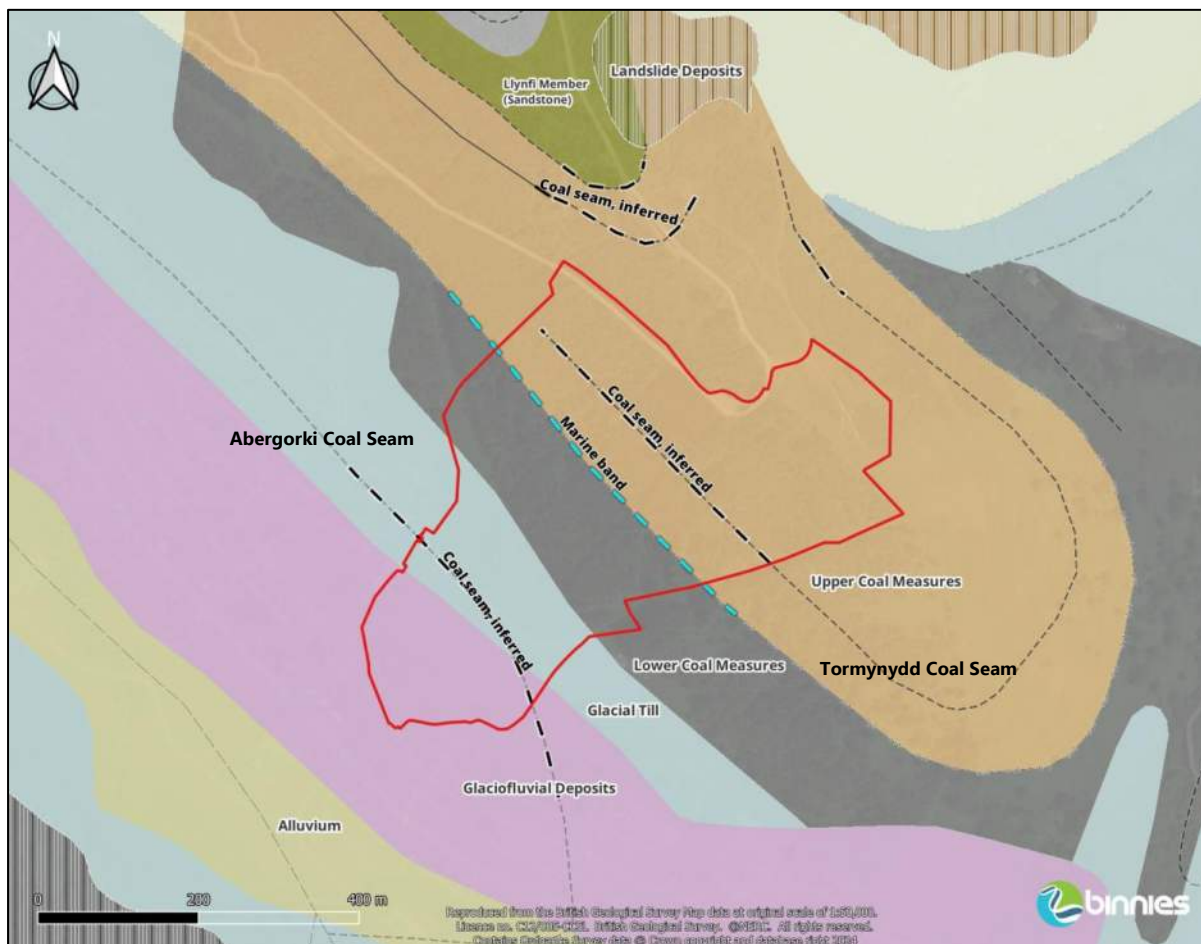
**Figure 5: Superficial and Bedrock Geology after (Groundsure, 2023).**

Beneath the plateau area, the geological mapping indicates the presence of Glaciofluvial sand and gravel deposits. Deposits of Glacial Till are noted within the northeastern edge of the plateau and extend up the hillside. While alluvial deposits are found along the valley floor and near the river's path, none are mapped within the site's boundaries. However, there may be small, localised deposits of finer-grained material adjacent to present-day watercourses across the site.

The remainder of the site sits on the Middle Coal Measures, which include the Abergorki coal seam. The beds within the Middle Coal Measures are generally sub-horizontal dipping away from the face of the hillside at the site towards the northwest to north-north-west direction, with angles varying from a gentle 1° to a more noticeable 20°. Previous ground investigations have observed that the siltstone layers tend to dip between 5° and 10°.

Inferred coal seams are mapped along the northeast edge of the plateau (Abergorki Coal seam) and towards the top of the hillside below the forestry track (Tormynydd Coal seam). As mentioned above there is also a marine band running parallel to the highest inferred coal seam further down the hillside which dictates the boundary between the upper and middle coal measures as shown in Figure 5.

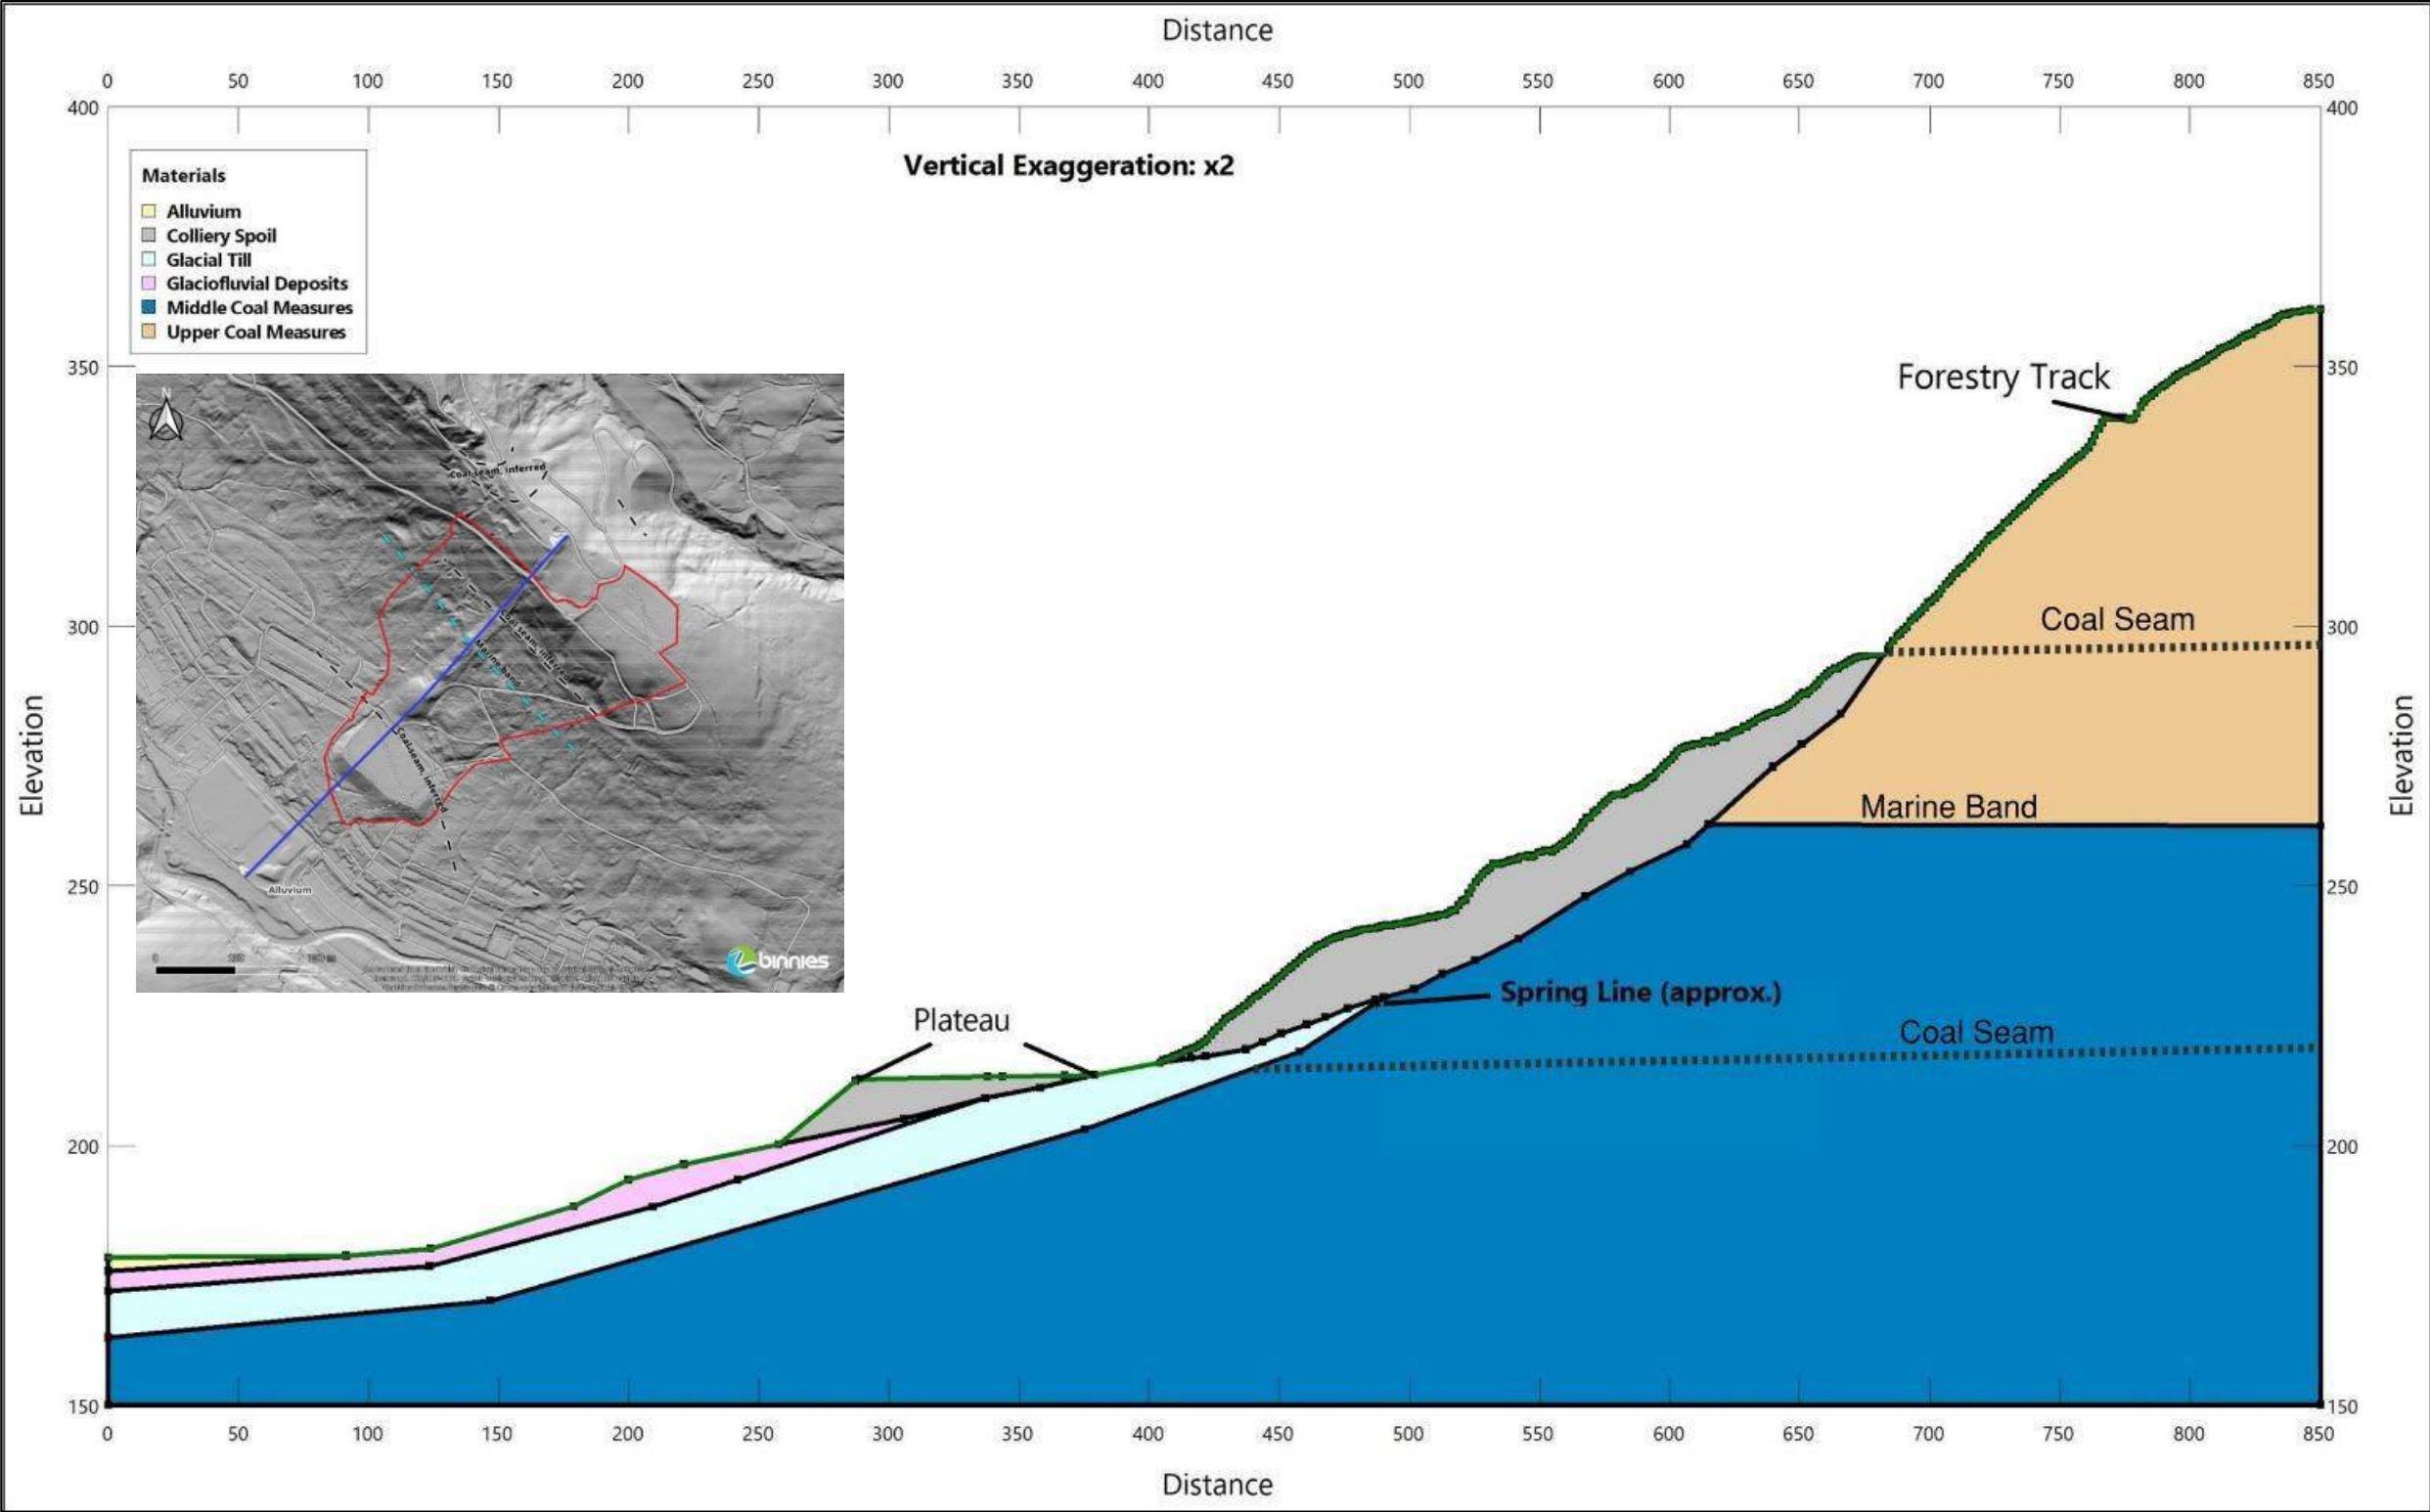
Figure 8: Geological cross-section representing the preliminary ground model where the tip material is assumed to be thickest. Insert map: shows the representative alignment used to develop the cross-section).

Based on the information obtained a conceptual ground model has been produced representing the transect along the middle tip and is presented in Figure 8. As a limited amount of information exists on the true thickness of the colliery spoil at the site, a comparison of the topography across the wider slope has been carried out in order to estimate its thickness alongside other supporting evidence.
