August 2025

Wales Metal Mines Programme Summary of Progress

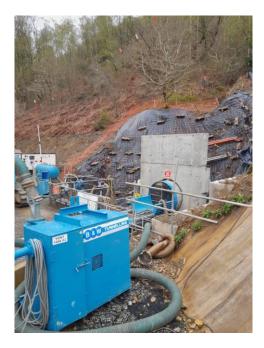
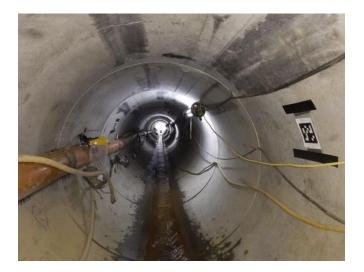
The Wales Metal Mines Programme has subsequently completed significant works to minimise the risk of an uncontrolled release of mine water from Adit 9 with the associated pollution and flood risk. These works involved driving a new mine entry to bypass a collapsing drainage adit and allow the minewater to flow freely from the mine; rather than building up and discharging in an acute event. Such events were witnessed in the 1980s and to a lesser degree in 2016 when a single event was estimated to discharge over 720 m3 of very contaminated minewater in 4 hours.

In 2025 a major wildfire in the wider Cwmrheidol area passed through the upper parts of the mine site. The pipeline carrying mine water from Adit 6 was lost to the fire and mine water discharged to the surface and found its way through rock fissures into adit 9, so increasing the risk of overwhelming the blow out prevention works. Rapid deployment of contractors by the Mining Remediation Authority, in collaboration with NRW, to replace the pipework averted any significant consequences.

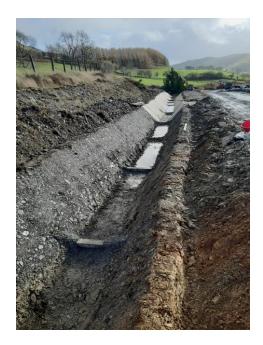
- replacing the liner on the surface water diversion channel to maintain flows and isolate the clean water from the mine waste.
- Maintaining and improving drainage pathways from the site to reduce sediment transport

In 2025 it is planned to install measures such as leaky dams upstream of the mine which will slow the flow of surface water is attenuated and that the diversion works installed in 2011 continue to operate and can handle potentially increased flows due to climate change.

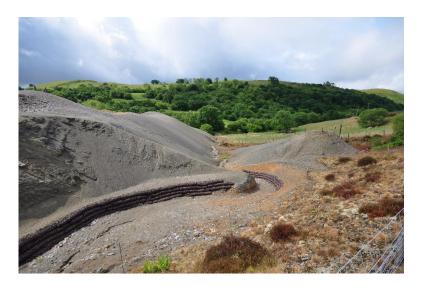
Adjacent to Frongoch Mine is the Wemyss mine and ore processing works. A single large conical waste tip has been subject to erosion of contaminated material since it was abandoned in the early 20th Century. In a single storm in 2012, and subsequently during Storm Darragh in 2024, rapidly increasing flows in the otherwise dry Mill Race stream caused the collapse of part of that tip, mobilising about 200m³ of metal rich mining waste into the Nant Cwmnewyddion watercourse, a tributary of the Afon Ystwyth. In 2025, erosion control works were completed to protect the toe of the tip from high flows in the Mill Race Stream. The works have stopped the further erosion of the tip at that point and have protected and improved water quality and reduced contamainated sediment deposition in 25km of the Afon Magwr and Ystywth.

Further works are planned in 2025 to divert the Nant Cwmnewyddion stream away from the southern part of the Wemyss Tip where it is undercutting the waste material and causing small collapses which again result in metal contaminated sediment being dispersed into downstream catchment.

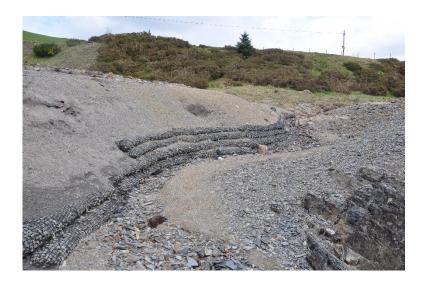
A significant remedial intervention is planned at Dylife mine in the upper reaches of the Afon Twymyn, a tributary of the Dyfi, starting in 2026, which will involve surface water management to stop clean water from two streams entering the mine and eroding waste material. However in 2022 the dressing floor area of the mine was identified as a significant source of contamination, with active erosion of material during high flow events. To combat the ongoing downstream movement of metal rich sediment, erosion controls were designed and installed. In the short time these erosion controls have been installed they stopped the mobilisation of c.400m3 of contaminated waste material into the wider Dyfi catchment, protecting and improving water quality in at least 15km of the Afon Twymyn.

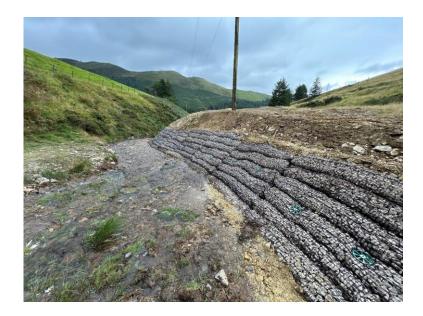
In 2024, works were completed to reduce erosion of a streamside mine waste facilities at Nant y Creiau Mine near Devil's Bridge and at Esgair Lle Old mine upstream of Ponterwyd. The works have stopped the active erosion of about 800m³ of tip material into the wider Rheidol catchment and protected vital infrastructure such as power supplies which were at risk of collapse at Esgairlle. These works have protected and improved water and sediment quality in over 30km of the Afon Rheidol and its tributaries.

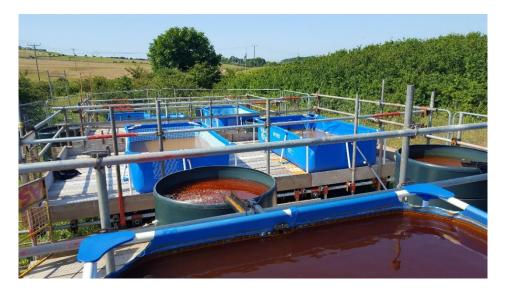
Dispersed alkaline substate technology was to pilot scale field trials at Parys Mountain Copper mine (Ynys Mon) and at Cwmrheidol. This system uses an organic substrate prepared with an alkali producing material, to capture metals in an insoluble form. The technique is semi passive in that it requires little energy or frequent addition of chemicals to function. The trials were successful at both sites and the trial reports are being considered for practical applications.
